WASHINGTON UNION STATION

HISTORIC PRESERVATION PLAN: VOLUME I

HISTORIC PRESERVATION PLAN

VOLUME I of III

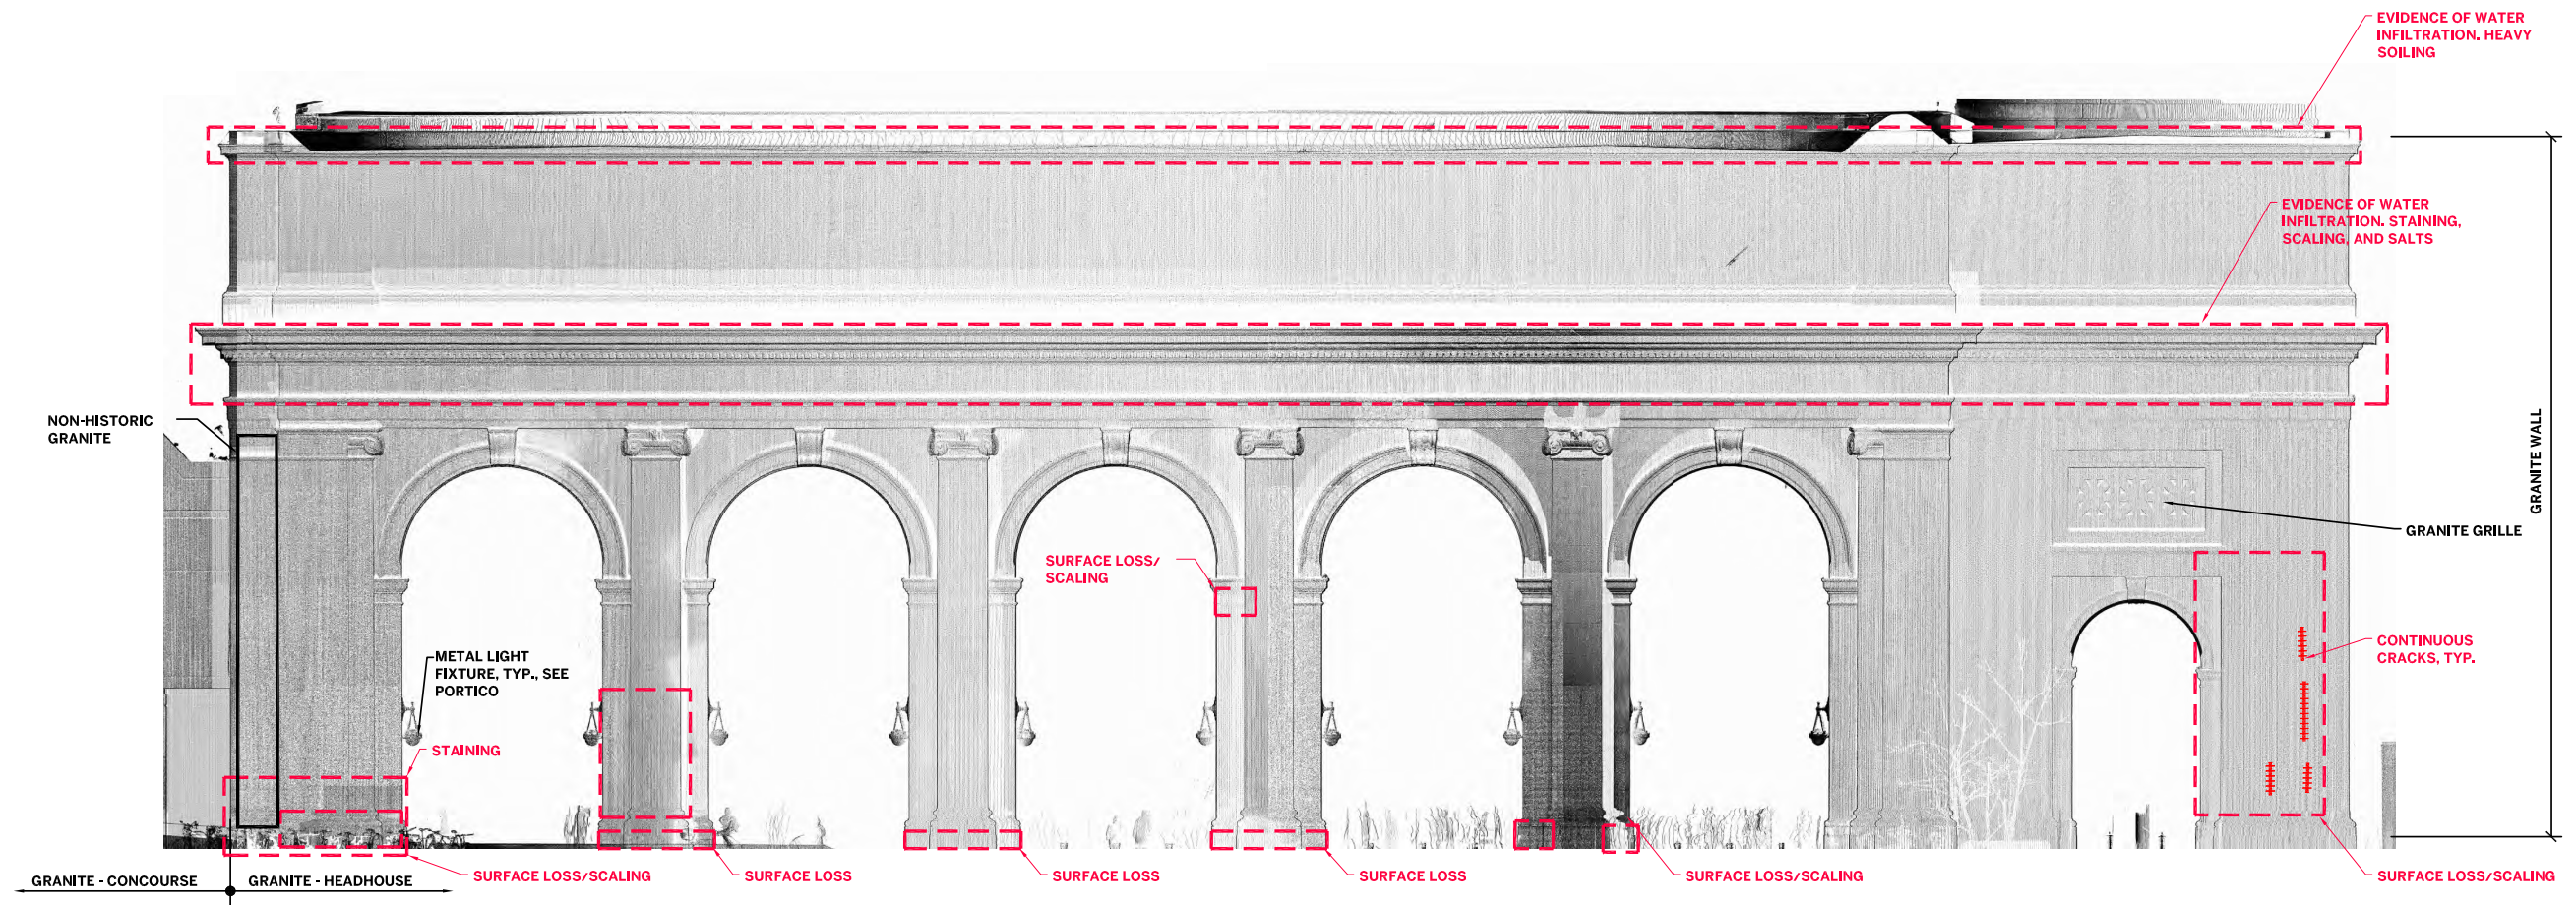
1. WEST ELEVATION

MATERIAL CONDITIONS WEST ELEVATION

CONTINUOUS CRACK

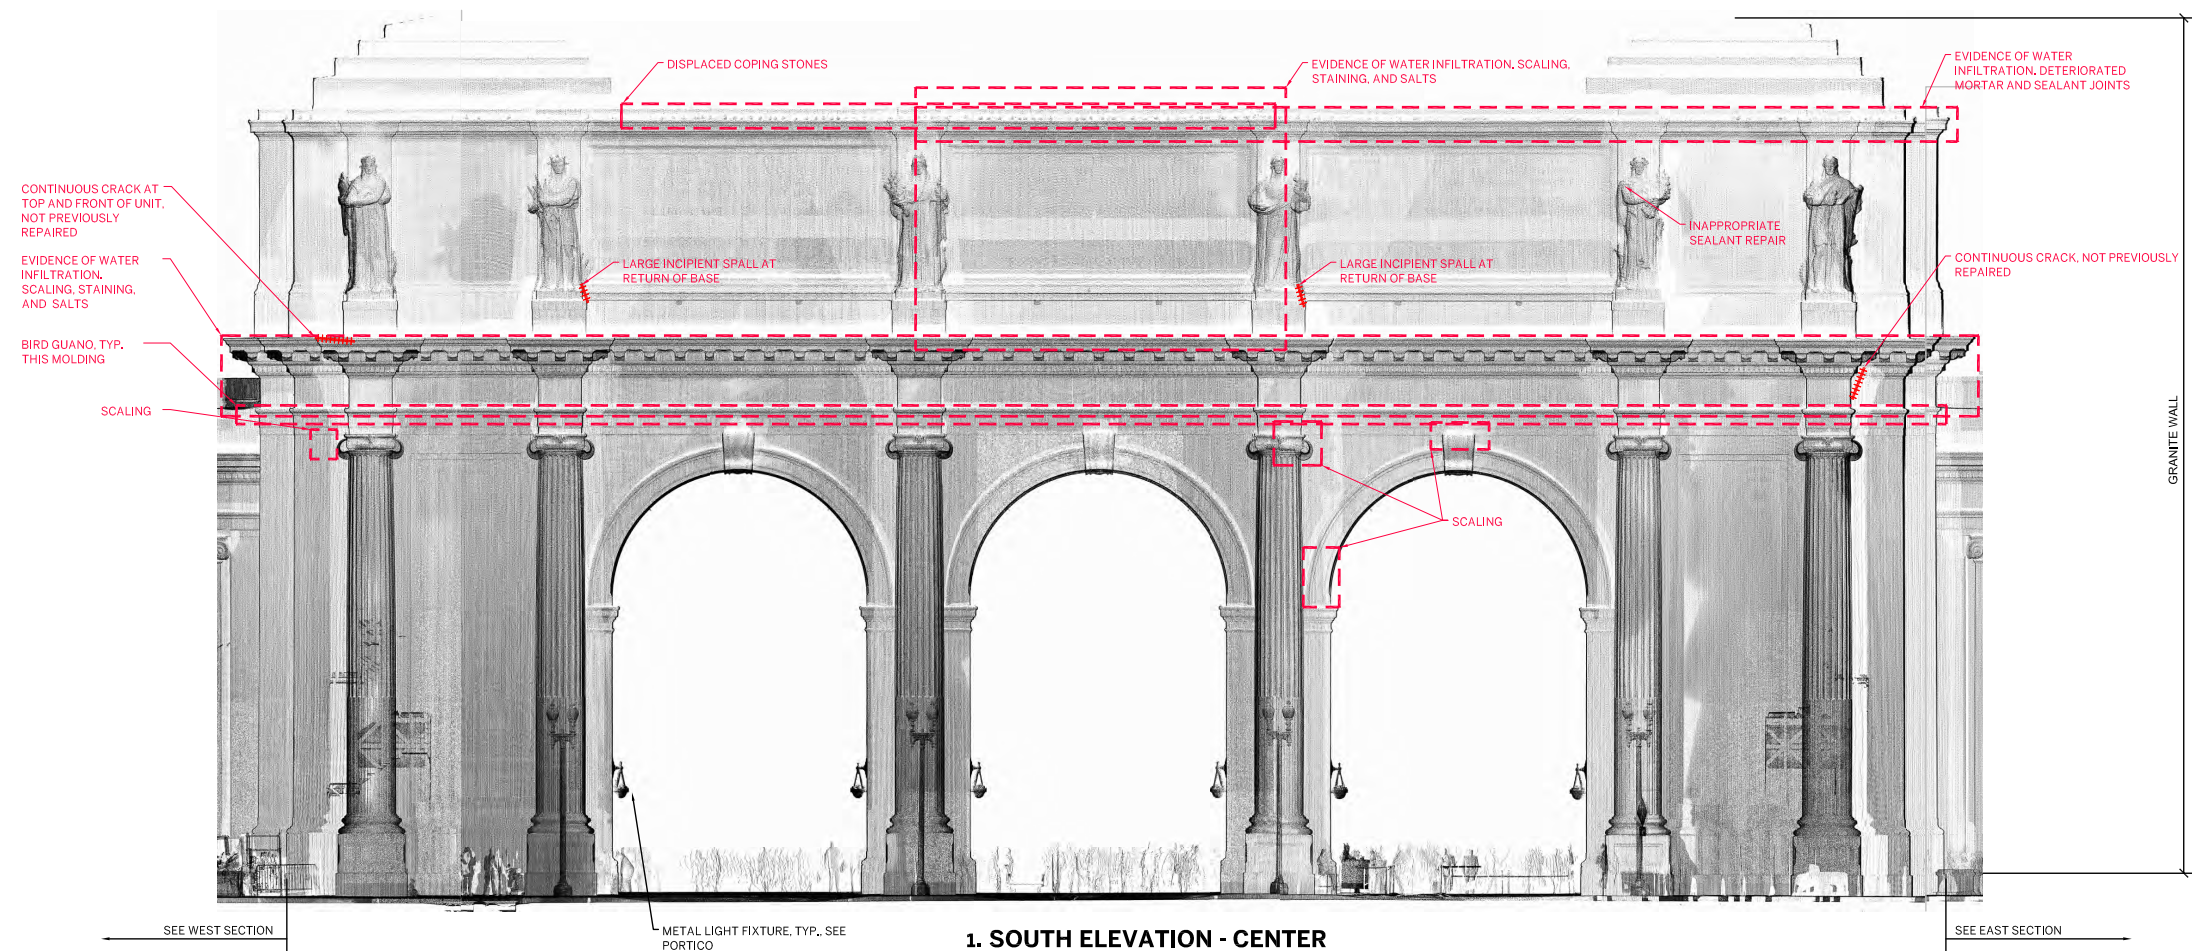
1. SOUTH ELEVATION - CENTER

MATERIAL CONDITIONS SOUTH ELEVATION

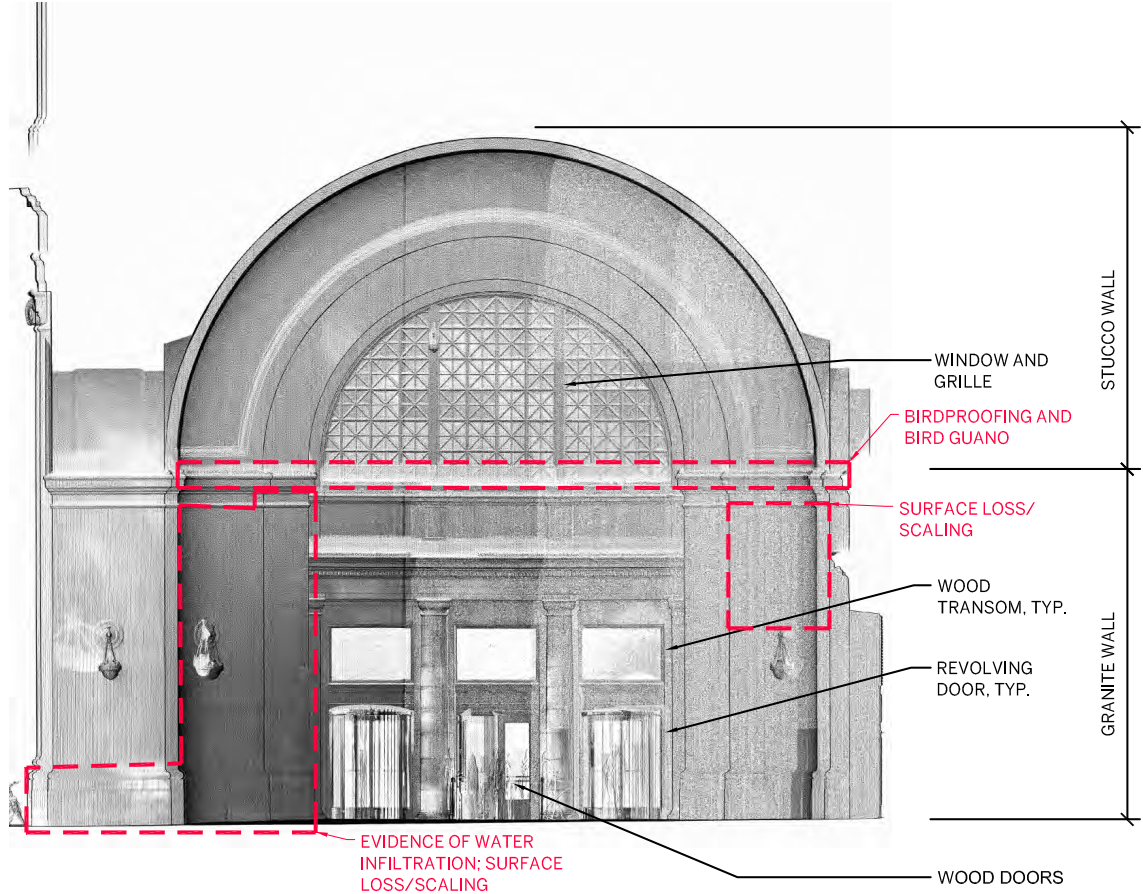
2. NORTH ELEVATION (ENTRANCE TO RETAIL CONCOURSE)

MATERIAL CONDITIONS CARRIAGE PORCH					SEE SHEETS: (E-9 - E-12)
ORIGINAL	ELEMENT	MATERIALS	FINISHES	CONDITIONS	NOTES
YES	CEILING	CEMENT STUCCO	PAINT	EVIDENCE OF WATER INFILTRATION, CRACKS, PAINT FAILURE	
NO	DOOR	METAL	PAINT	NOT SURVEYED	
NO	DOOR	WOOD	CLEAR COATING	NOT SURVEYED	
YES	DOOR FRAME AND TRANSOM	METAL AND WOOD	PAINT	LOSS, PAINT FAILURE	
YES	FIXTURES	METAL	-	NOT SURVEYED	WALL LIGHT FIXTURES
YES	GRILLE FRAME AND GRILLE		PAINT		
YES	WALL	GRANITE	-	SURFACE LOSS/SCALING, STAINING, CRACK(S), CONTINUOUS CRACKS, EVIDENCE OF WATER INFILTRATION, BIRDPROOFING, BIRD GUANO, DETERIORATED MORTAR, ABANDONED ANCHORS,	
YES	WINDOW AND WINDOW GRILLE	WOOD	PAINT

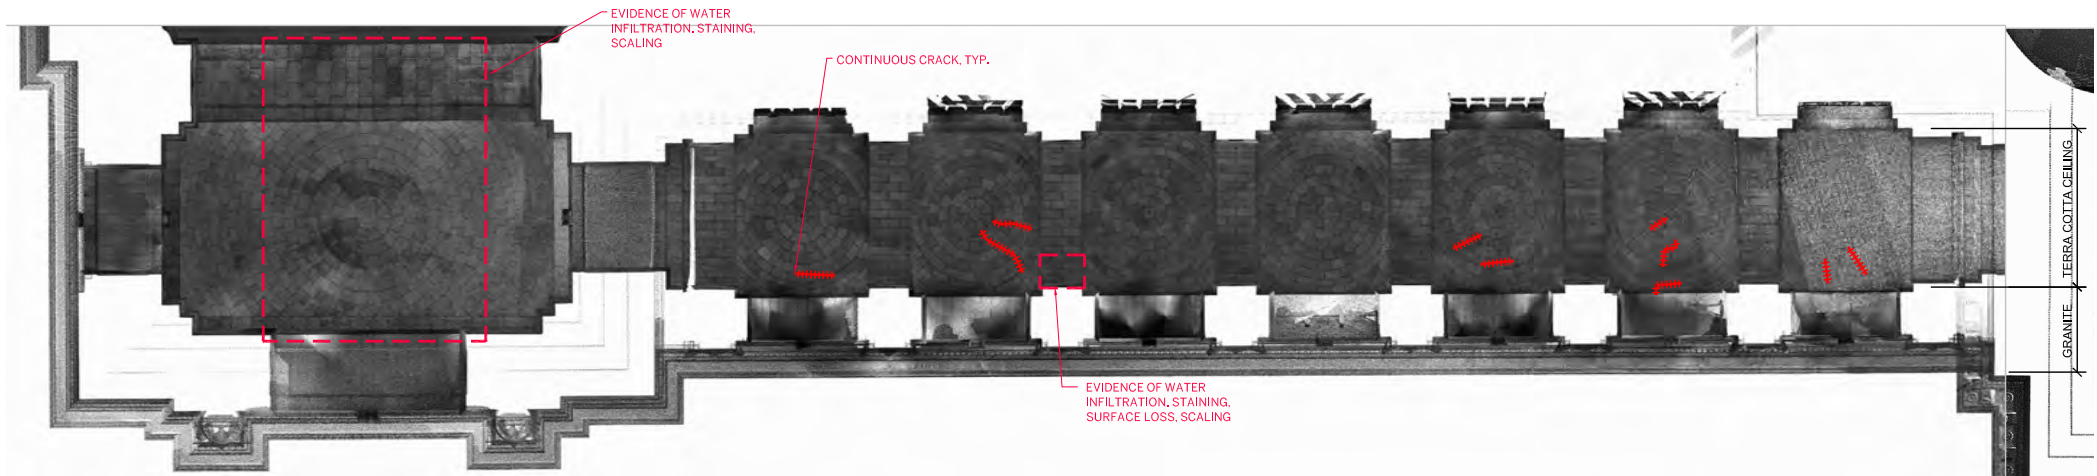
2. REFLECTED CEILING PLAN - WEST SECTION

MATERIAL CONDITIONS SOUTH PORTICO				SEE SHEETS: (E-13 - E-19)	
ORIGINAL	ELEMENT	MATERIALS	FINISHES	CONDITIONS	NOTES
NO	ACCESS PANEL DOOR	METAL	PAINT	INAPPROPRIATE HARDWARE, PAINT LOSS	
YES	CEILING	TERRA COTTA	-	CONTINUOUS CRACKS, SPALLS, BIRD GUANO, FAILED PREVIOUS REPAIR, BIRDPROOFING	
YES	DOOR FRAME AND TRANSOM	METAL AND WOOD	PAINT	PAINT FAILURE, WOOD DETERIORATION, LOSS, PAINT LOSS	
NO	DOORS	WOOD	CLEAR COATING	WORN FINISHES, SCRATCHES, GOUGES	
YES	FIXTURES	METAL	-	NOT SURVEYED	CEILING AND WALL LIGHT FIXTURES
NO	GRILLE FRAME AND GRILLE	METAL		INAPPROPRIATE MESH COVERING	
YES	WALL	GRANITE	-	SURFACE LOSS/SCALING, CRACKS, DISPLACED UNIT, STAINING, EVIDENCE OF WATER INFILTRATION, BIRD GUANO, BIRDPROOFING, COATING/ADHESIVE RESIDUE, INAPPROPRIATE/FAILED PREVIOUS

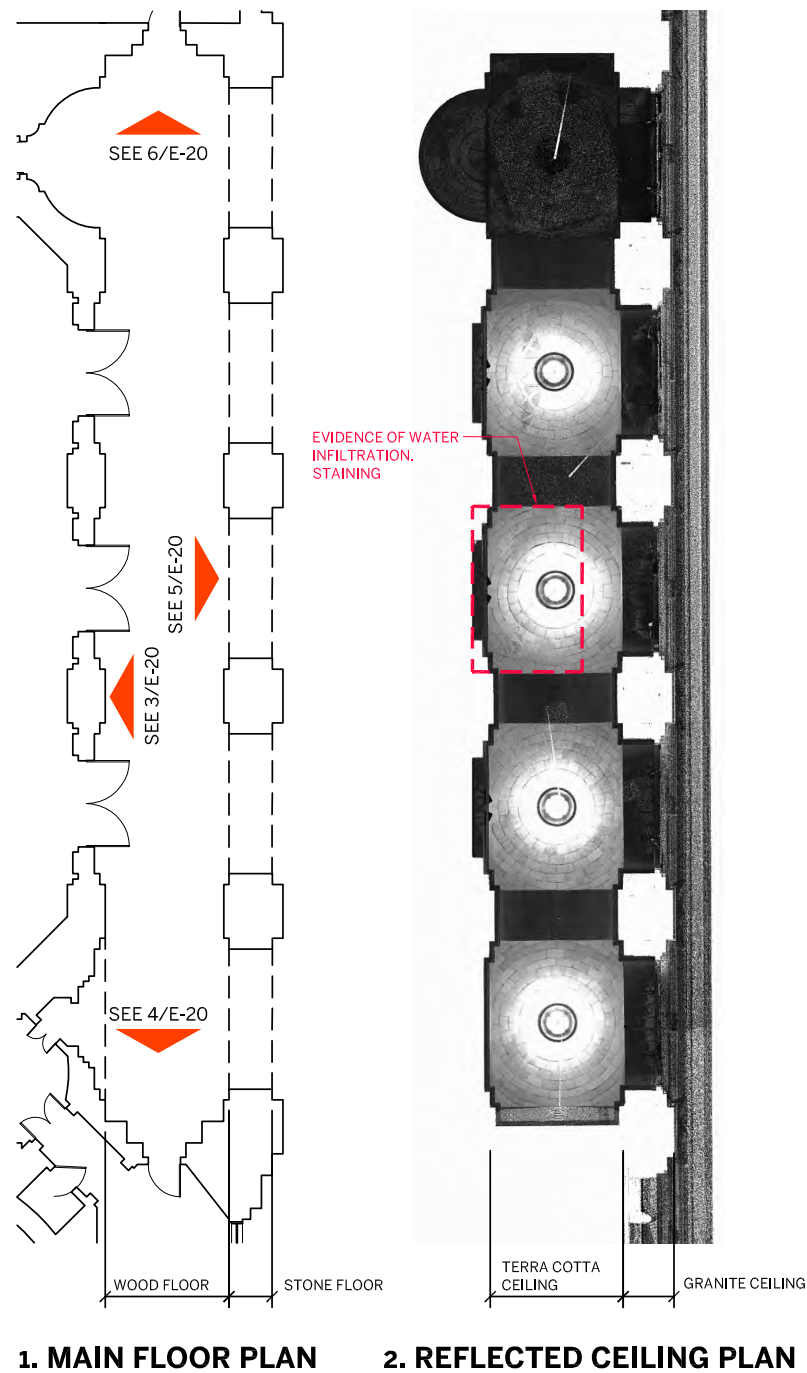
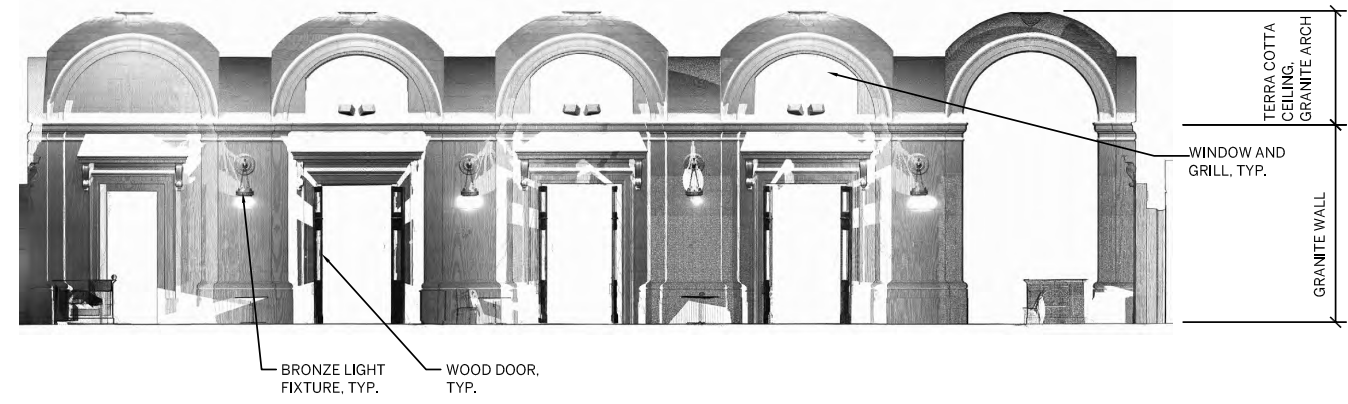
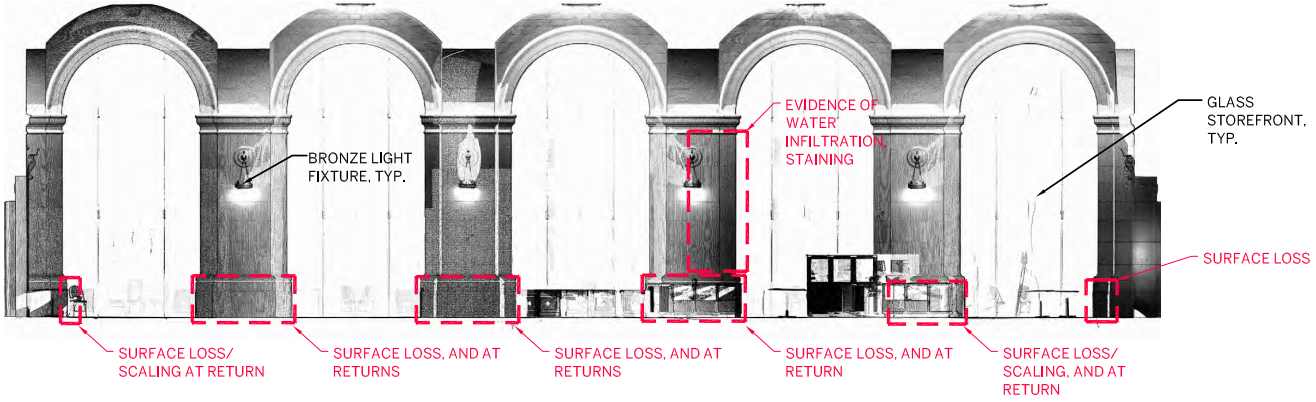
MATERIAL CONDITIONS EAST PORCH					SEE SHEETS: (E-20, E-21)
ORIGINAL	ELEMENT	MATERIALS	FINISHES	CONDITIONS	NOTES
YES	CEILING	TERRA COTTA	GLAZED	CONTINUOUS CRACK, STAINING	
NO	DOOR	GLASS AND METAL	-	NOT SURVEYED	
YES	DOOR AND FRAME	WOOD	CLEAR COATING	DAMAGED FINISHES, SCRATCHES/GOUGES	
YES	FIXTURES	METAL	-	NOT SURVEYED	WALL AND CEILING LIGHT FIXTURES
NO	FLOOR	TILE	-	NOT SURVEYED	
NO	FLOOR	WOOD	CLEAR COATING	NOT SURVEYED	
YES	GRILLE	WOOD	PAINT	-	
YES	WALL	GRANITE	-	SURFACE LOSS/SCALING, ABANDONED ANCHORS

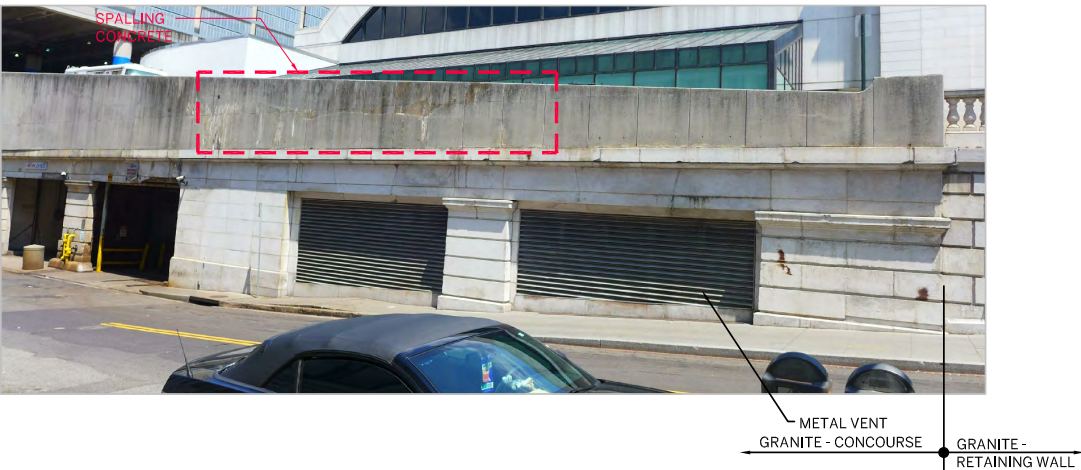
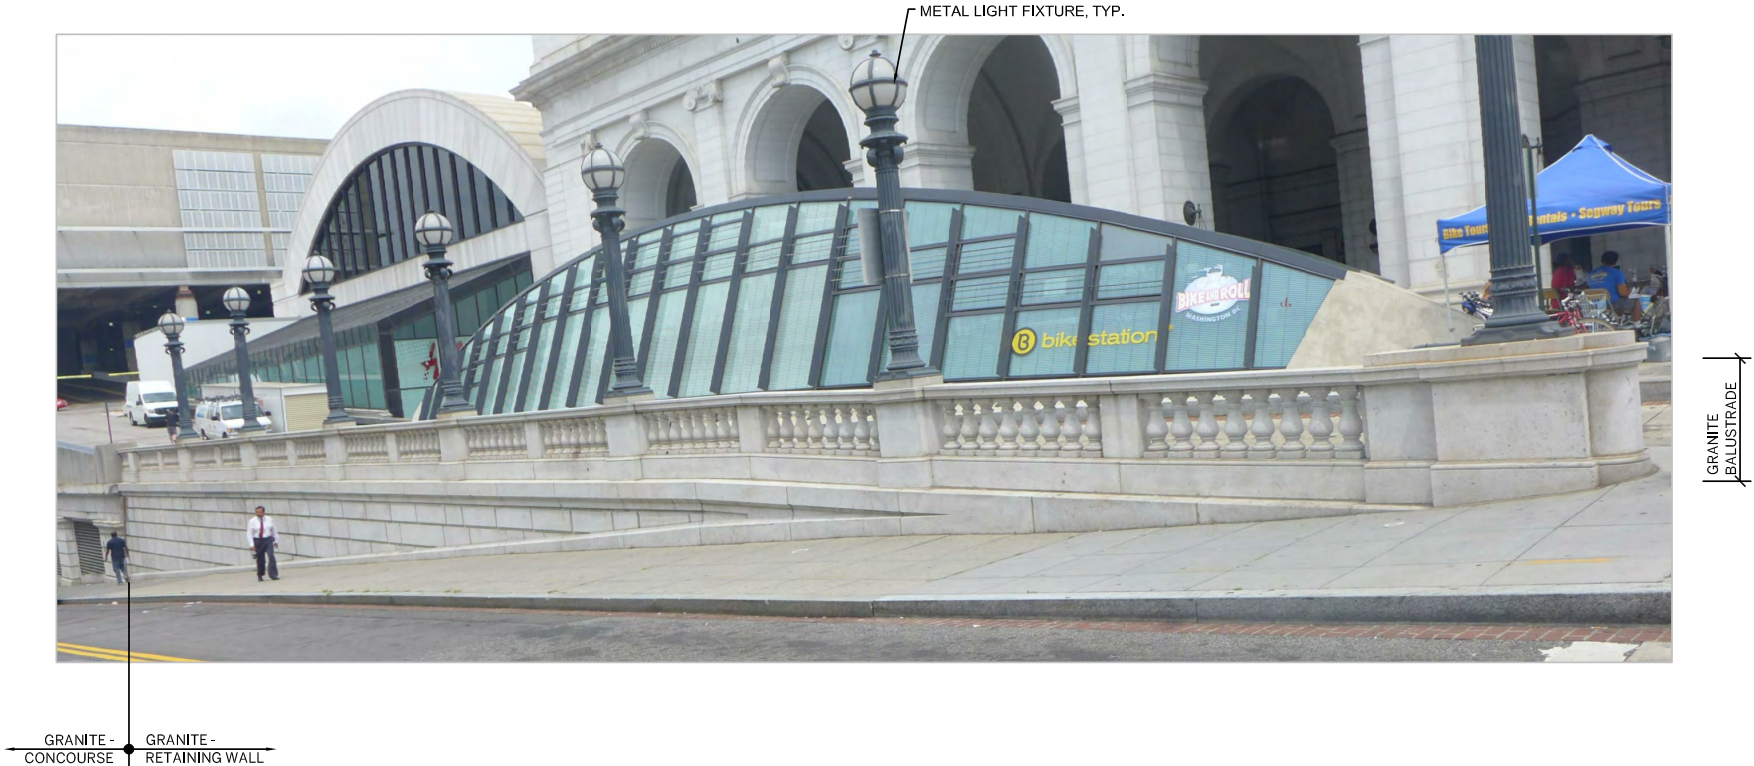
2. CONCOURSE WEST ELEVATION (LOWER LEVEL)

MATERIAL CONDITIONS WEST ELEVATION LOWER LEVEL AND BALUSTRADE SEE SHEETS: (E-22 - E-23)

The granite in all locations is in fair condition. Typical conditions include open joints and scaling of the stone, along with some minor cracks, small losses and significant amount of staining, including isolated areas of ferrous stains. One large piece of stone lintel is missing over the north opening of the west elevation. While not original, there is some significant cracking and spalling of the concrete ramp cheek wall. Since this wall is overhead, these conditions should be monitored.

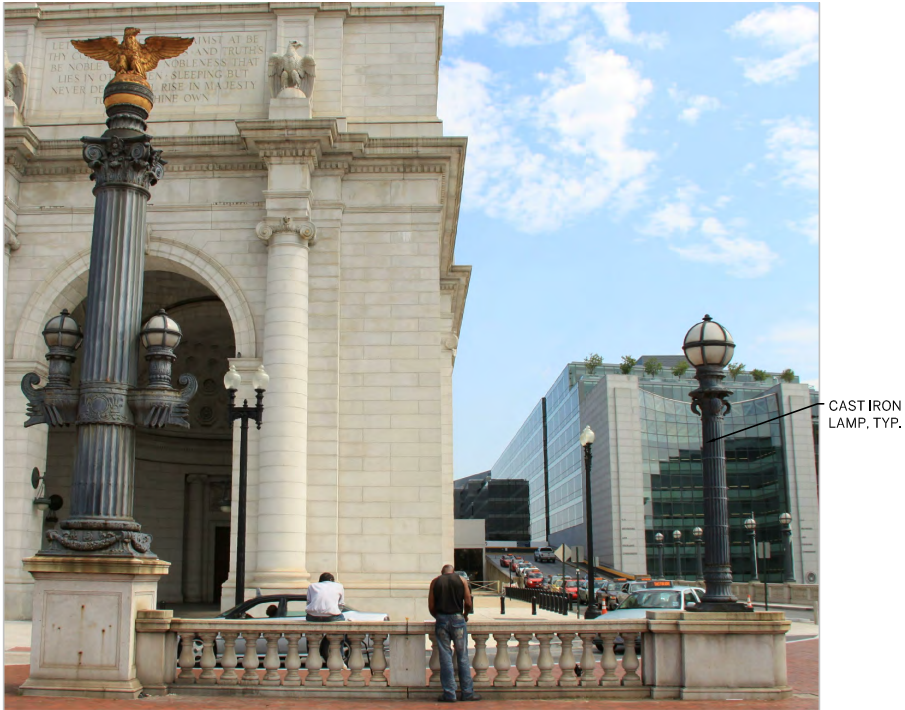
4. SOUTH BALUSTRADE - EAST SECTION, RIGHT

MATERIAL CONDITIONS SOUTH BALUSTRADE					SEE SHEETS: (E-24, E-25)
ORIGINAL	ELEMENT	MATERIALS	FINISHES	CONDITIONS	NOTES
YES	BALUSTRADE	GRANITE	-	STAINING, SCALING, CRACK, SPALL, OPEN JOINT, ABANDONED ANCHOR, LOOSE UNIT, PATCH, SMALL HOLE	
YES	BALUSTRADE BASE	GRANITE	-	STAINING, SCALING, CRACK, SPALL, OPEN JOINT, ABANDONED ANCHOR	
YES	COLUMN	CAST IRON	PAINT	CRACK, SURFACE CORROSION, PAINT FAILURE	
YES	DECORATIVE SCULPTURE	BRONZE	CLEAR COATING	FINISH FAILURE	
NO	LIGHT FIXTURE	GLASS	-	GENERAL SOILING	BOTH HISTORIC AND REPLICA FIXTURES
YES	LIGHT POLE	CAST IRON	PAINT	CRACK, SURFACE CORROSION, PAINT FAILURE

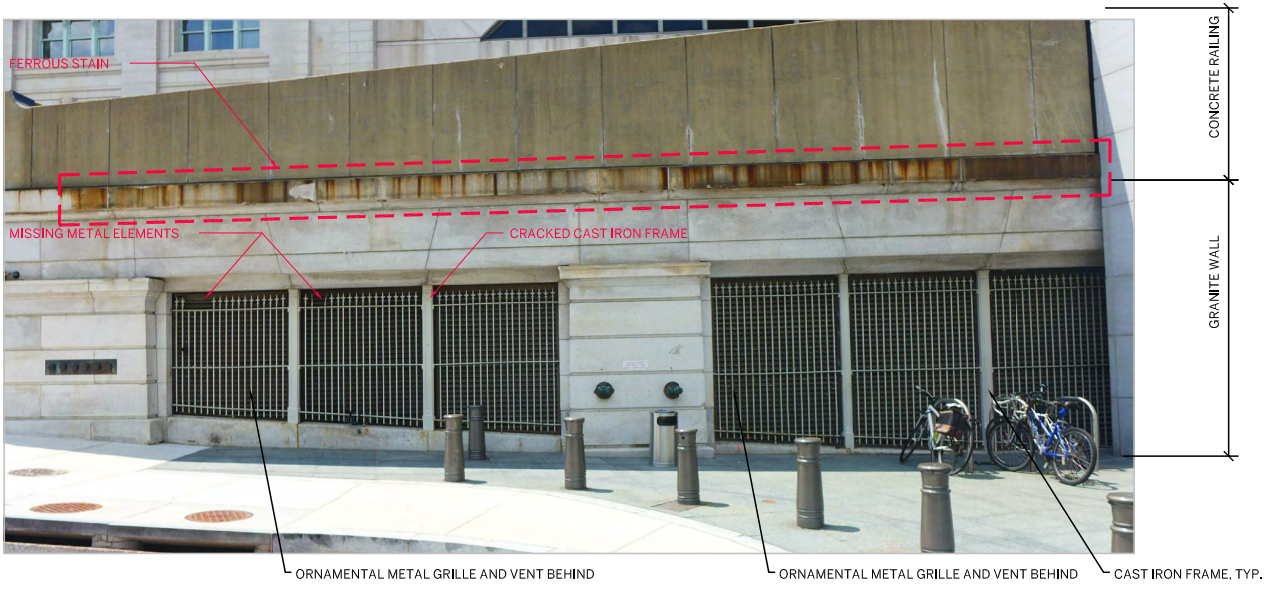
5. EAST ELEVATION (LOWER LEVEL)

MATERIAL CONDITIONS EAST ELEVATION LOWER LEVEL AND BALUSTRADE					SEE SHEETS: (E-26, E-27)
ORIGINAL	ELEMENT	MATERIALS	FINISHES	CONDITIONS	NOTES
YES	BALUSTRADE	GRANITE	-	SCALING, LOOSE UNIT, CRACK, SPALL, PATCH, OPEN JOINT	
NO	CURTAIN WALL	METAL AND GLASS		BROKEN GLASS	
YES	ORNAMENTAL GRILLE	CAST IRON	PAINT	MISSING ELEMENT, CRACKED UNIT	
NO	SIDE WALL	CONCRETE	-	FERROUS STAIN, SPALL, CRACK	
YES	WALL	GRANITE	-	SCALING, CRACK, SPALL, PATCH, OPEN JOINT, ABANDONED ANCHOR, SMALL HOLE, FERROUS STAIN	
NO	WALL	CONCRETE	-	NOT SURVEYED	CONCOURSE END

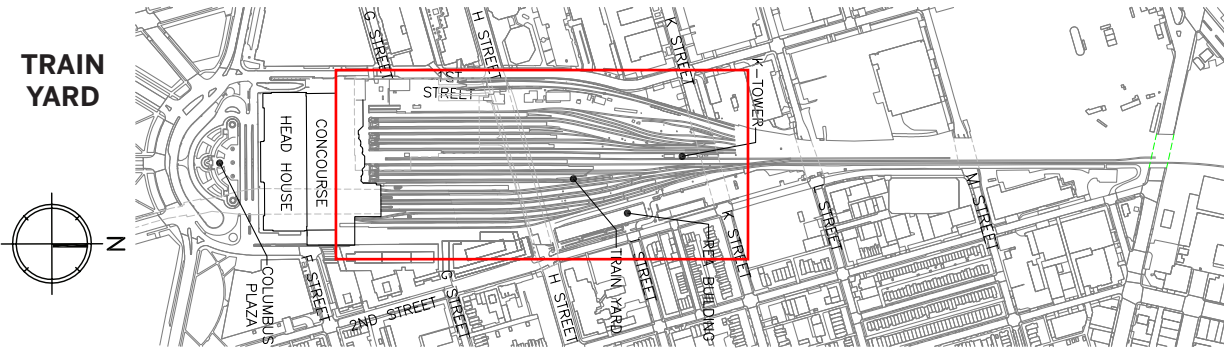
TERMINAL RAIL YARD PLATFORMS—T-12

MATERIAL CONDITIONS PLATFORMS				SEE SHEETS: (T-12 -T-14)	
ORIGINAL	ELEMENT	MATERIALS	FINISHES	CONDITIONS	NOTES
NO	CAPITAL	ALUMINUM	-		
YES	COLUMN	CAST IRON	PAINT	MISSING UNIT, CRACKS, PATCHES, STAINING, SURFACE CORROSION, PAINT FAILURE	
NO	FLOOR	CONCRETE	-	CRACKS, SPALLS	
NO	STRUCTURAL PIERS	CONCRETE AND STEEL			
NO	UMBRELLA SHED	STEEL		STAINING, SURFACE CORROSION, PAINT FAILURE	
YES	UMBRELLA SHED	CAST IRON	PAINT	STAINING, SURFACE CORRISION, PAINT FAILURE	
NO	UMBRELLA SHED DECKING	WOOD OR CORRUGATED METAL		MISSING UNIT
