WASHINGTON UNION STATION

HISTORIC PRESERVATION PLAN: VOLUME II

BUILDING CONSERVATION ASSOCIATES, INC. (BCA)

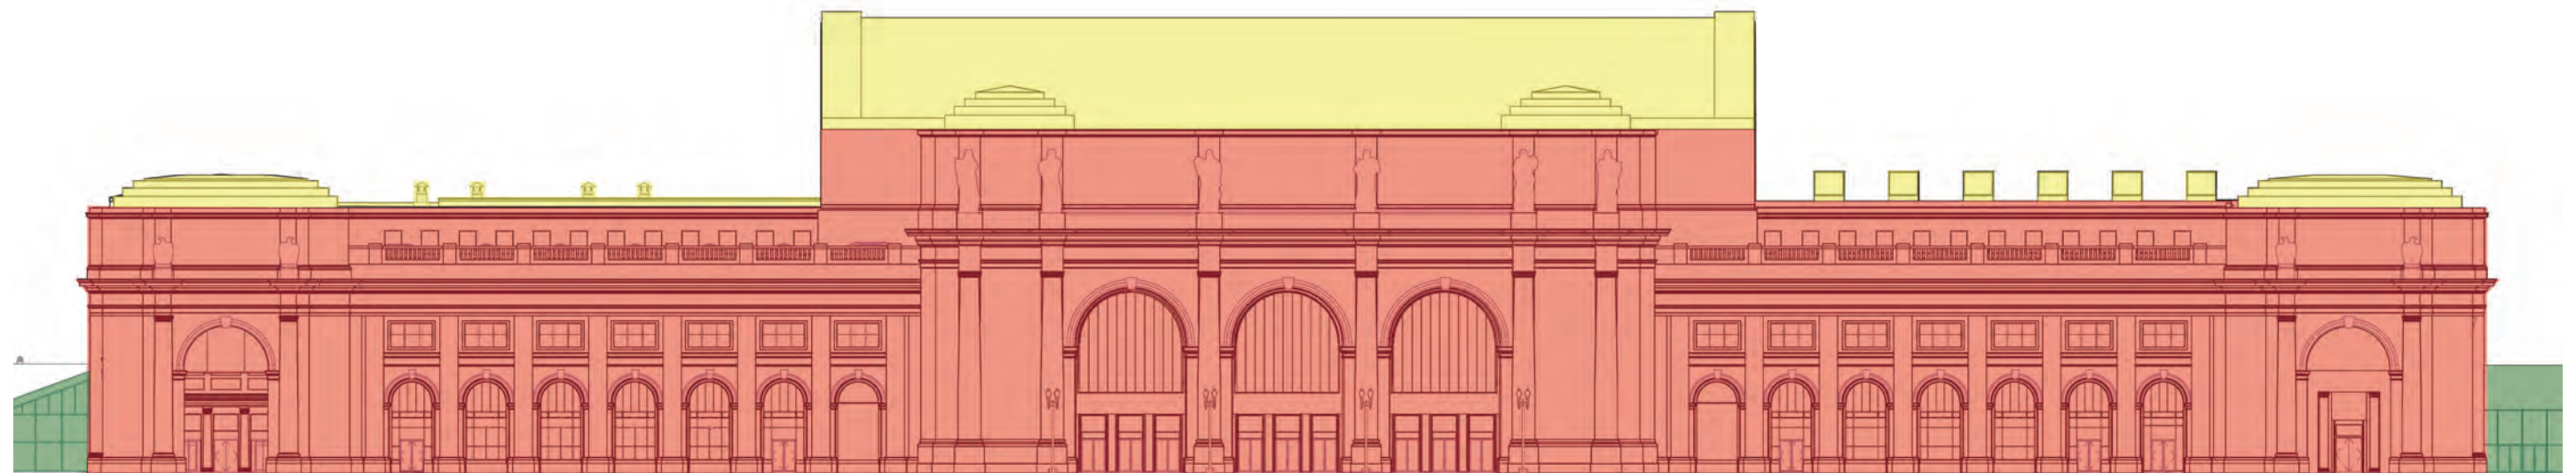
HISTORIC STATION BUILDING— SOUTH FAÇADE PRESERVATION ZONES

When a color is applied to a space or component in plan, it indicates that the zone applies to both the spatial characteristics (e.g., volume, etc.) and all of the materials that make up the historic space and/or element.

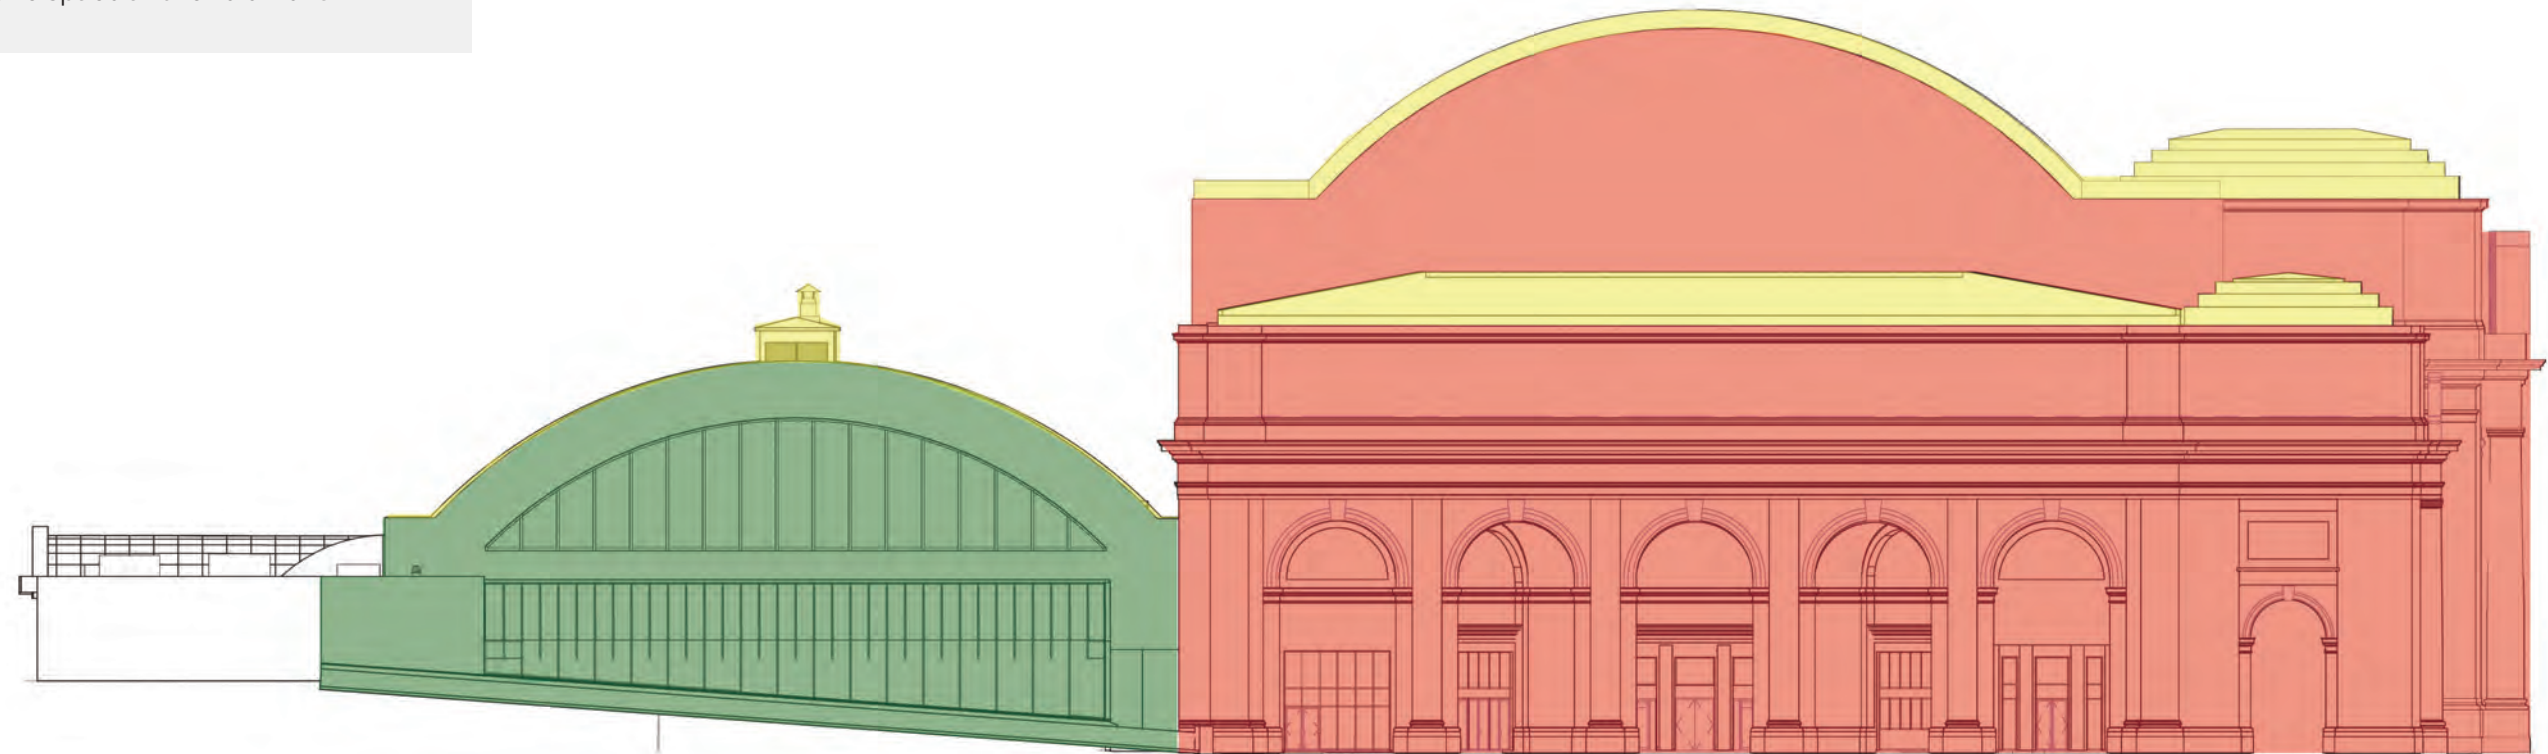
HISTORIC STATION BUILDING—WEST FAÇADE PRESERVATION ZONES

When a color is applied to a space or component in plan, it indicates that the zone applies to both the spatial characteristics (e.g., volume, etc.) and all of the materials that make up the historic space and/or element.

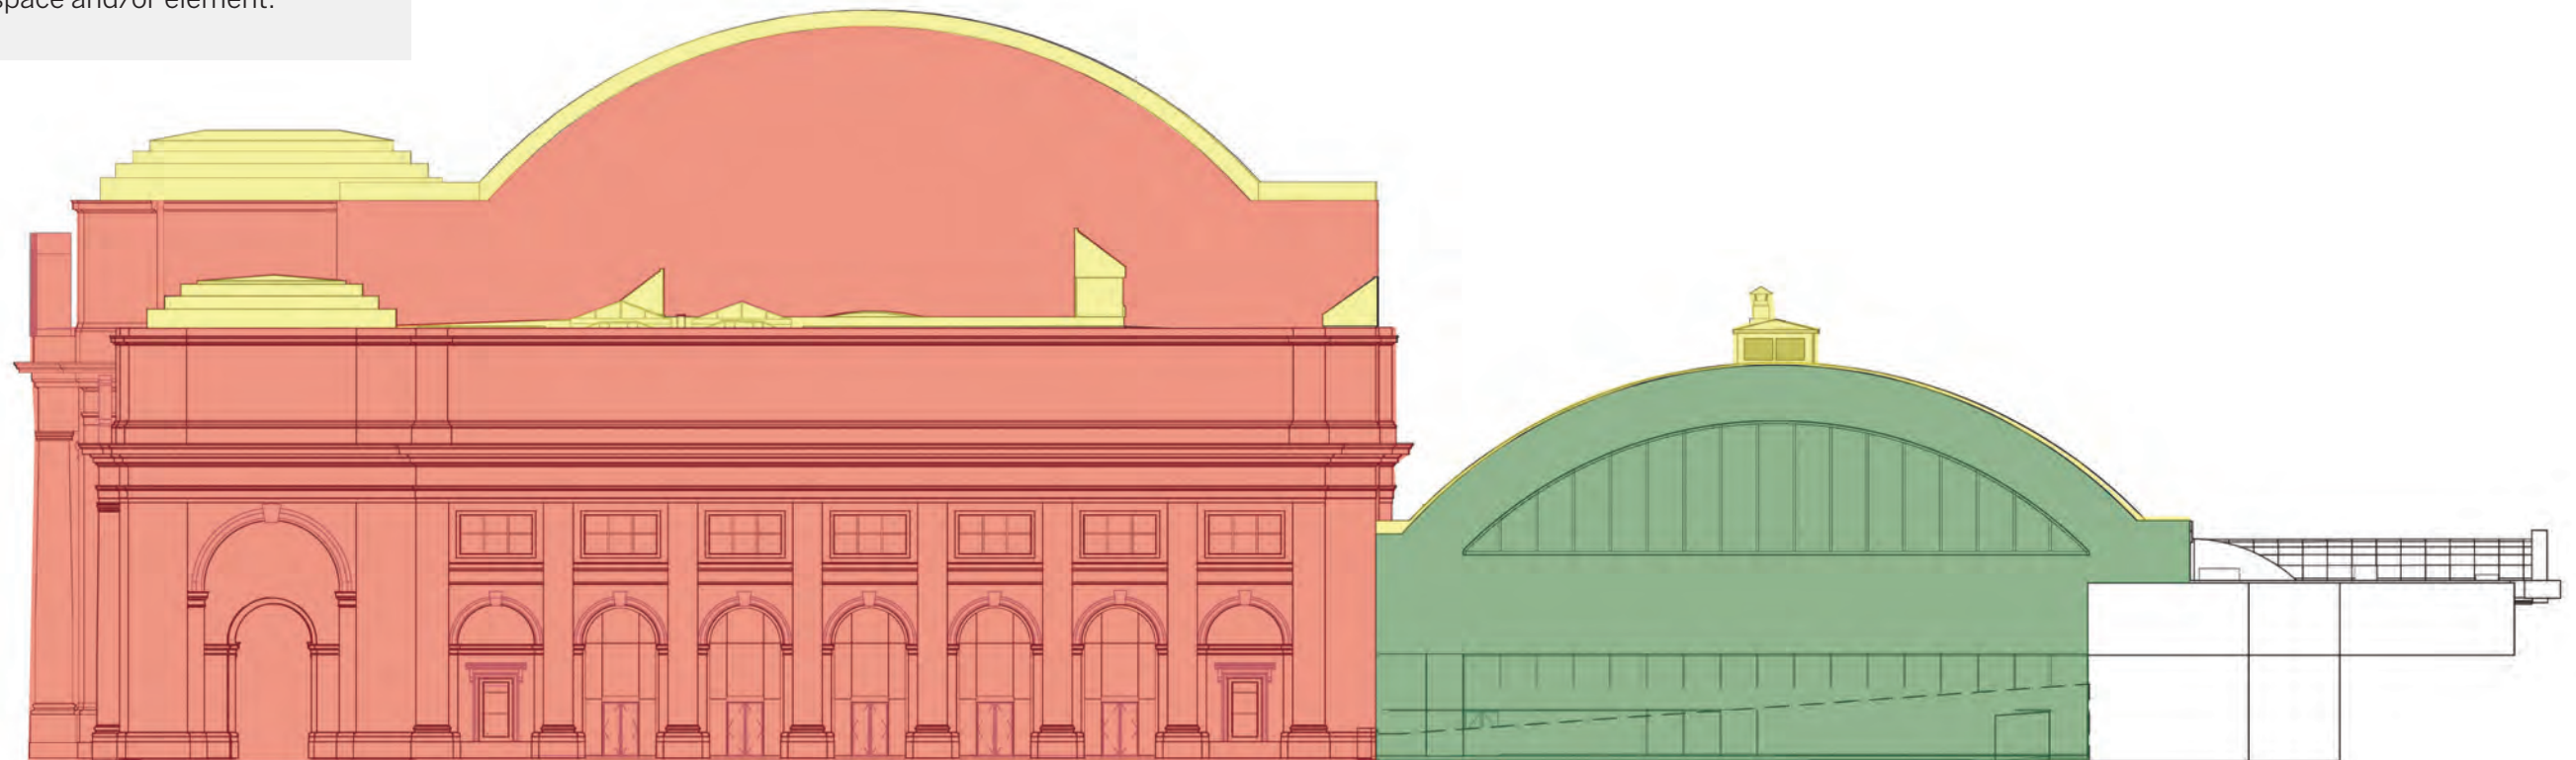
HISTORIC STATION BUILDING— EAST FAÇADE PRESERVATION ZONES

When a color is applied to a space or component in plan, it indicates that the zone applies to both the spatial characteristics (e.g., volume, etc.) and all of the materials that make up the historic space and/or element.

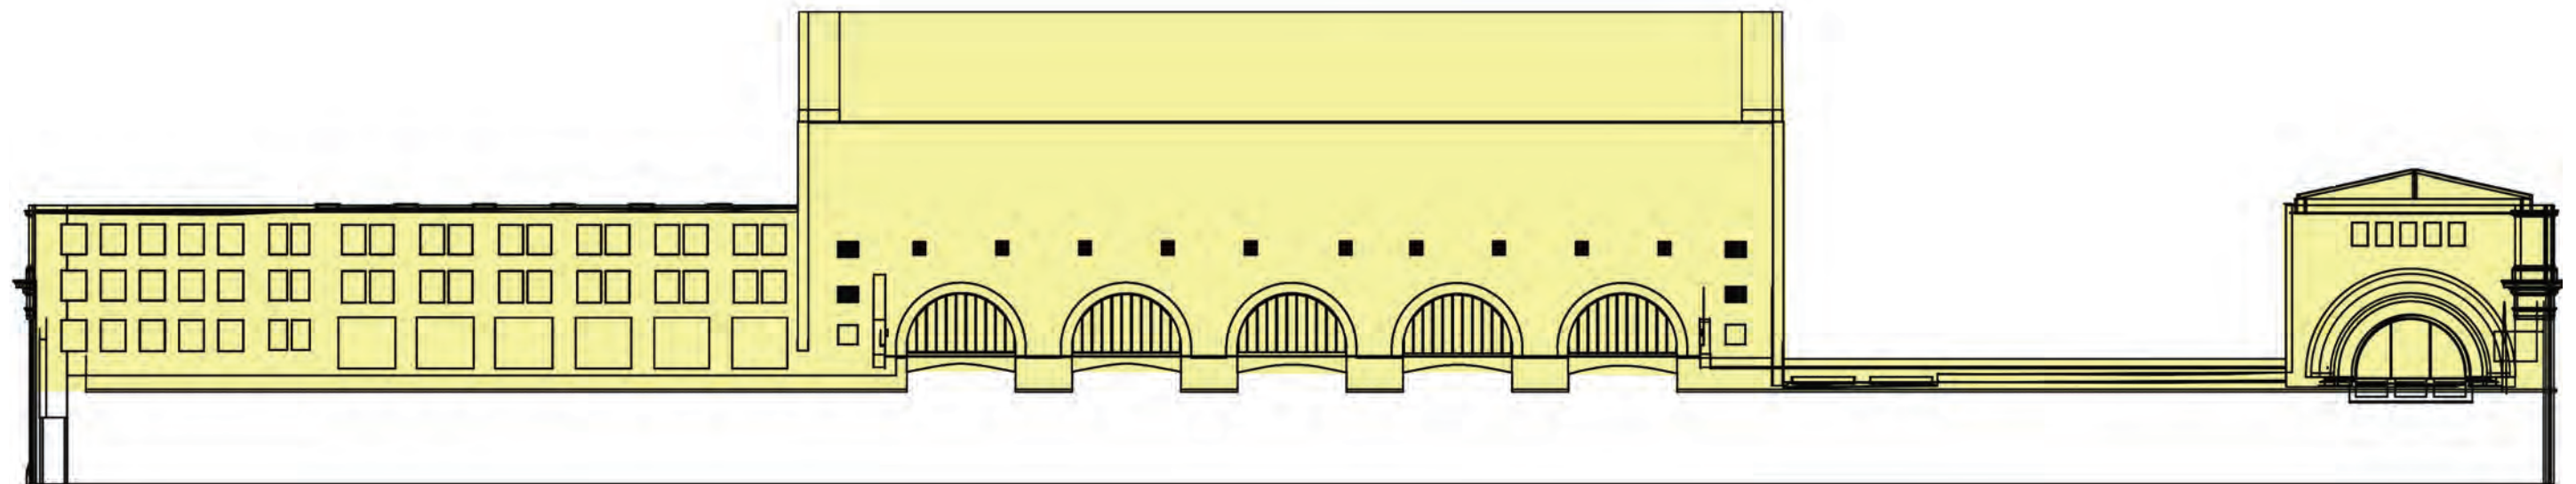
HISTORIC STATION BUILDING—NORTH FAÇADE PRESERVATION ZONES

When a color is applied to a space or component in plan, it indicates that the zone applies to both the spatial characteristics (e.g., volume, etc.) and all of the materials that make up the historic space and/or element.

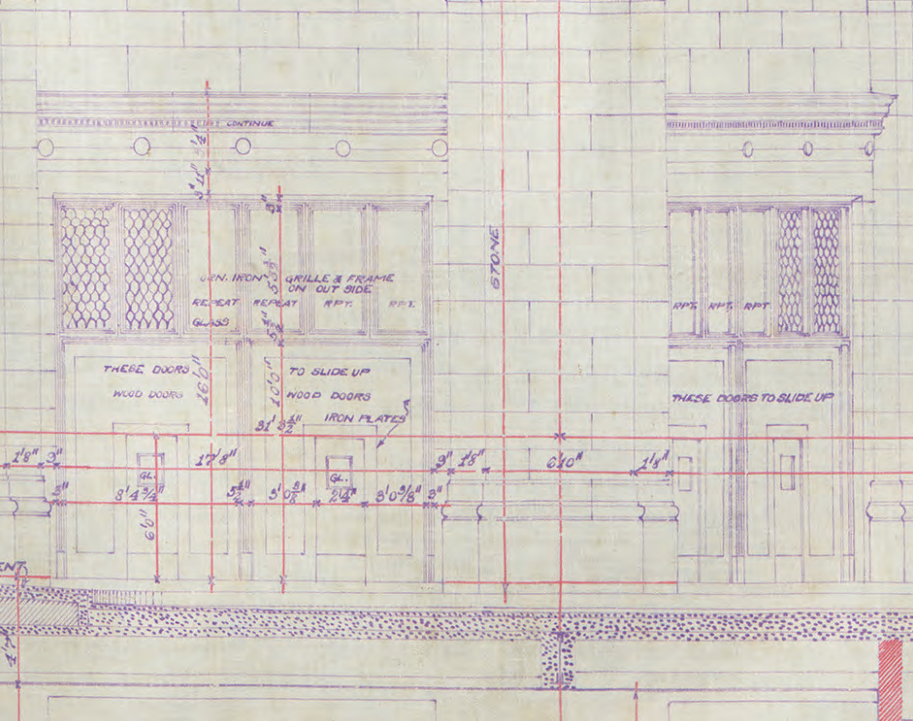
H-W-13. Burnham & Co. drawing of Carriage Porch, east wall, 1905. (Library of Congress)

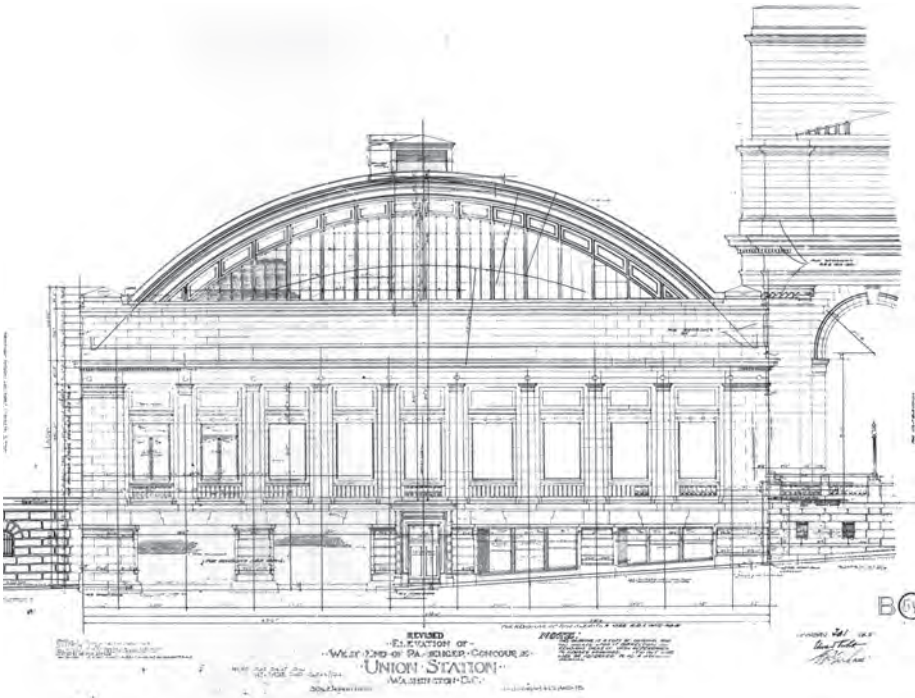
C-EW-7. Burnham & Co. drawing of west concourse façade, 1905. (Library of Congress)

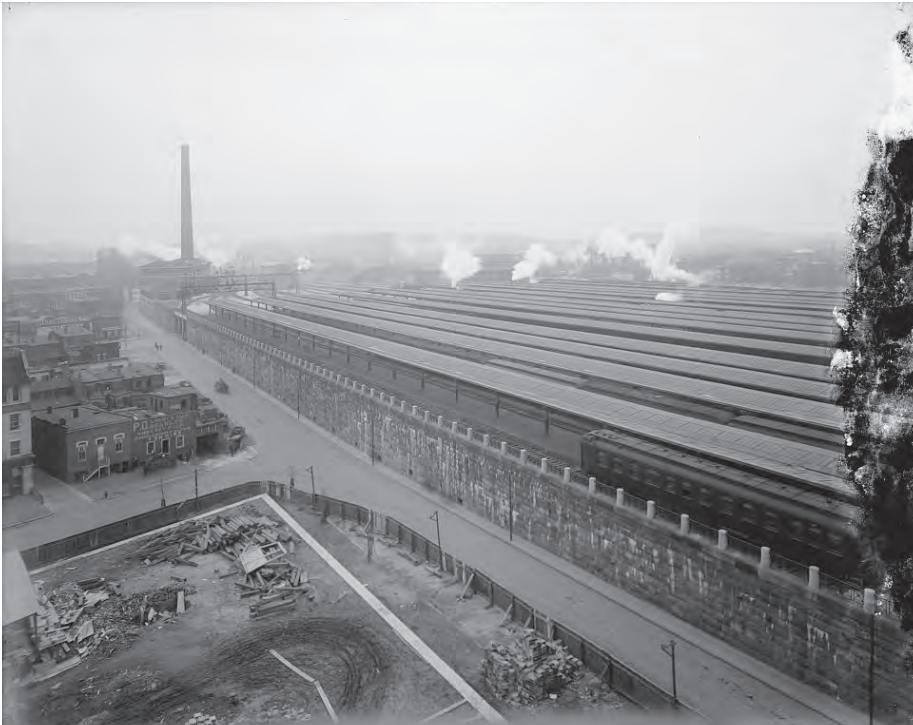
RW-1. Retaining wall along First Street, facing northeast, c. 1914-45. (Library of Congress)

- Existing Historic Character-Defining Features**
- Rusticated ashlar sandstone walls with sandstone coping.
 - Circular indentations visible in individual stones added to facilitate the use of a kerb-lifter during construction.
 - Height from 5 to 35 feet above the surface of the ground, with the greatest height being on the west side to the north of the station.
 - Surviving ornamental iron railing decorated in a Grecian pattern strung between round granite posts.

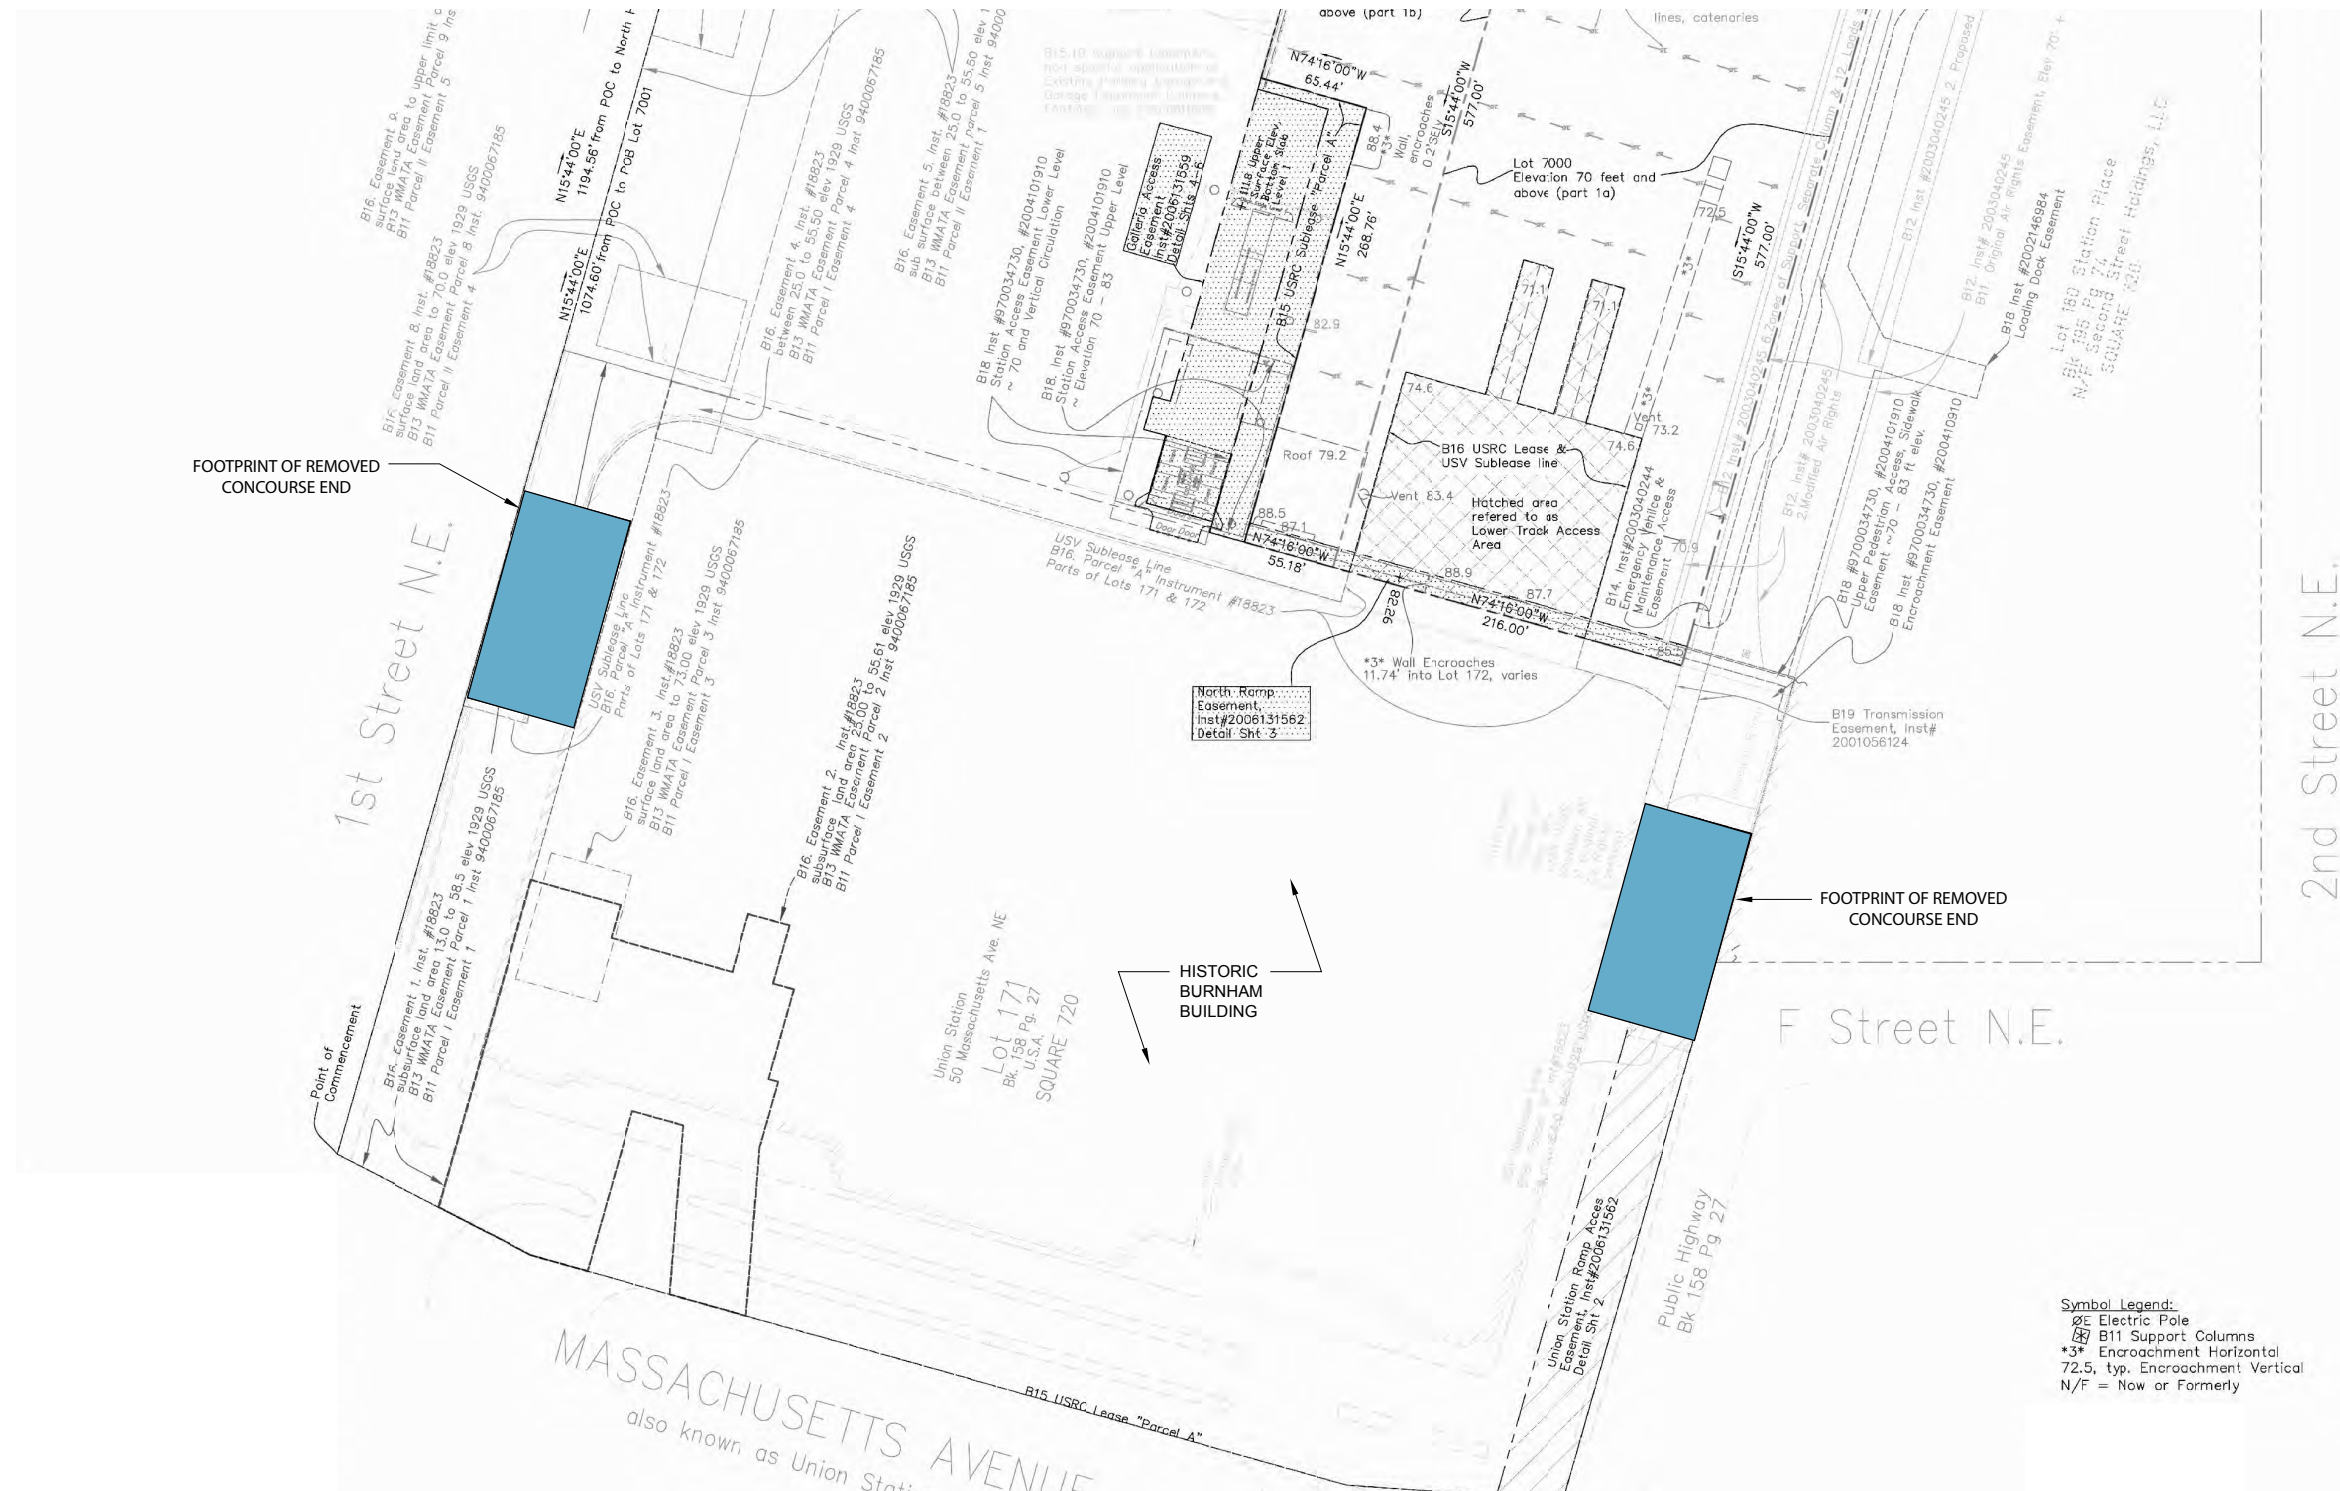
FIGURE E-1. SITE PLAN—LOCATIONS OF REMOVED CONCOURSE ENDS

SITE PLAN—LOCATIONS OF REMOVED CONCOURSE ENDS

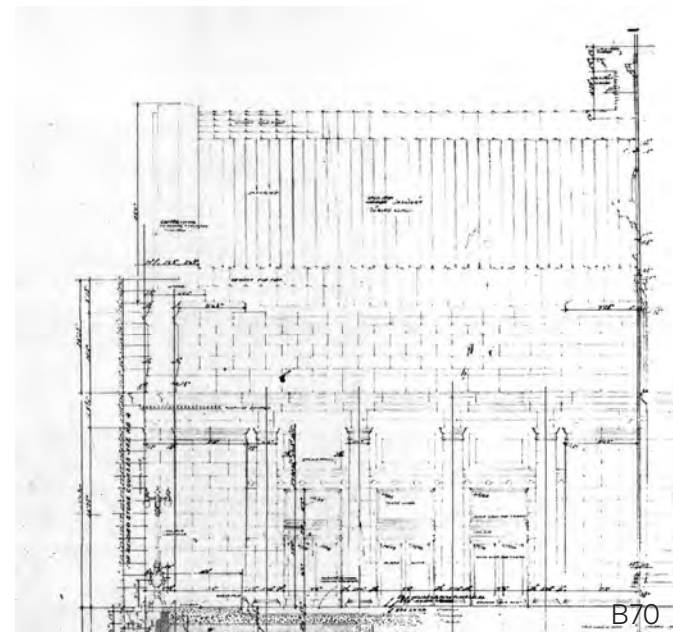
Burnham & Co. drawing of south elevation of west end of concourse, 1905. (Library of Congress)

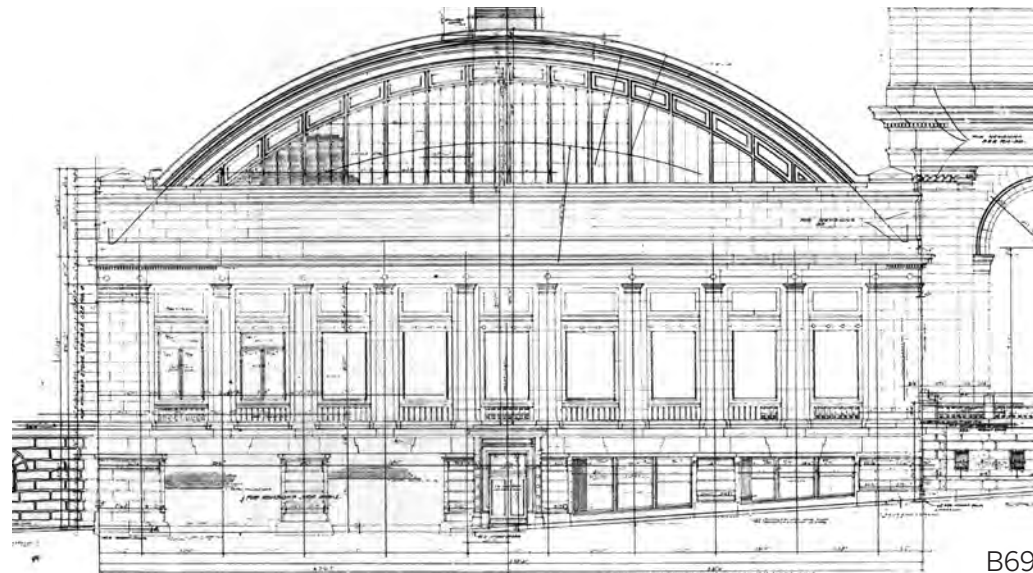
Burnham & Co. drawing of concourse west elevation, 1905. (Library of Congress)
