WASHINGTON UNION STATION

HISTORIC PRESERVATION PLAN: VOLUME I

HISTORIC PRESERVATION PLAN

VOLUME I of III

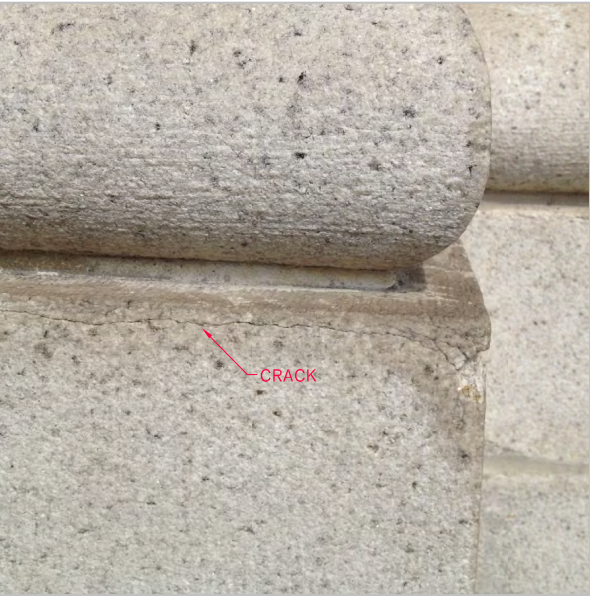
CONTINUOUS CRACK

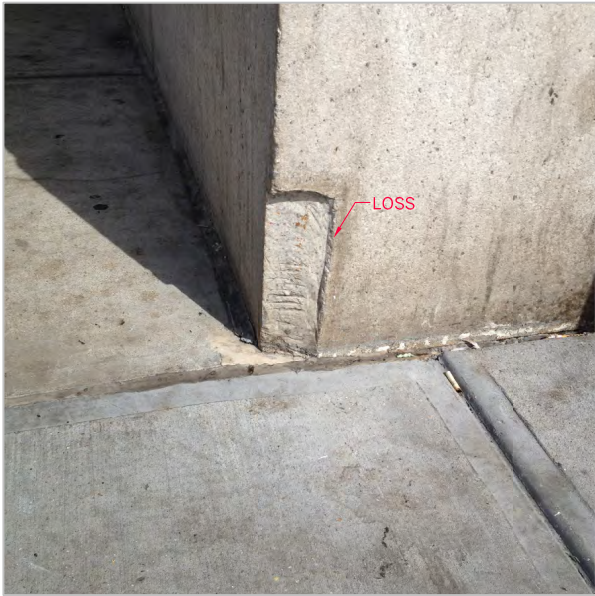
LOSS AT CORNER OF STONE UNIT

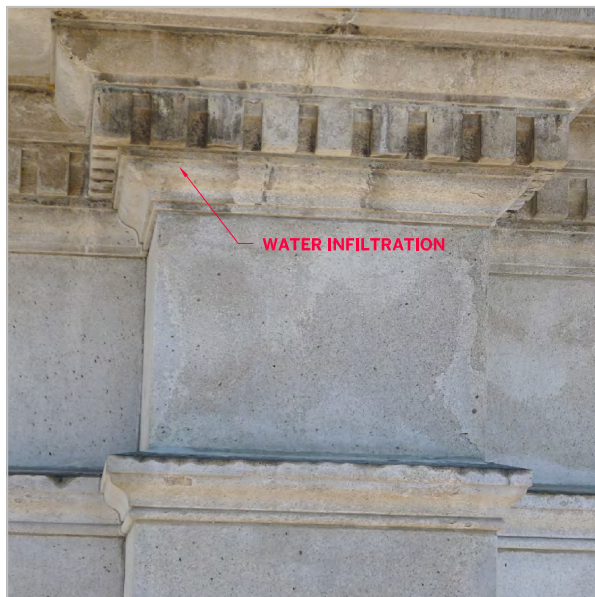
WATER INFILTRATION AT EAST SIDE

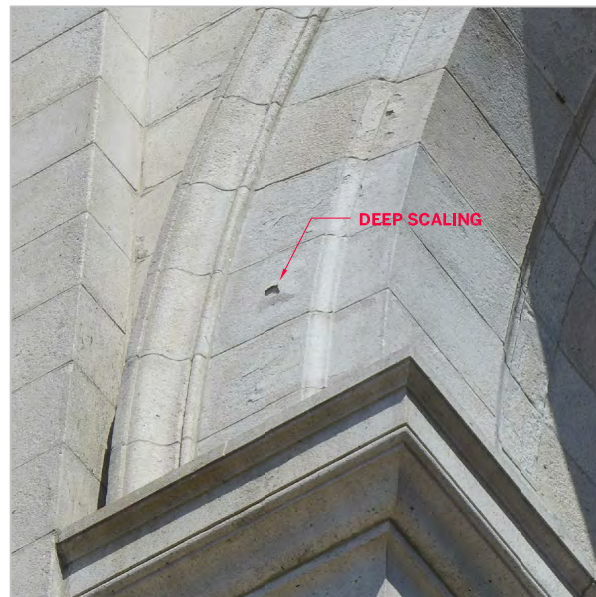
SCALING

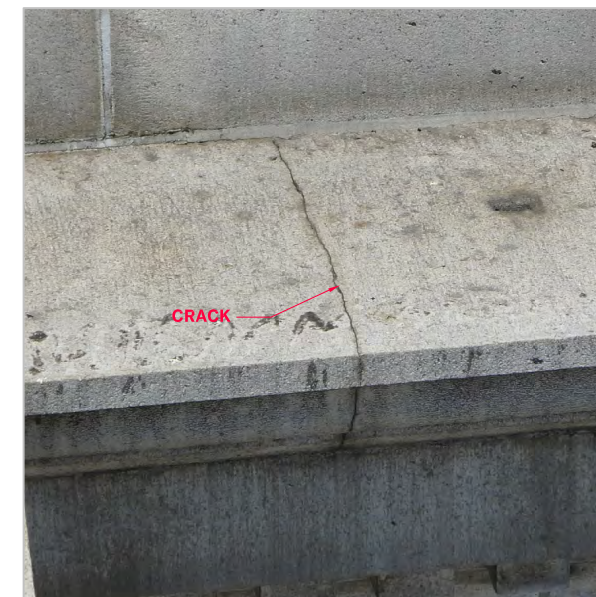
CRACK THROUGH CORNICE UNIT

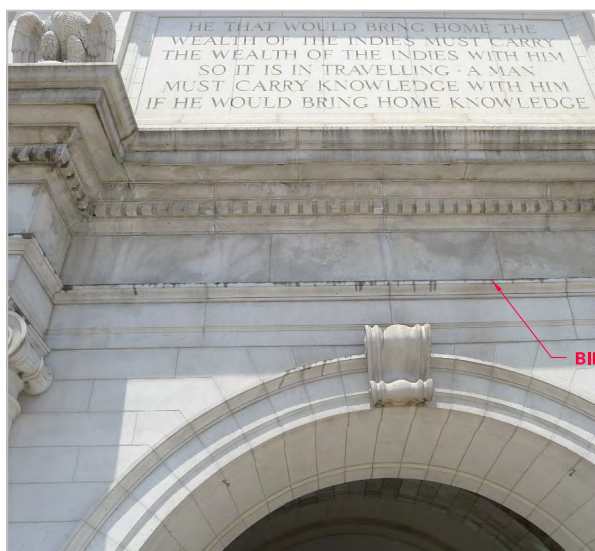
EVIDENCE OF WATER INFILTRATION AND
LIQUID APPLIED BIRD REPELLENT AT MAIN
PORTICO

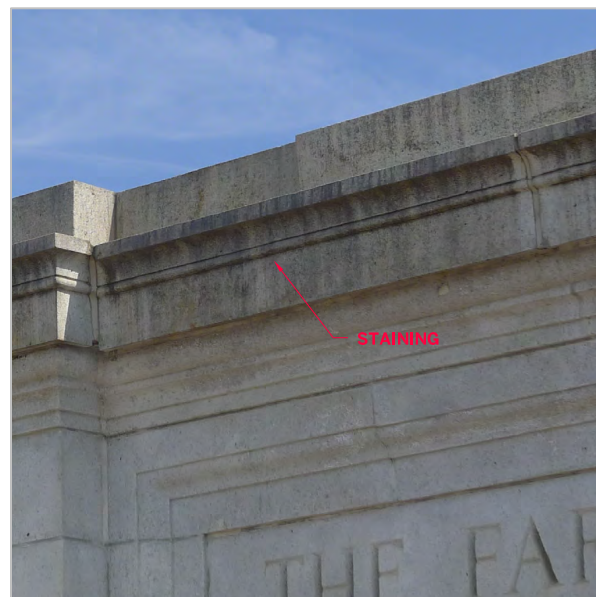
WATER INFILTRATION AND STAINING AT
COPING STONES

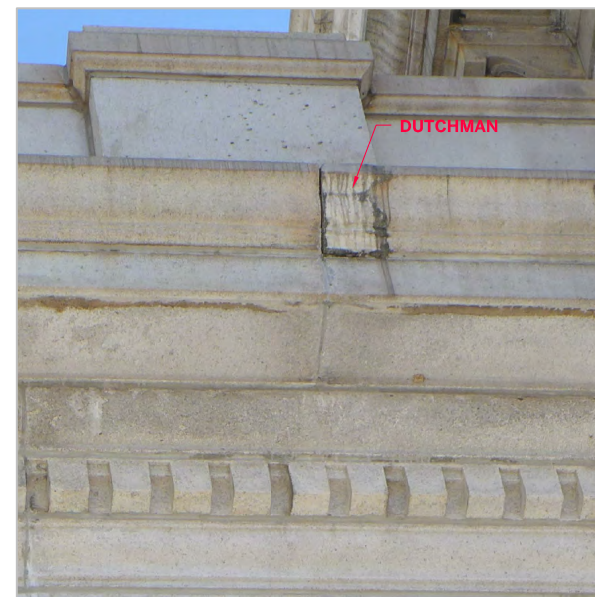
EXISTING DUCHMAN

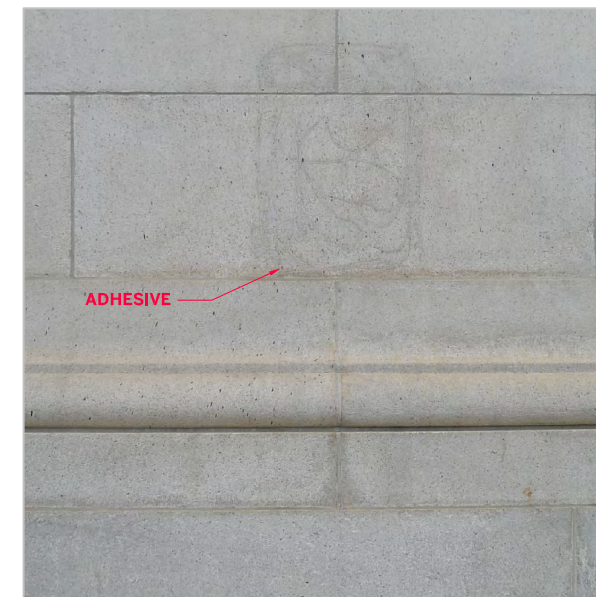
ADHESIVE RESIDUE

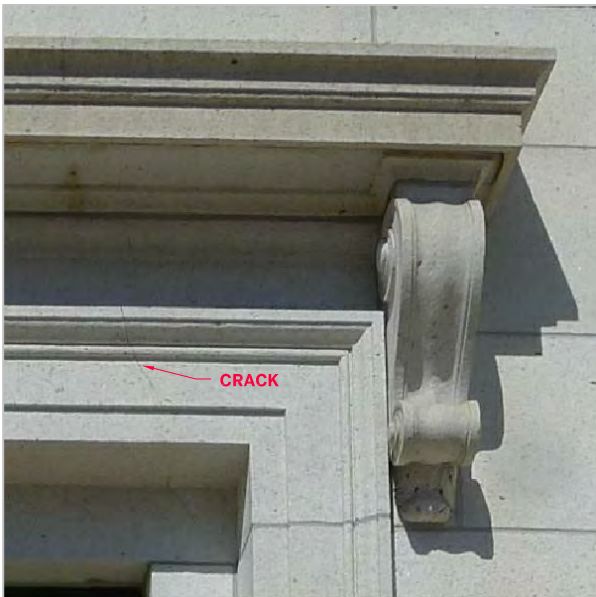
CRACK IN GRANITE WINDOW LINTEL

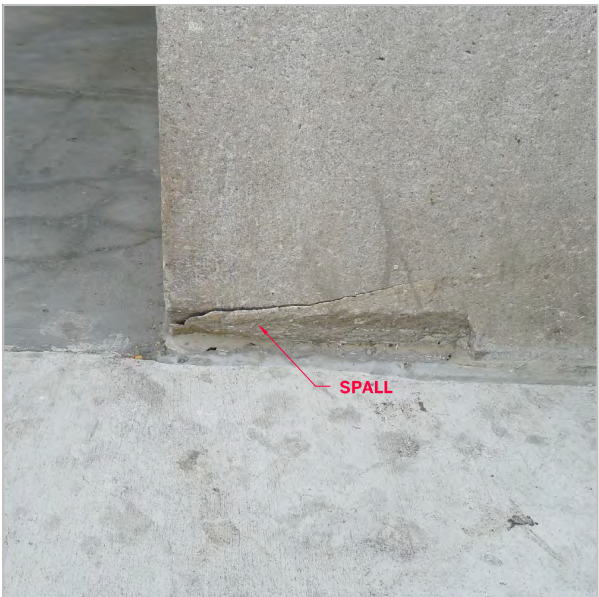
SPALL AT CORNER GRANITE UNIT

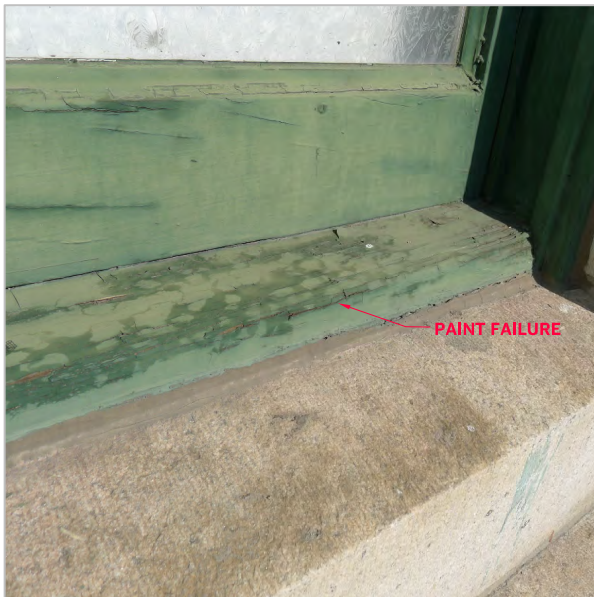
PAINT FAILURE AND DETERIORATED SEALANT AT WOOD WINDOW

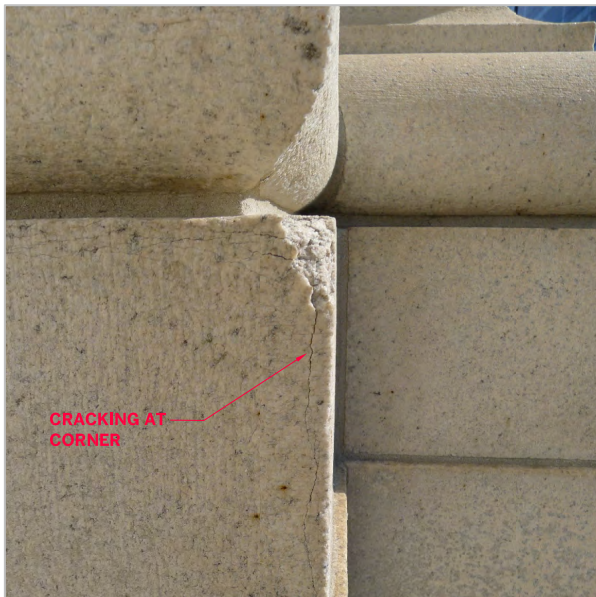
CRACKING AT CORNER OF GRANITE

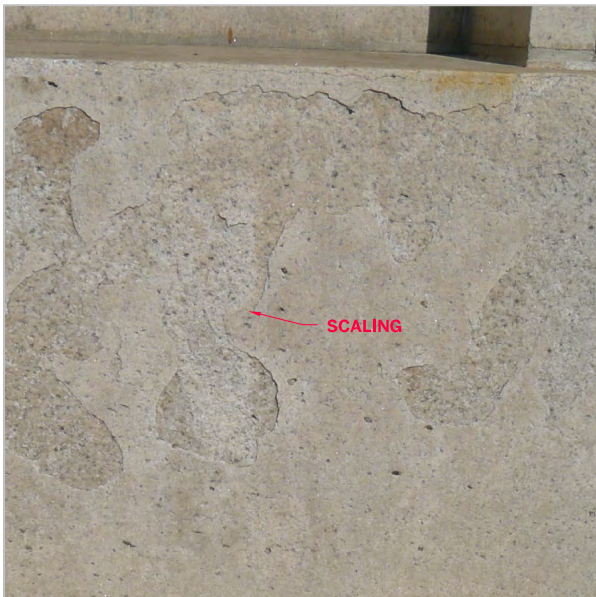
SCALING AT BASE OF GRANITE WALL

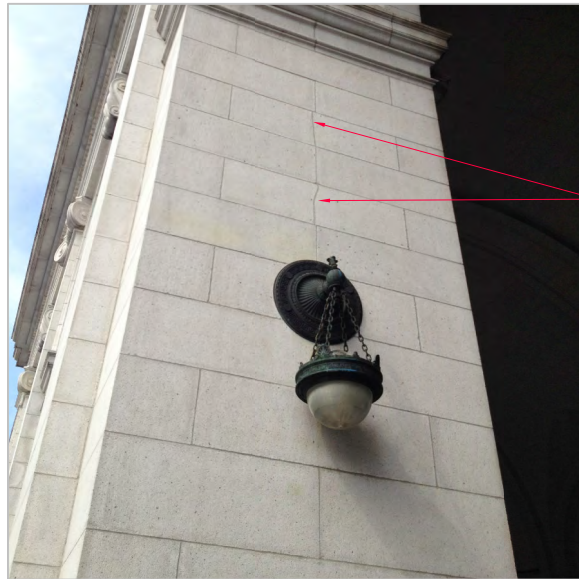
CRACK

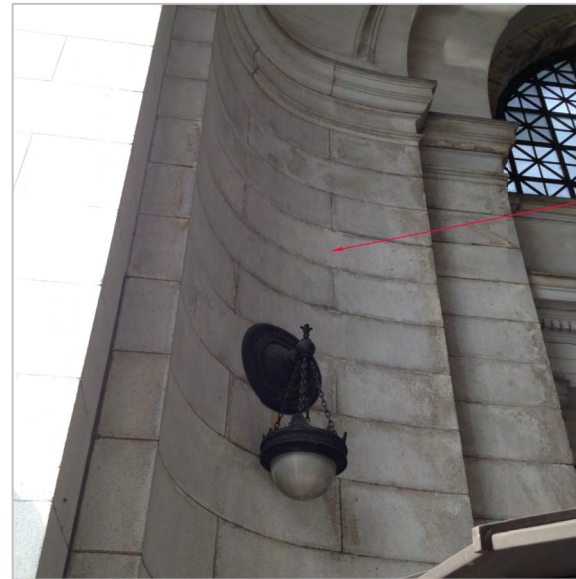
The most pervasive condition in the Carriage Porch is surface loss and scaling of the granite. Several previously repaired continuous cracks run along the return walls of the granite piers above the light fixtures.

CONTINUOUS CRACK ABOVE LIGHT FIXTURE

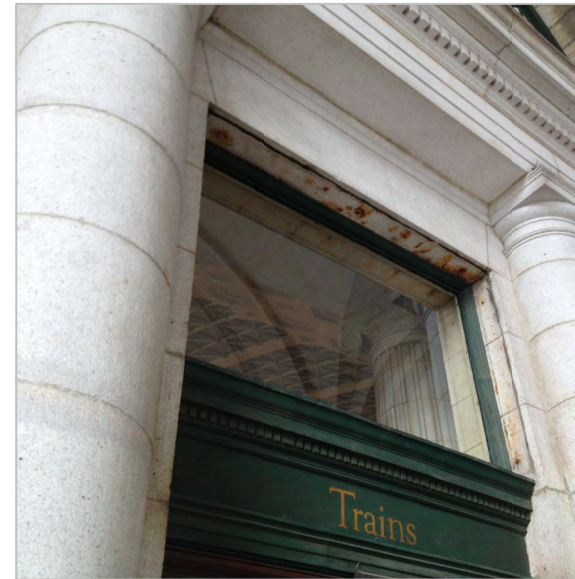
SCALING AND
SURFACE LOSS

EVIDENCE OF WATER INFILTRATION, SURFACE
LOSS AND SCALING

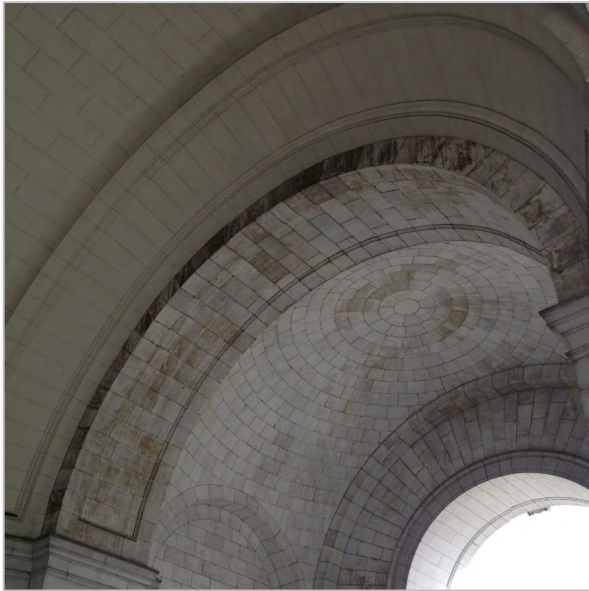
BIRD GUANO AND STAINING AT ARCH BETWEEN SOUTH PORTICO AND CARRIAGE PORCH

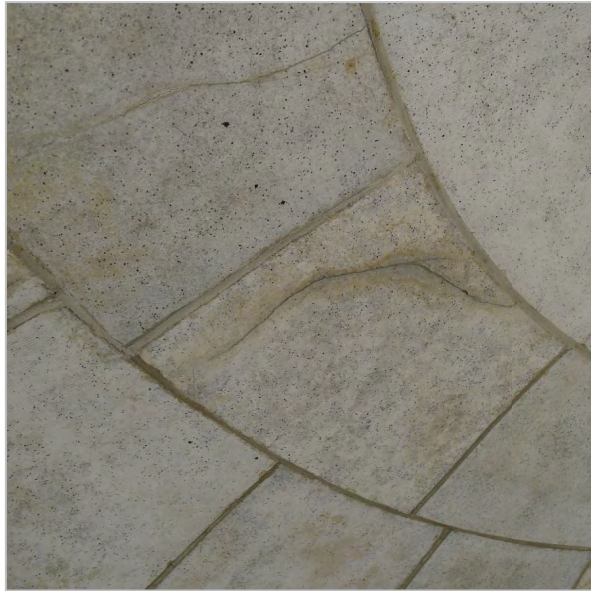
CRACK IN TERRA COTTA CEILING TILE

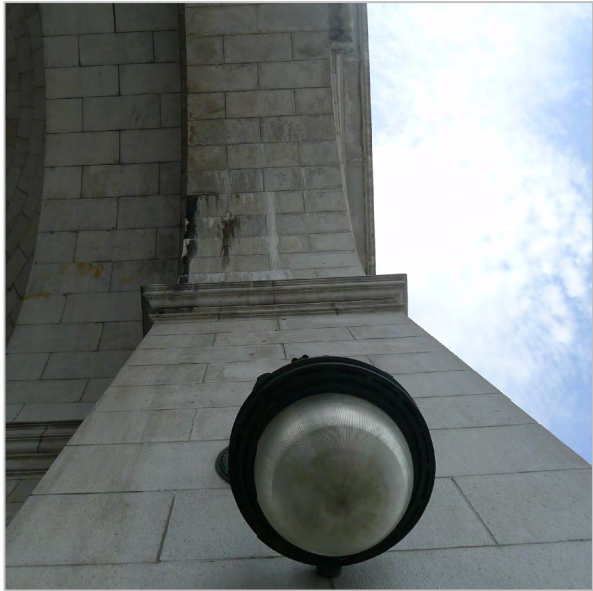
EVIDENCE OF WATER INFILTRATION AND STAINING AT ARCH

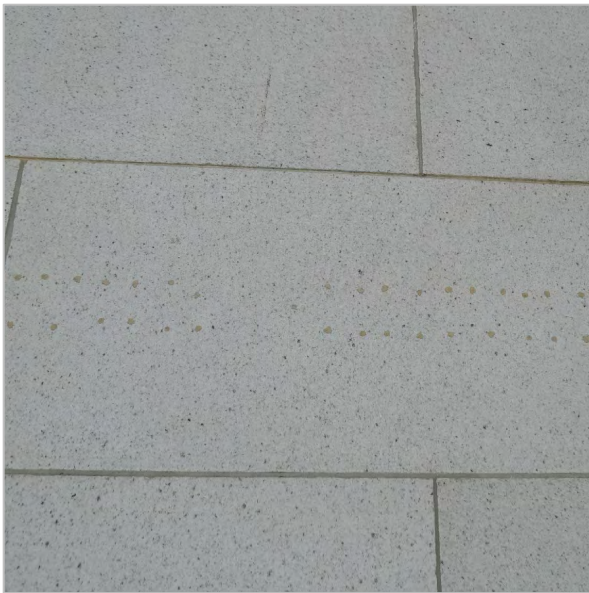
PREVIOUS PATCHES

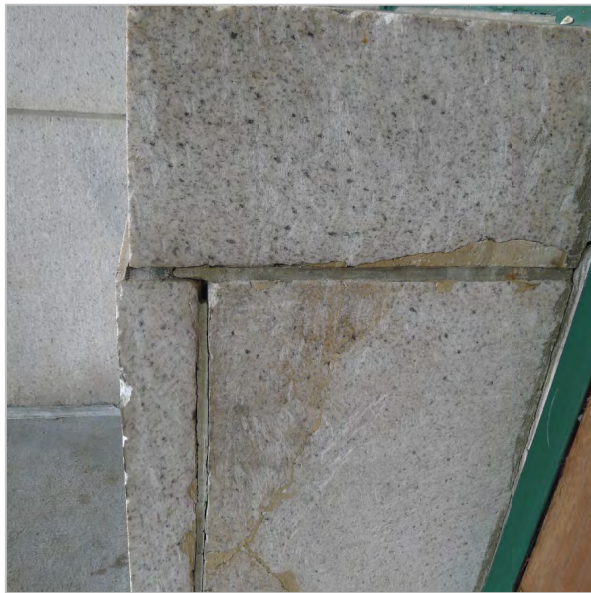
CRACKS AND SPALLS AT NON-ORIGINAL DOOR OPENING

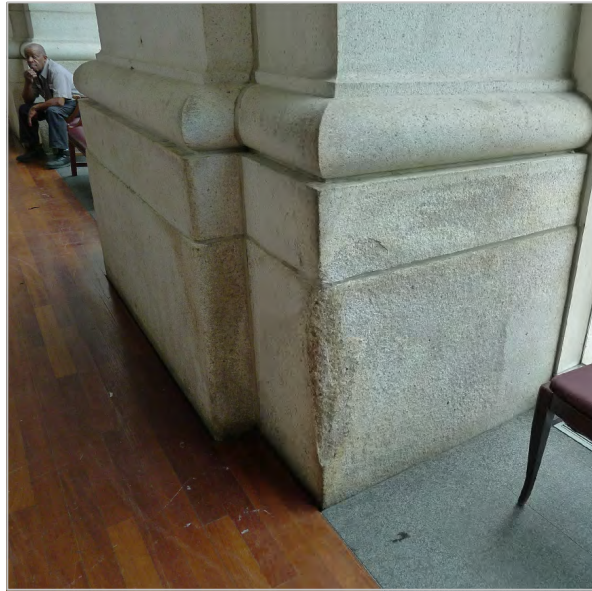
The base of the granite piers (but not the walls) are exhibiting surface loss and scaling. One section of the terra cotta ceiling is stained, suggesting previous water infiltration.

SURFACE LOSS AND SCALING

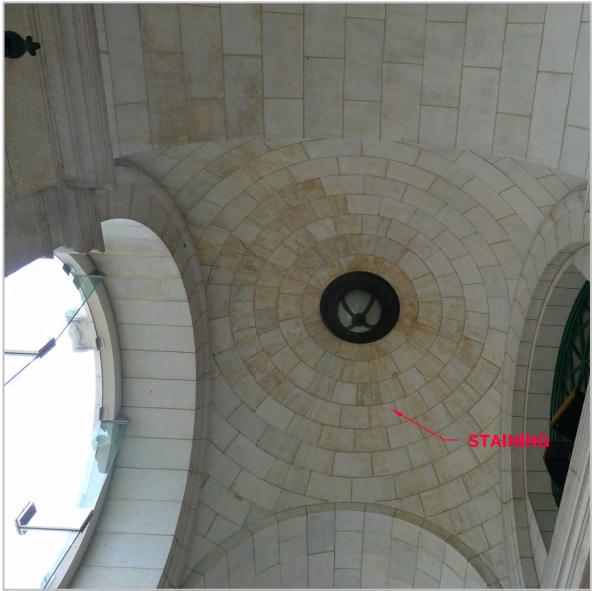
STAINING AT CEILING

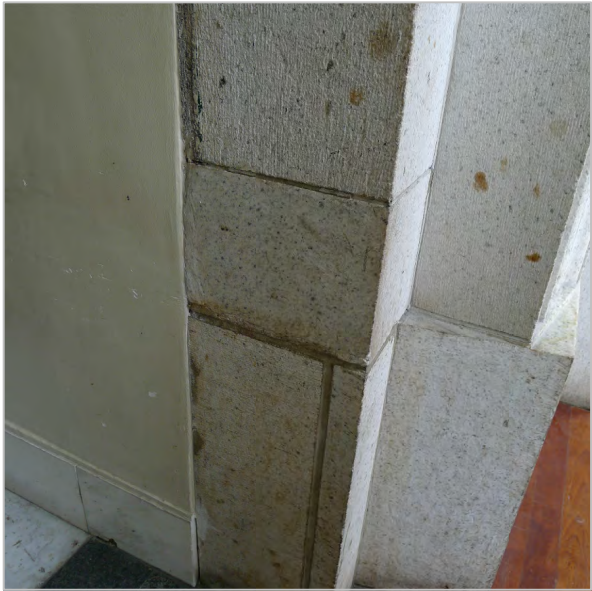
GRANITE AT NON-HISTORIC OPENING BETWEEN SOUTH VESTIBULE AND EAST PORCH

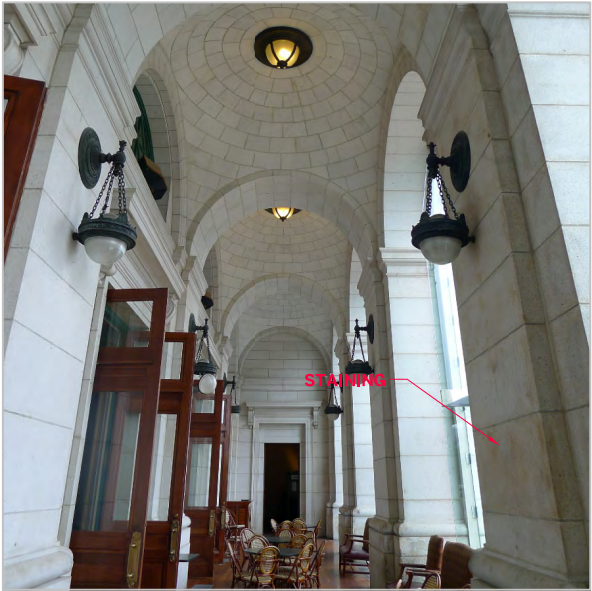
STAINING AT EAST WALL UNDER CEILING

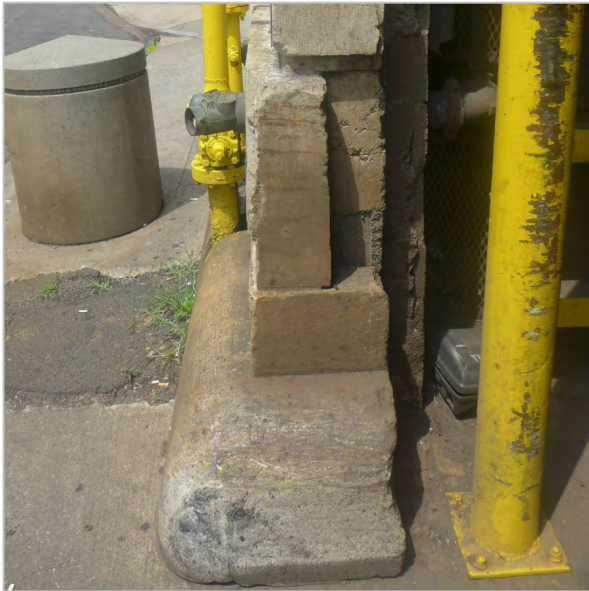
DAMAGED GRANITE JAMB

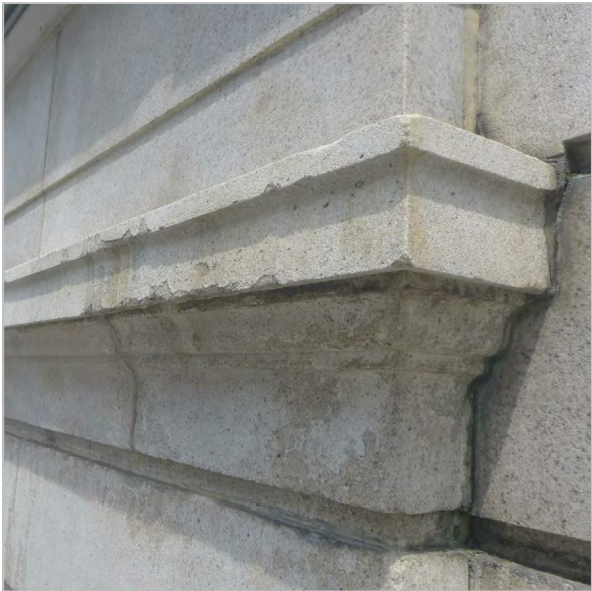
SCALING AND SPALLING GRANITE

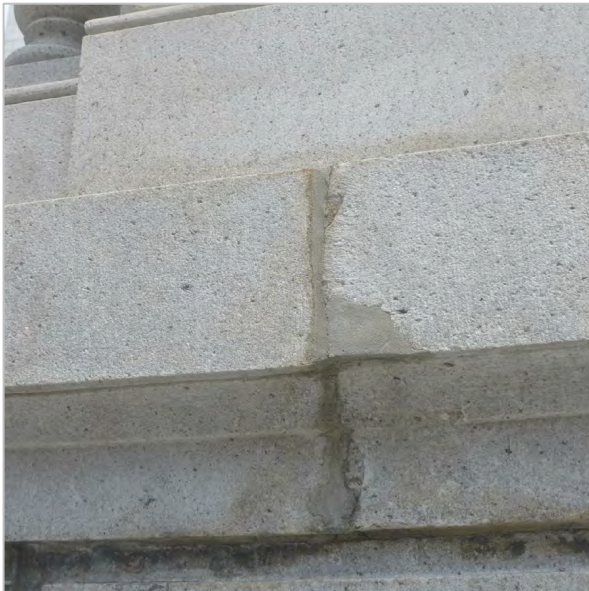
PATCH AT GRANITE

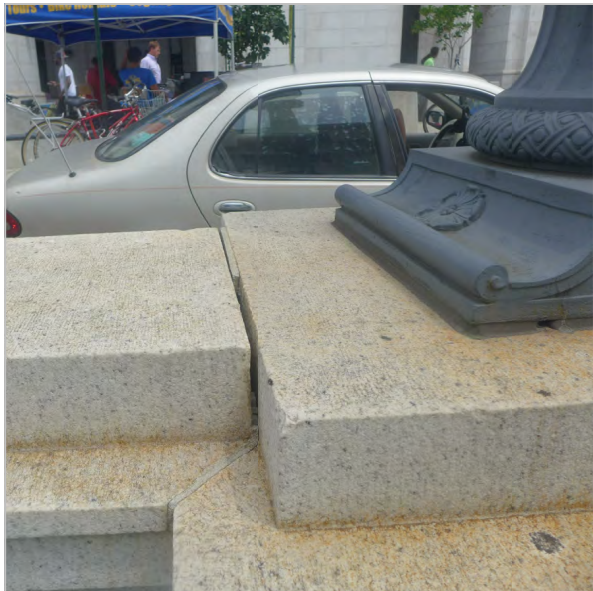
OPEN JOINT AT COPING

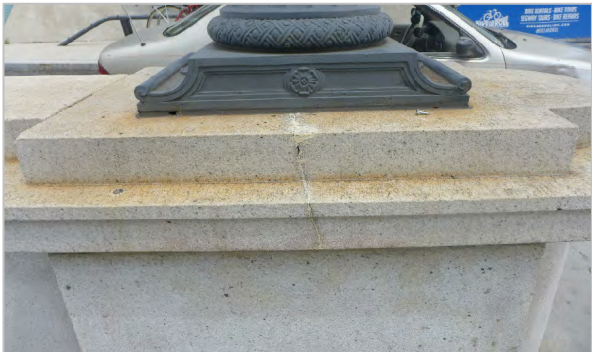
CRACK AT COPING

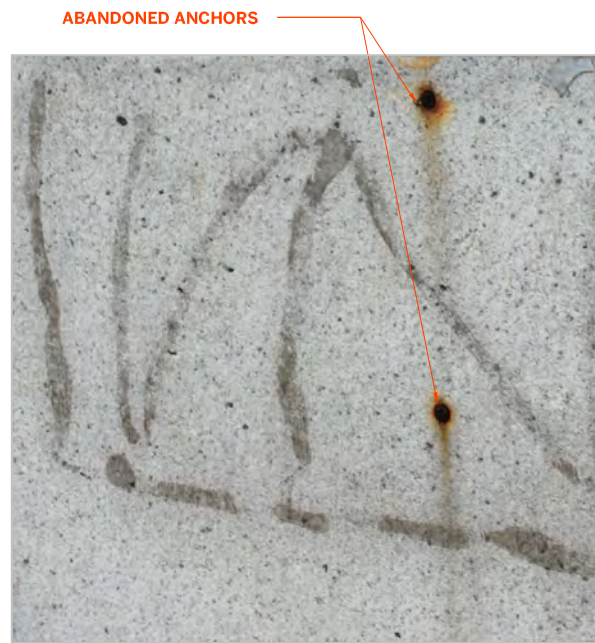
ABANDONED ANCHORS AND RESIDUE FROM FORMER SIGNAGE

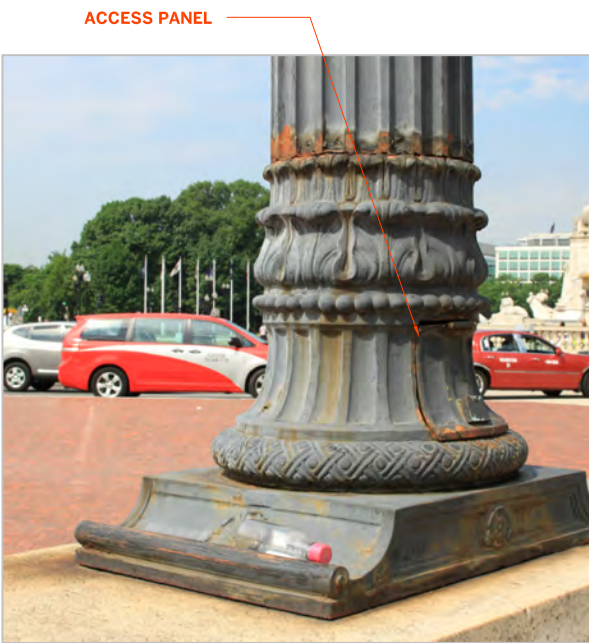
PAINT FAILURE AND CORROSION

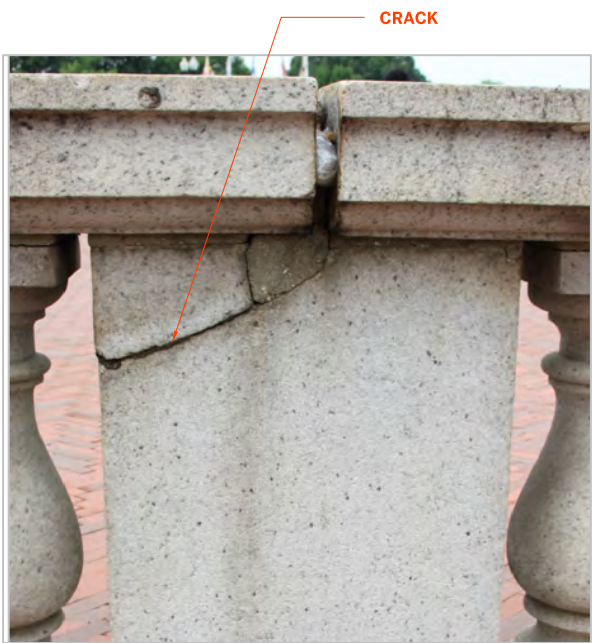
CRACKING THROUGH MASONRY

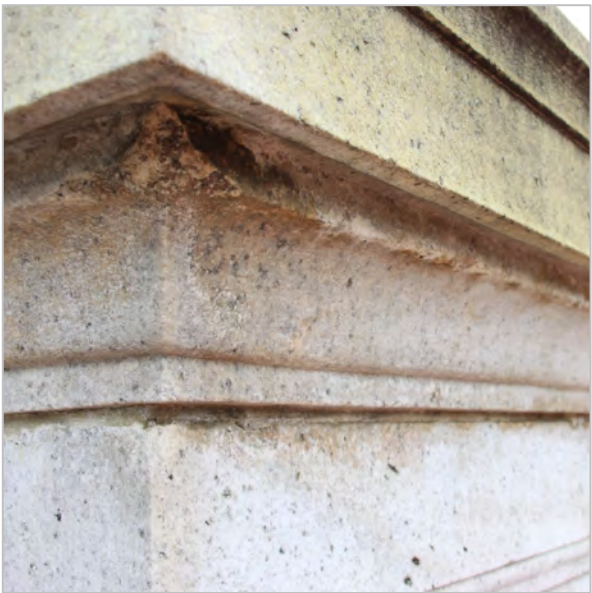
DISAGGREGATION OF GRANITE ON TOP RAIL OF BALUSTRADE

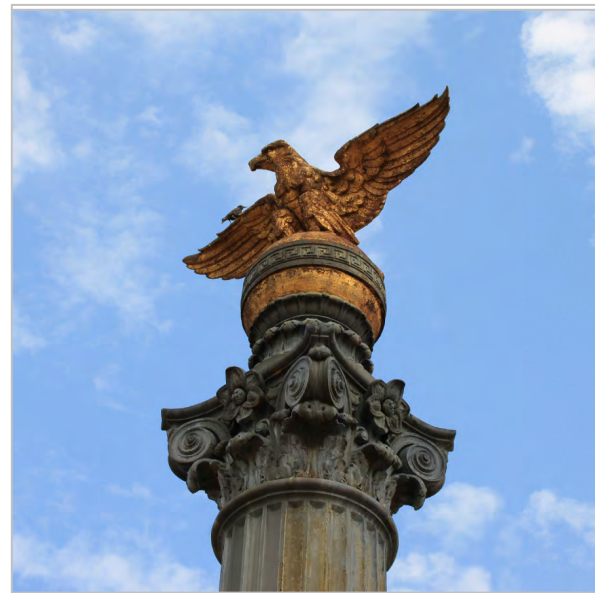
FINISH FAILURE ON EAGLE SCULPTURES

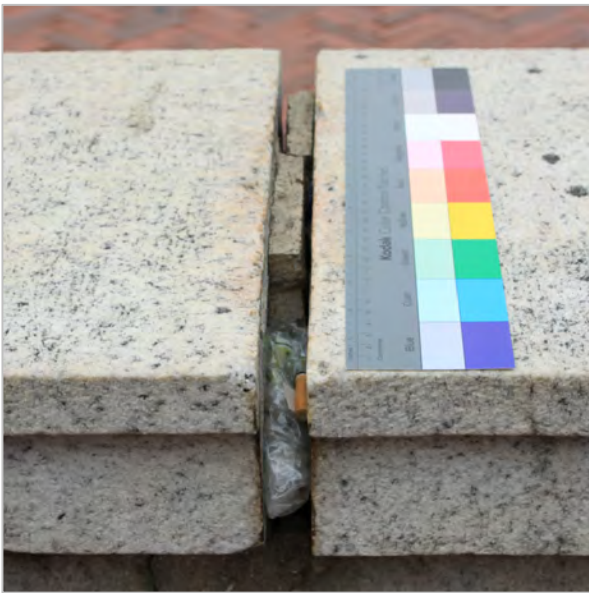
OPEN MORTAR JOINTS

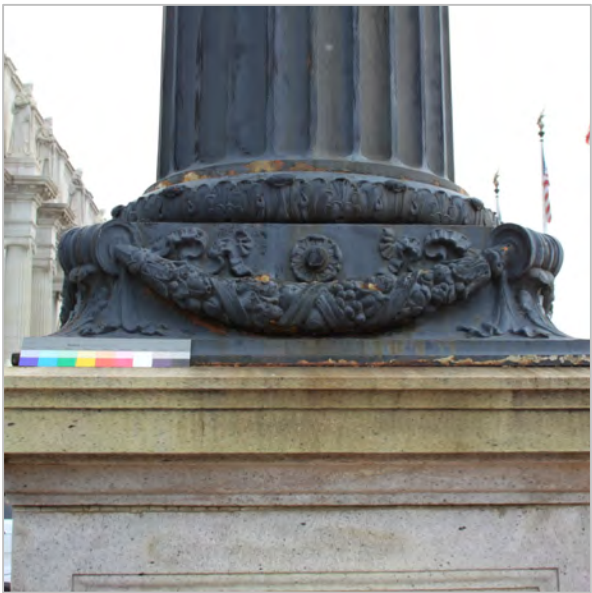
SURFACE CORROSION AND FERROUS STAINING ON GRANITE BASE

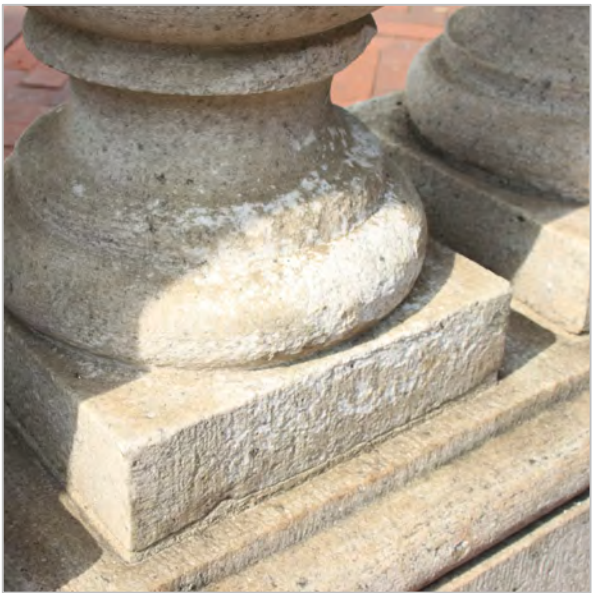
DISAGGREGATION OF GRANITE BASE OF BALUSTER

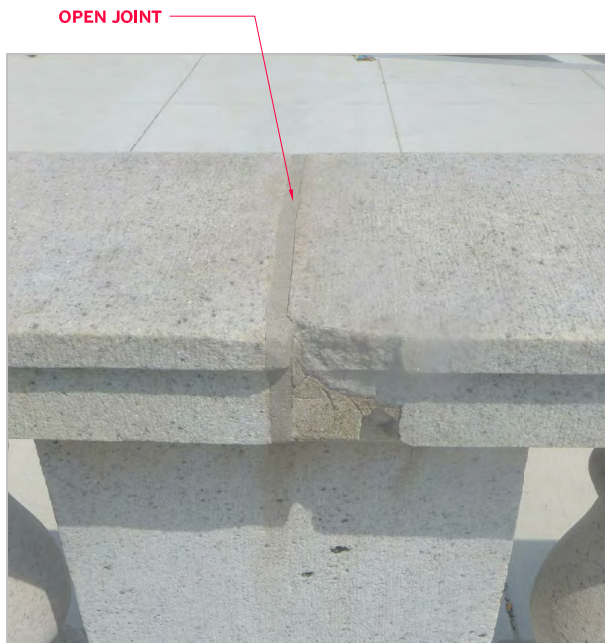
SPALL AND PATCH AT GRANITE

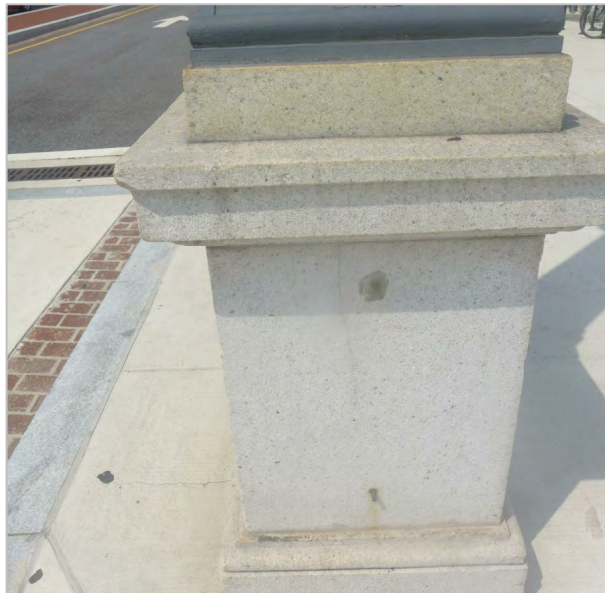
PATCHED HOLES AT GRANITE

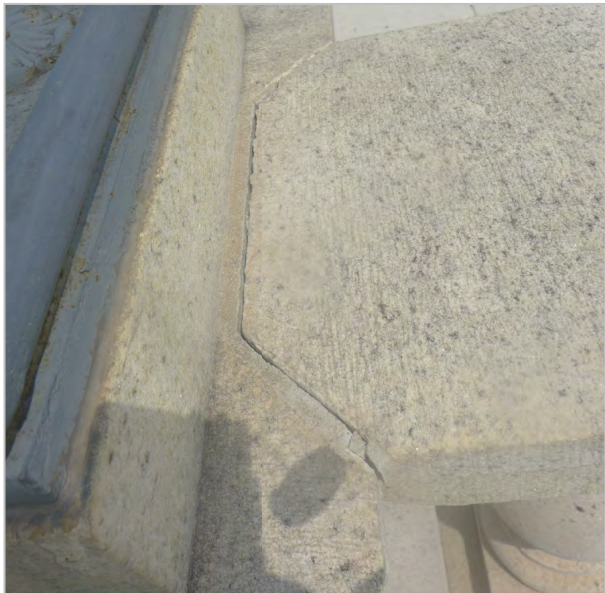
OPEN JOINT AT COPING

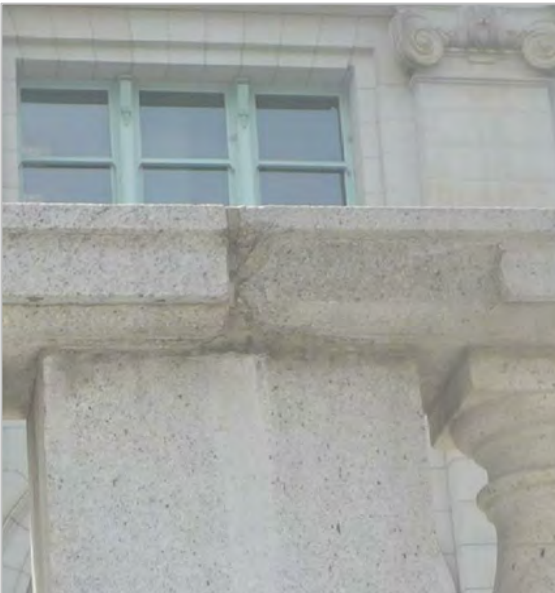
SPALL AT GRANITE

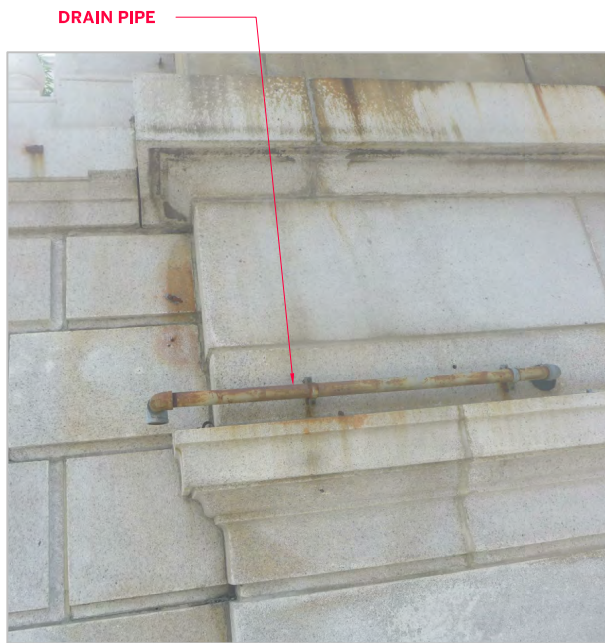
FERROUS STAIN AT GRANITE

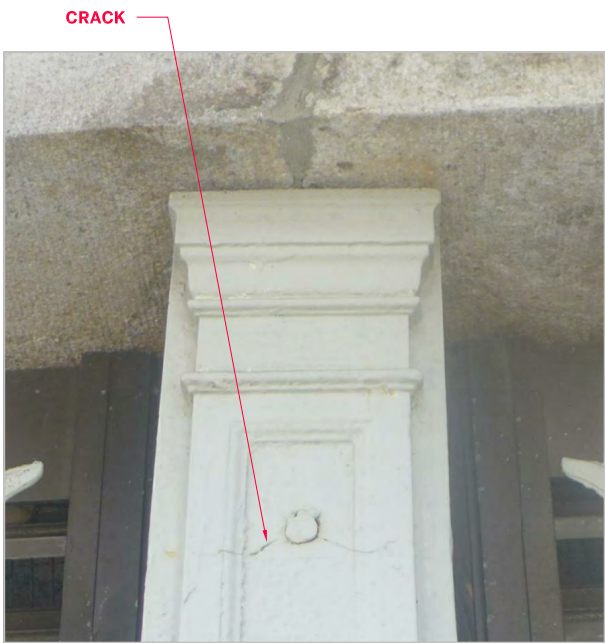
CRACKED CAST IRON PANEL WITH PIN

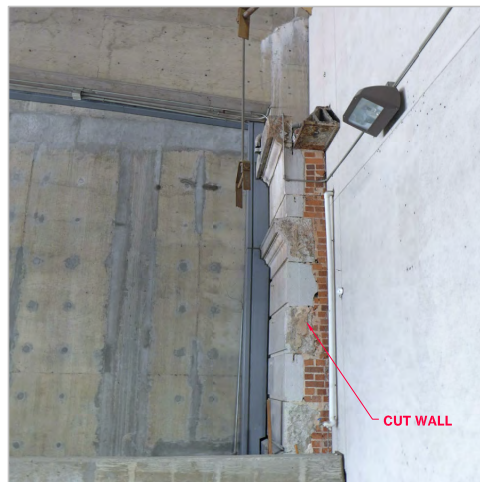
ORIGINAL MASONRY WALL CUT AT NEW RAMP, EAST CORNER

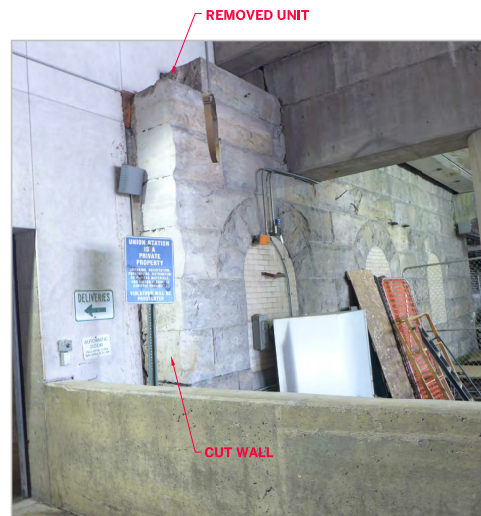
ORIGINAL MASONRY WALL CUT AT NEW RAMP

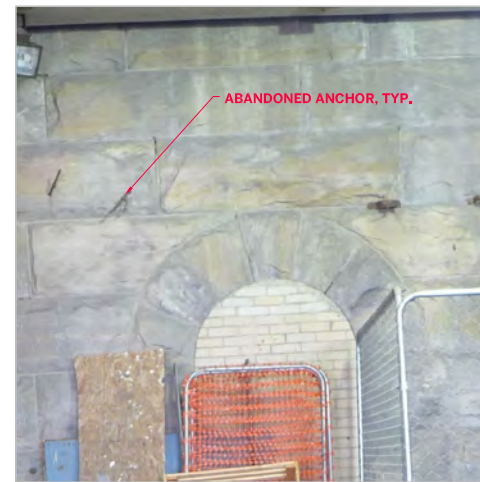
ABANDONED ANCHORS IN MASONRY WALL

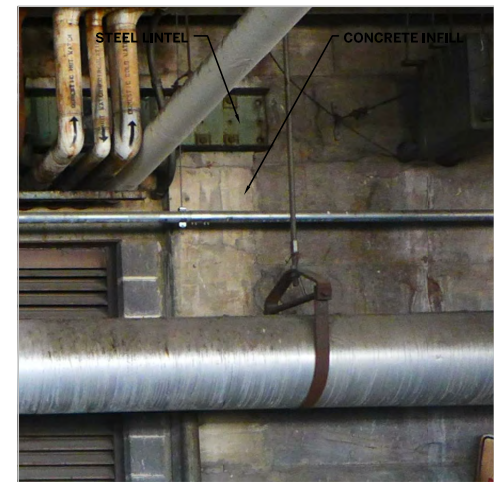
NON-ORIGINAL STEEL LINTEL AND CONCRETE INFILL

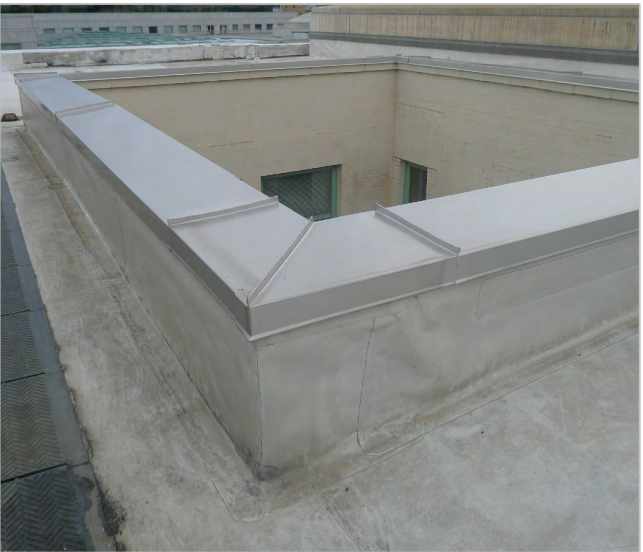
REPLACEMENT ROOFING MATERIAL AND FLASHING

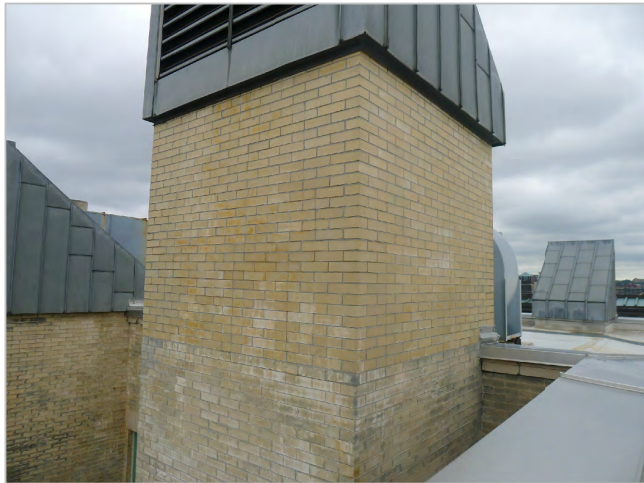
BRICK EXTENSION AT VENT

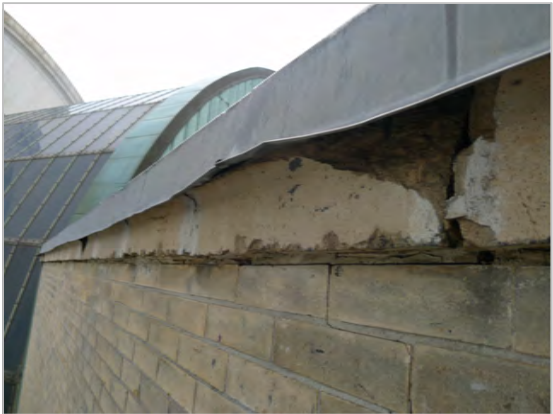
SPALLED TERRA COTTA AND BRICK

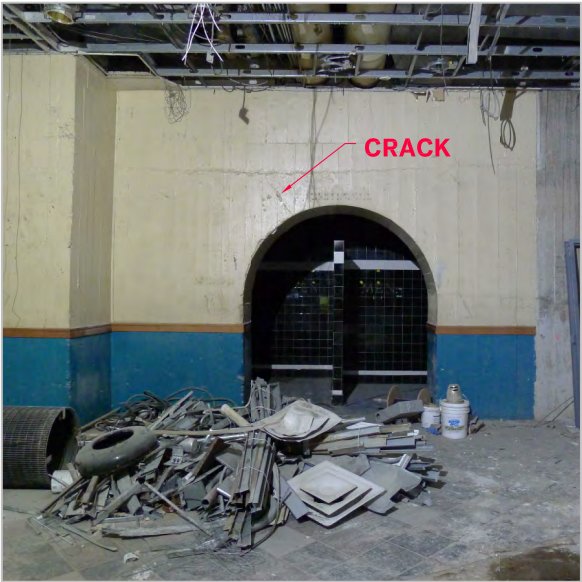
CRACK AT CONCRETE WALL

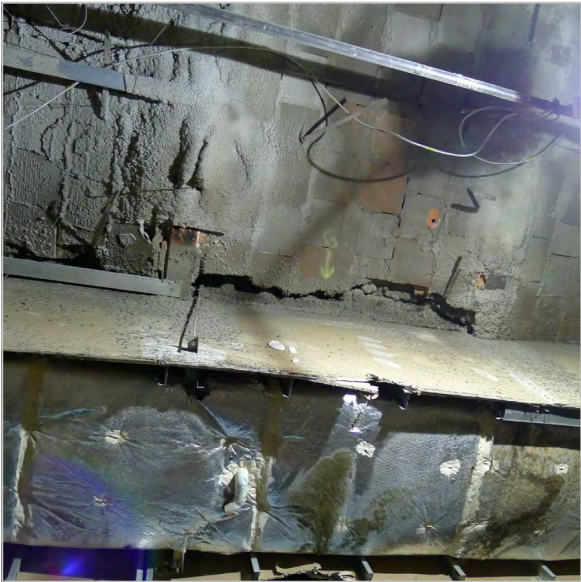
This area is in unfinished and somewhat poor condition. There are several areas of scaffolding set up in the center of the roof supporting the ceiling, and there is visible damage to the terra cotta ceiling. The concrete arches all contain cracks at their peak. Some of the column foundations are cracked. Remnants of the former theater remain.

CRACKED TERRA COTTA SLAB

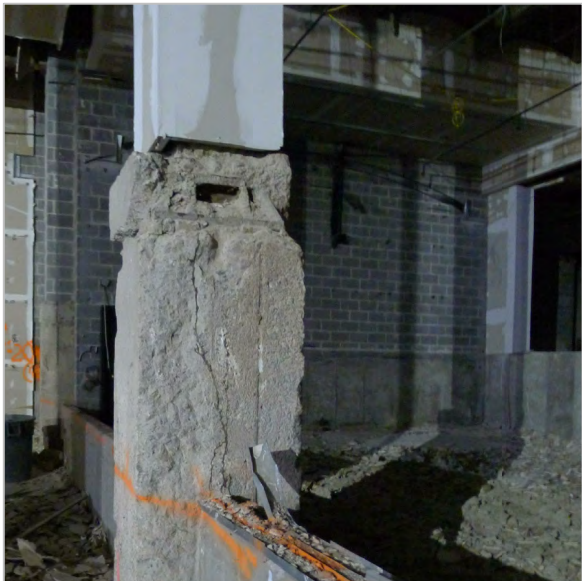
CRACKED COLUMN FOUNDATION

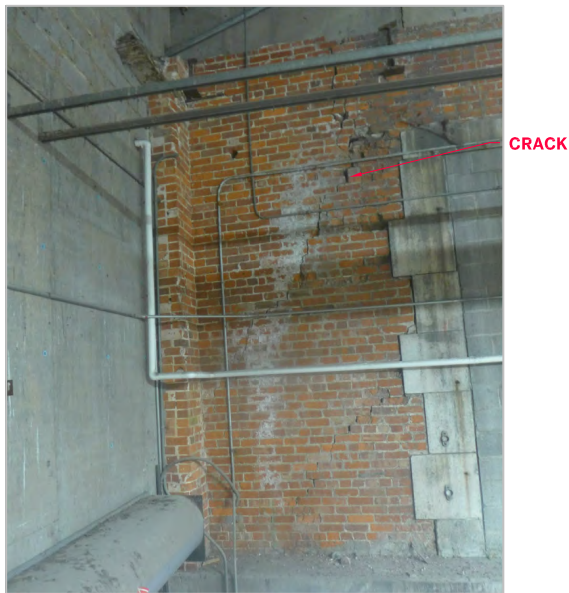
CONTINUOUS CRACK AT EXTERIOR WALL

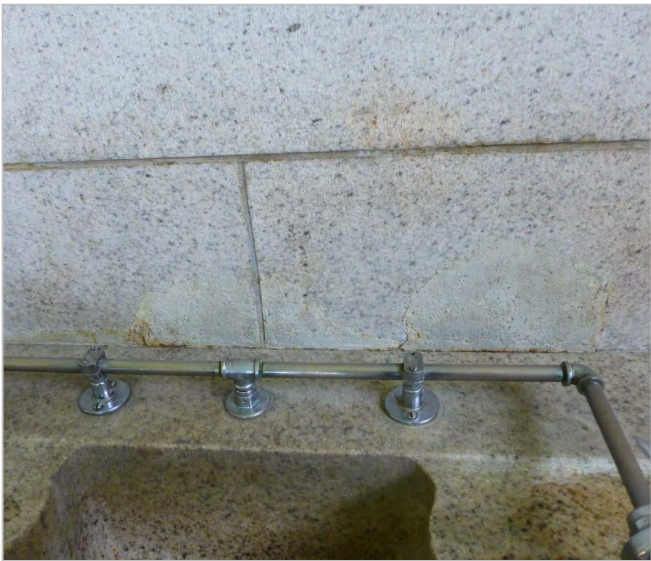
PATCH AT GRANITE

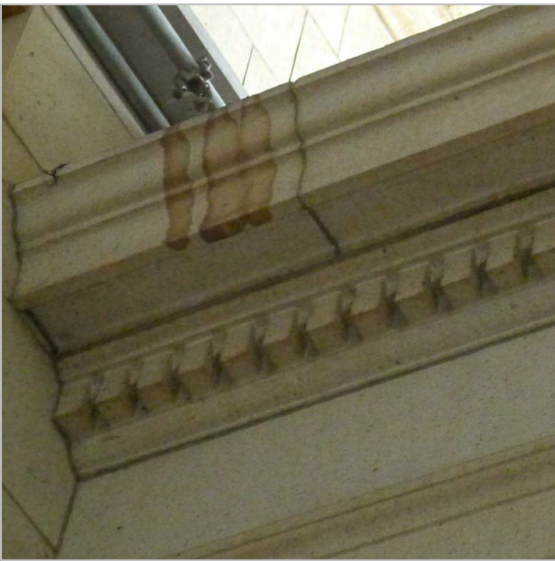
STAIN AT GRANITE

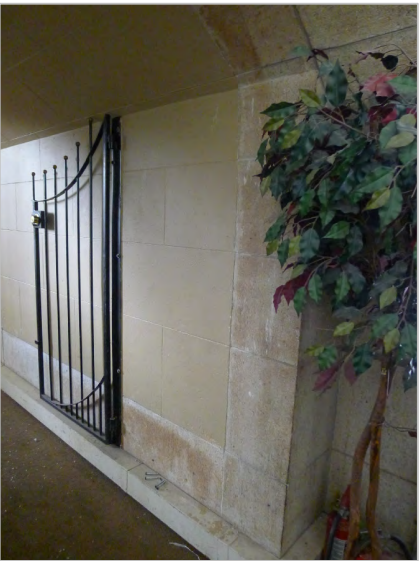
PAINTED GRANITE AND SOILING AT SOUTH GALLERY

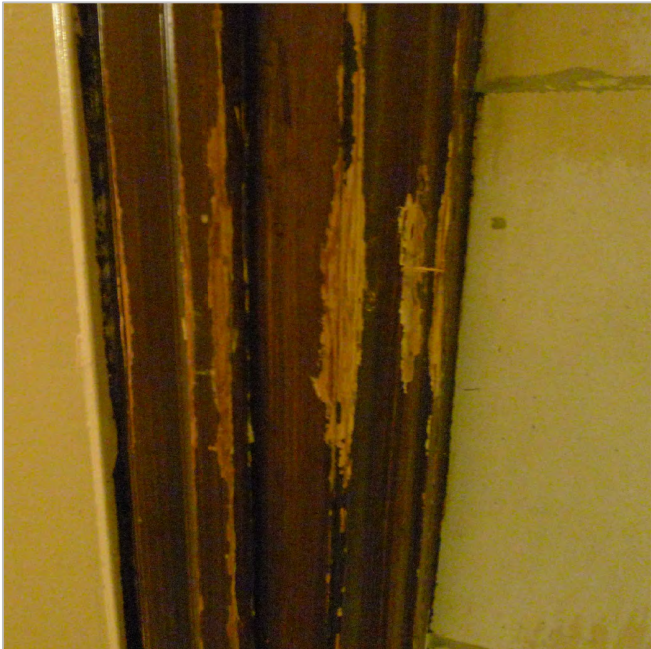
The wood door frames and metal transoms are generally intact, with scratches and gouges in the wood. At the bottom of a number of frames, the wood is cracked. In general, the granite is more soiled at the gallery spaces than at the main level. The granite is typically painted at the undersides of the arches, and the granite pieces at the end of the arches are often heavily stained.

DAMAGE TO WOOD FRAME

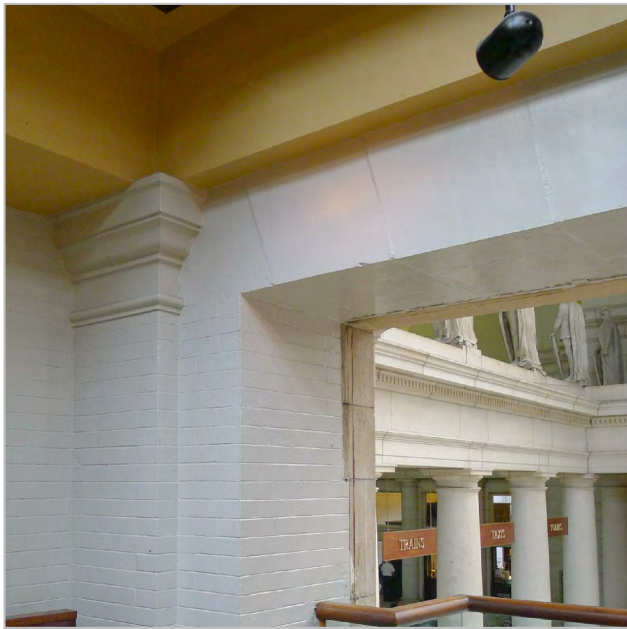
BRICK WALL AND TERRA COTTA LINTEL

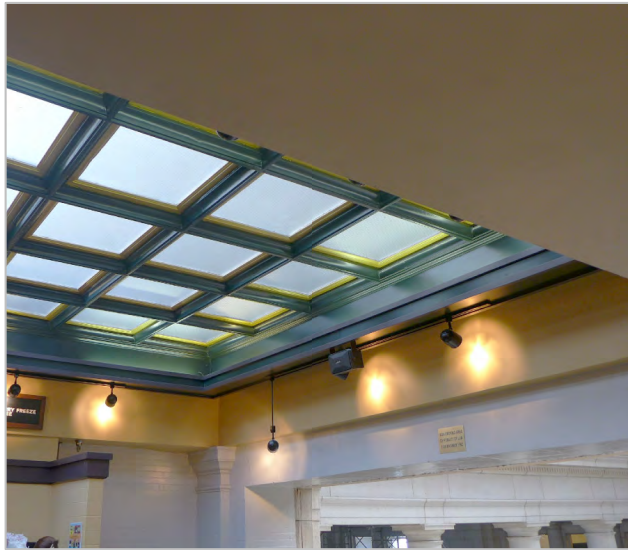
LAYLIGHT

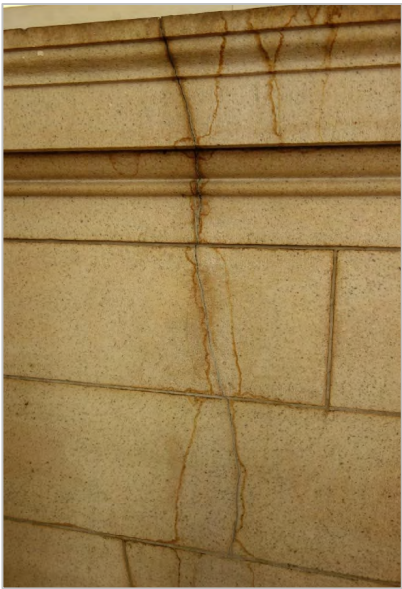
CONTINUOUS CRACK AND WATER STAIN

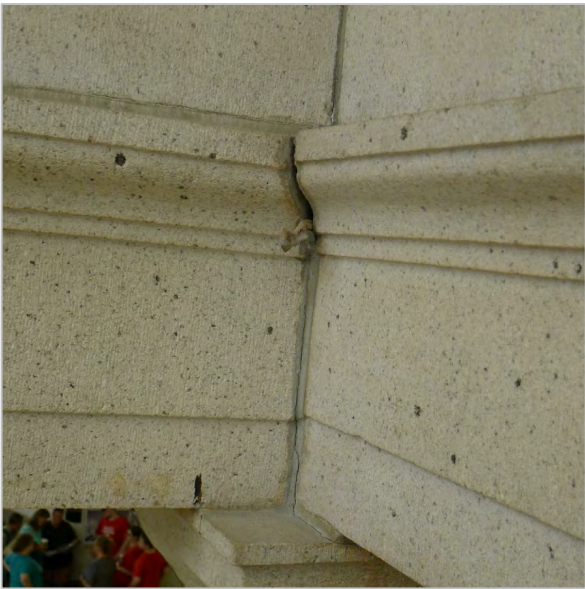
CRACKED AND OPEN JOINT

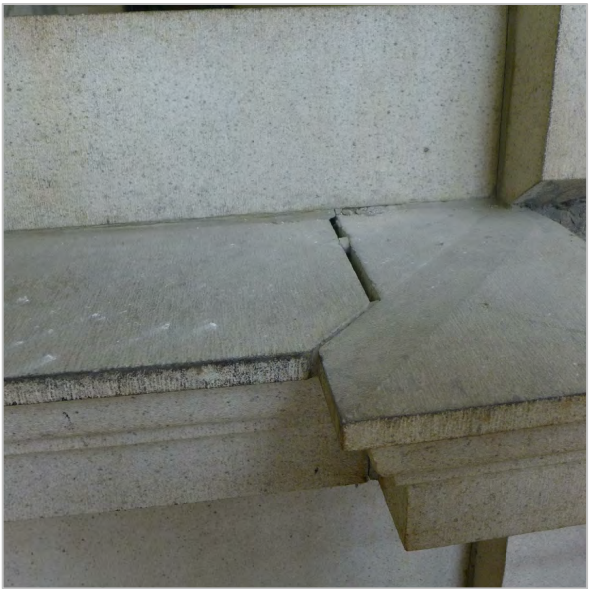
MORTAR LOSS

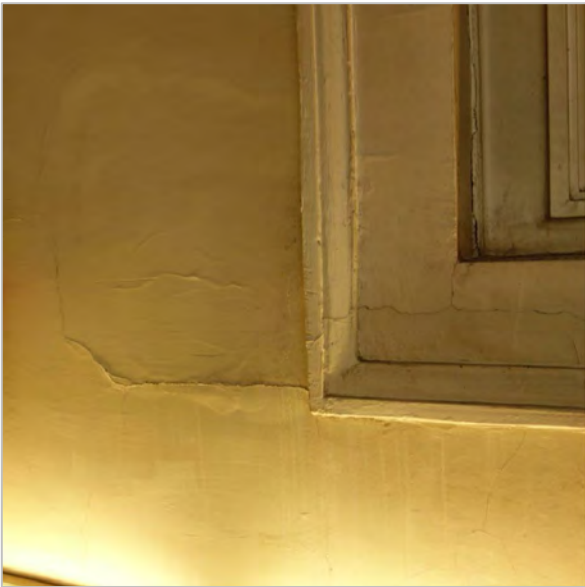
CRACKED PLASTER
