WASHINGTON UNION STATION

HISTORIC PRESERVATION PLAN: VOLUME I

HISTORIC PRESERVATION PLAN

VOLUME I of III

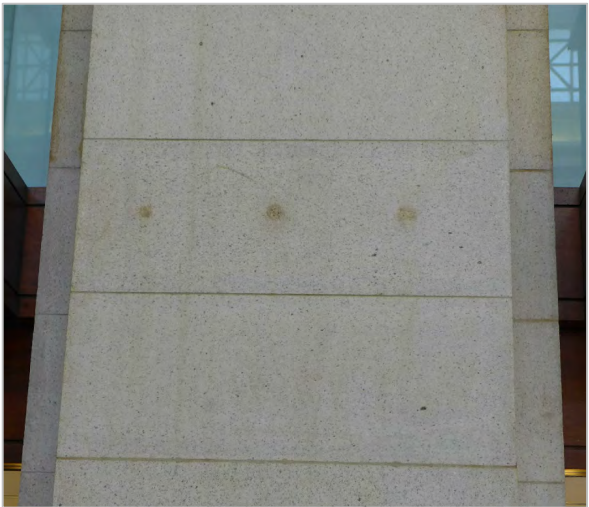
PATCHED HOLES

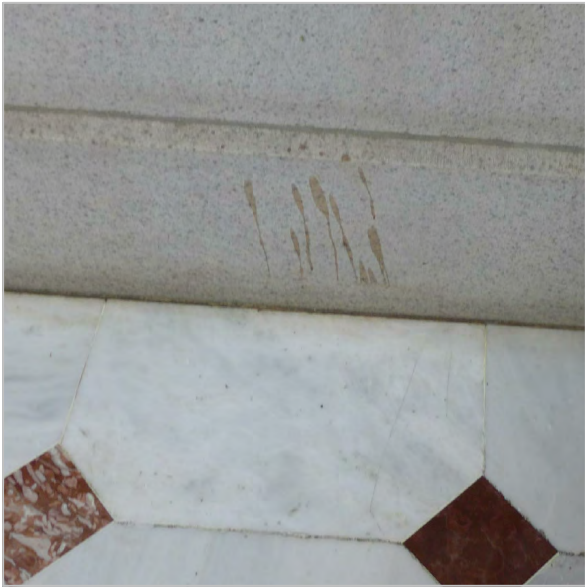
PAINT SPLASH

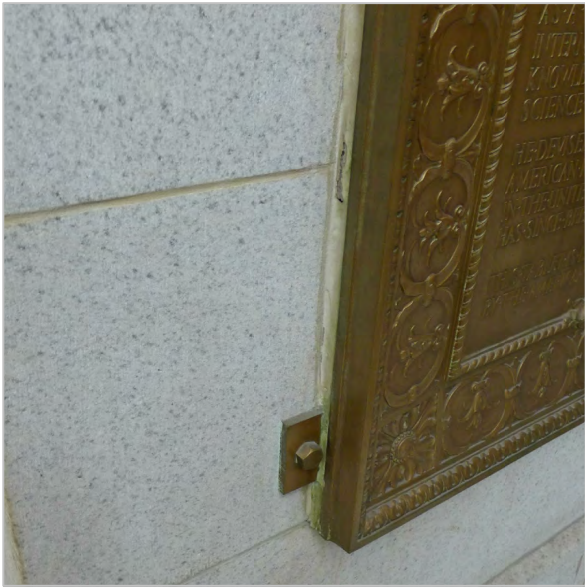
OPEN JOINT AROUND PLAQUE

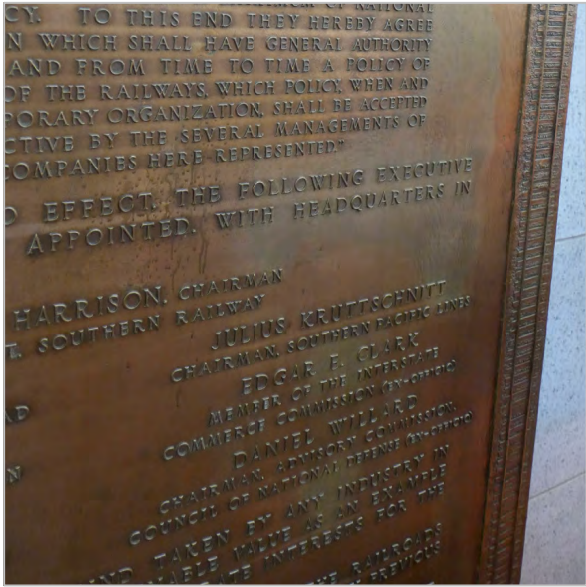
DETERIORATED FINISH

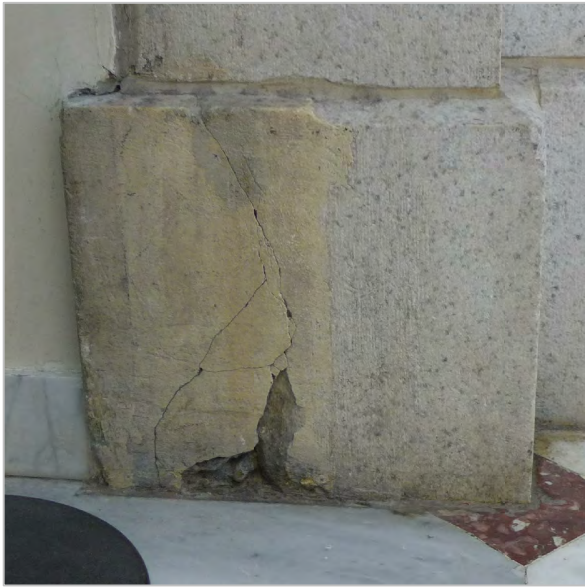
CRACKED PATCH

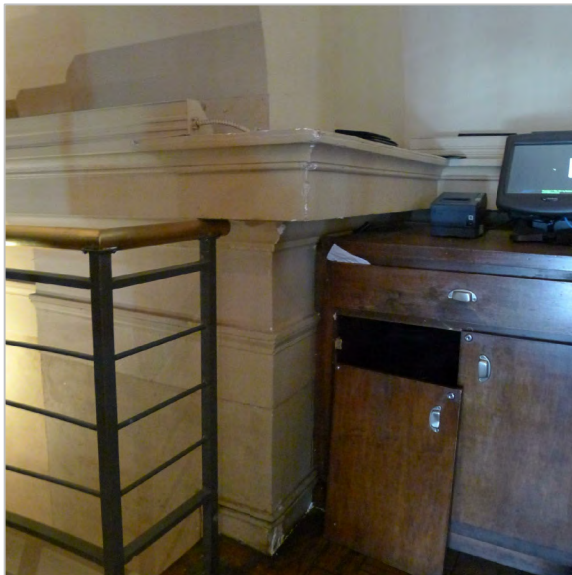
DAMAGED PLASTER CORNER

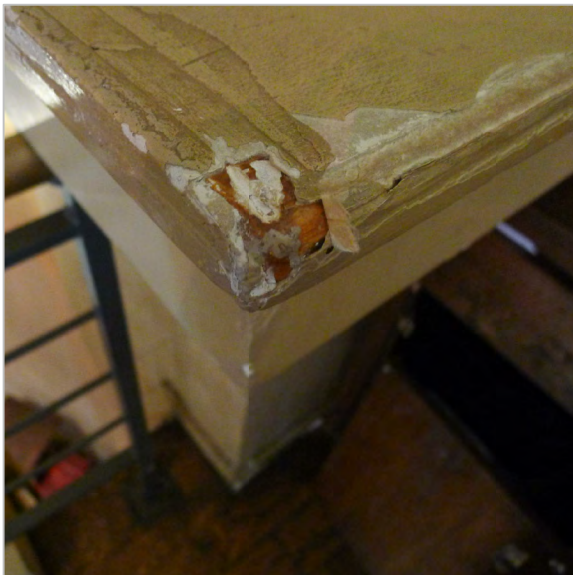
SPALL IN PLASTER

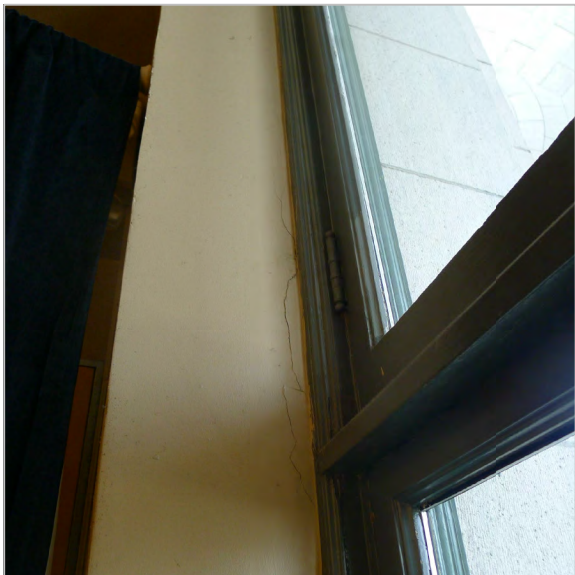
CRACK IN PLASTER

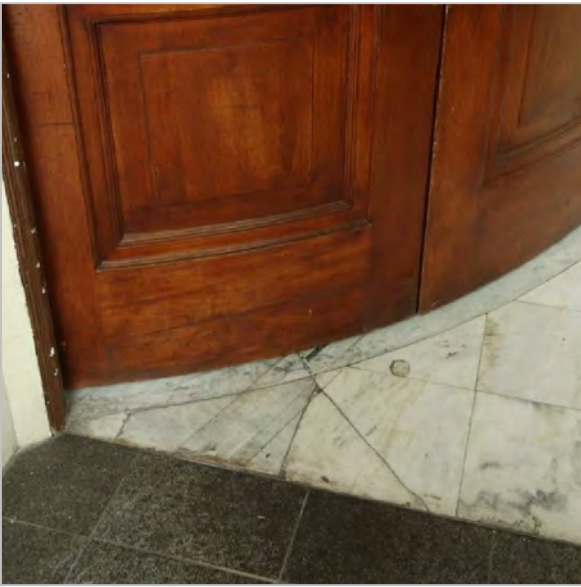
CRACK AT MARBLE FLOOR (SOUTH VESTIBULE)

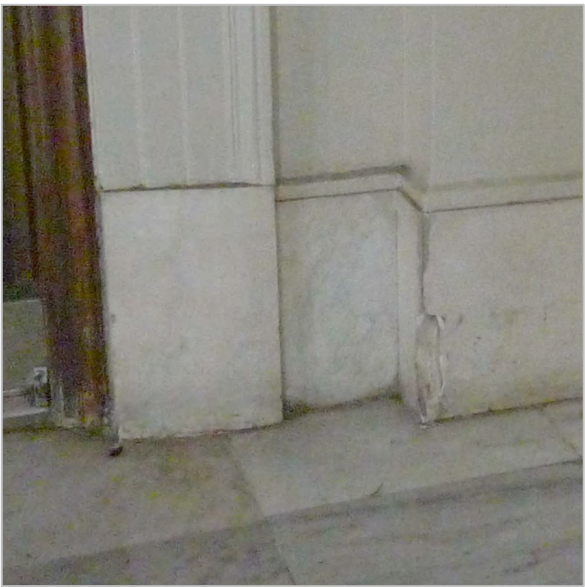
SPALL AT MARBLE BASEBOARD (SOUTH VESTIBULE)

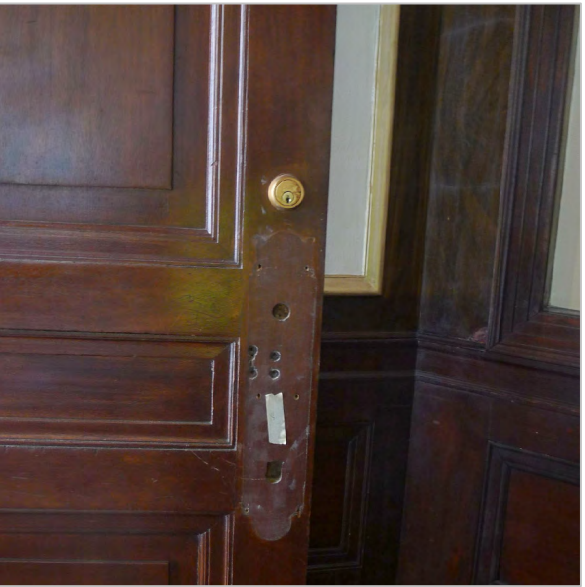
MISSING HARDWARE (SOUTH VESTIBULE)

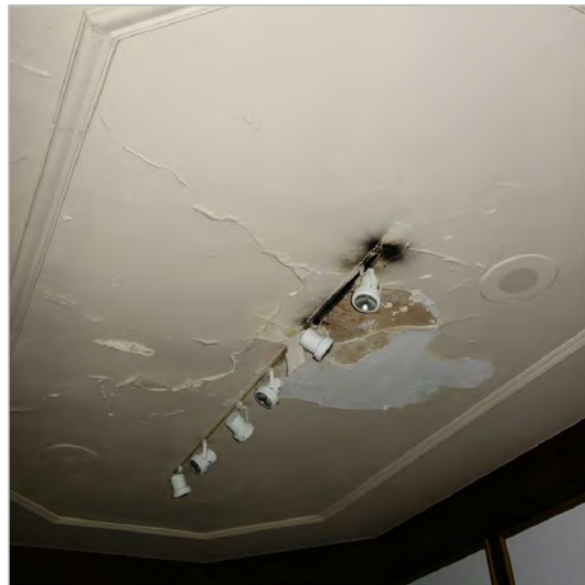
The small southwest room contains a significant amount of plaster damage from water infiltration. Based on its location inside the building, the water infiltration is likely a result of interior plumbing rather than water infiltrating from the exterior. It is unclear if the leak is still active.

PLASTER CEILING WATER DAMAGE (WEST RETIRING ROOM)

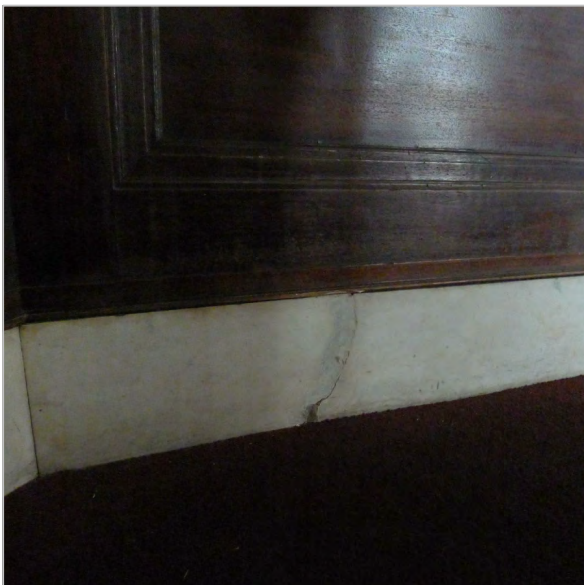
CRACK AT MARBLE BASEBOARD (EAST RETIRING ROOM)

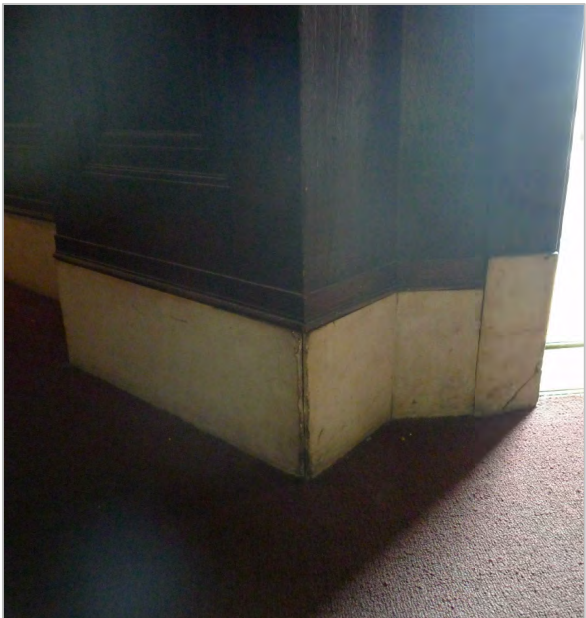
SPALLS AT MARBLE BASEBOARD (EAST RETIRING ROOM)

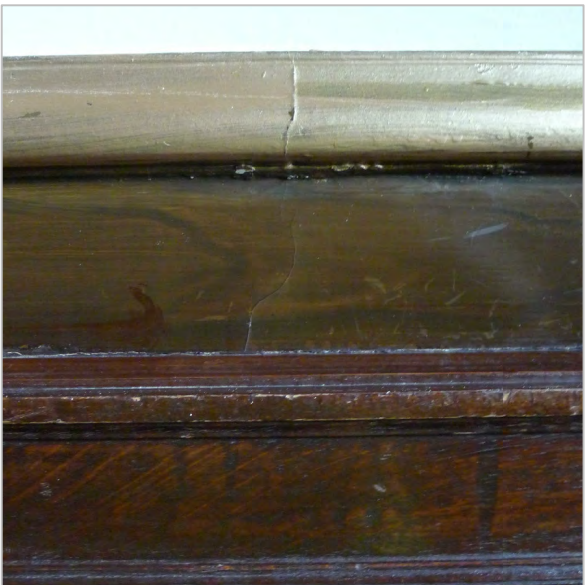
CRACKED PLASTER MOLDING (EAST RETIRING ROOM)

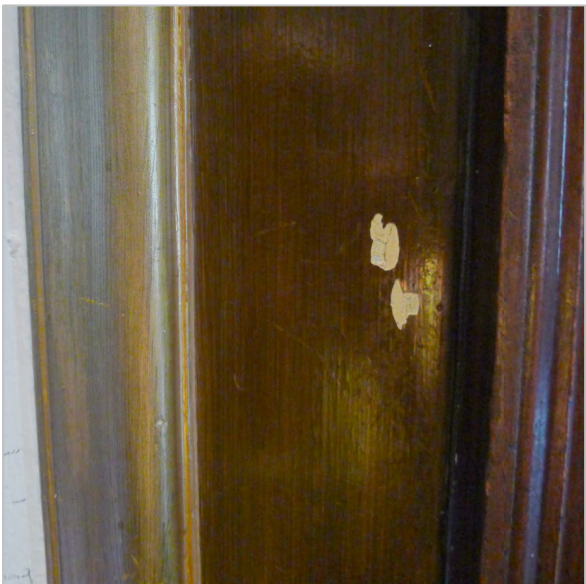
IMPACT AT PLASTER PANEL (EAST RETIRING ROOM)

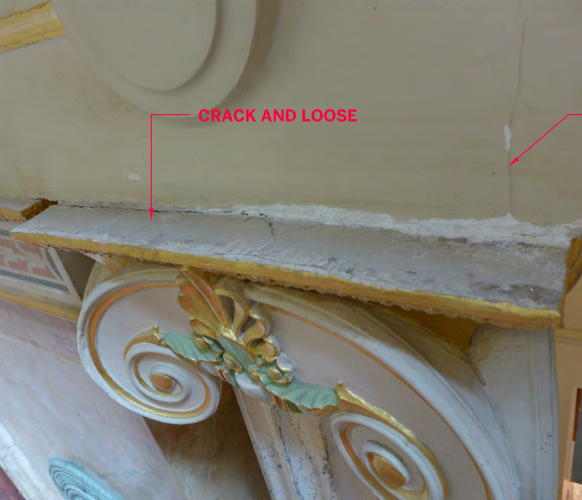
During the up-close inspection, cracks were also observed in the plaster column capitals and cornice. While the plaster was loose in some places, it did not appear in danger of falling.

LOOSE PLASTER AT COLUMN CAPITAL

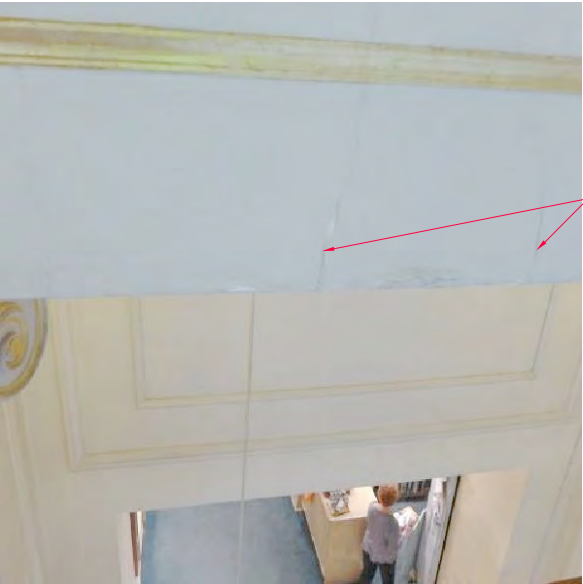
CRACK AT PLASTER SOFFIT

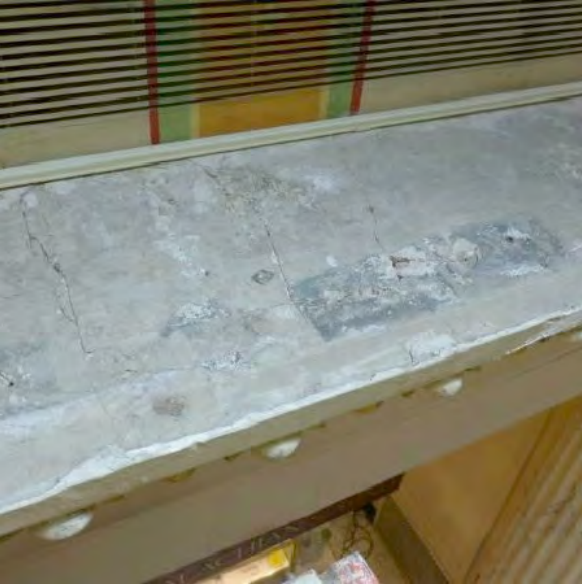
CRACKED LEDGE CLOSE TO ORIGINAL LIGHT COVE

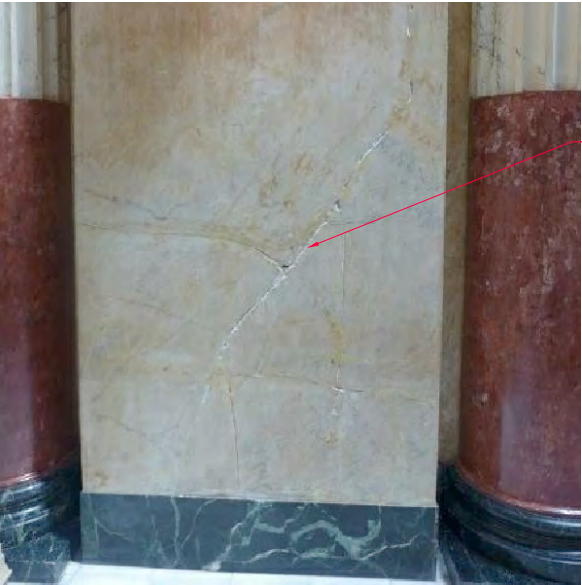
The most significant condition in the East Hall is cracking of the scagliola pilasters. Nearly all of the pilasters exhibit some cracking. In some cases, the cracked material is loose and/or displaced. The East Hall is located over the First Street Tunnel which causes the room to vibrate on a regular basis. The ongoing vibrations may be contributing to the cracking of the scagliola.

CRACKED AND LOOSE SCAGLIOLA PILASTER

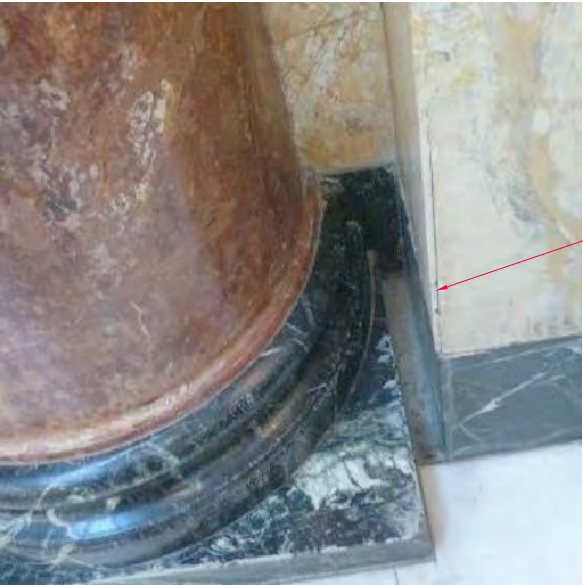
OPEN JOINT AT SCAGLIOLA PILASTER

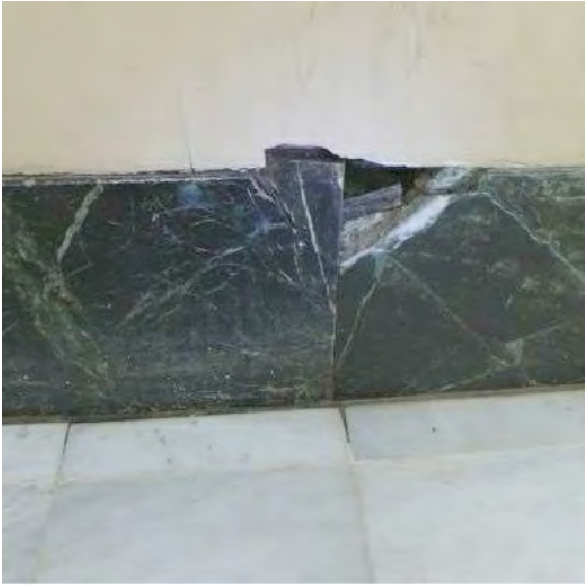
CRACKED, SPALLED, AND LOOSE MARBLE BASE

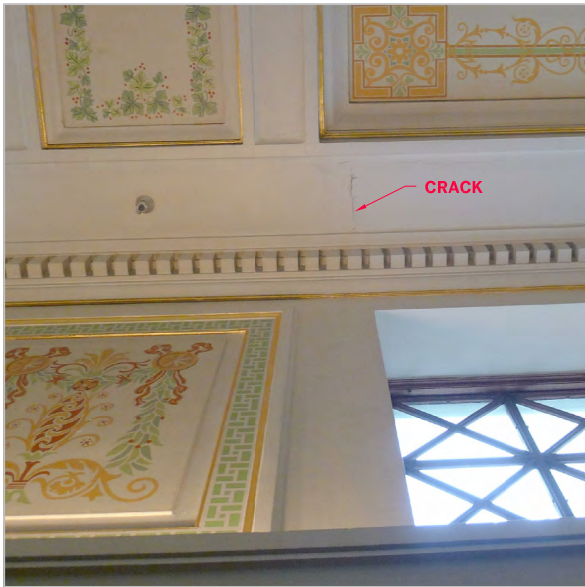
The historic materials are generally in good condition. The plaster walls, cornice, and ceiling all contain hairline cracks. There is some paint loss of the replica decorative paint.

CRACKED PLASTER CEILING

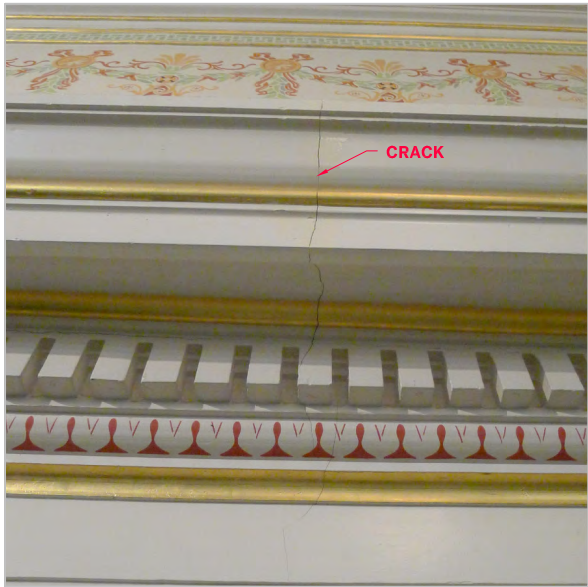
CRACK AT PLASTER CORNICE

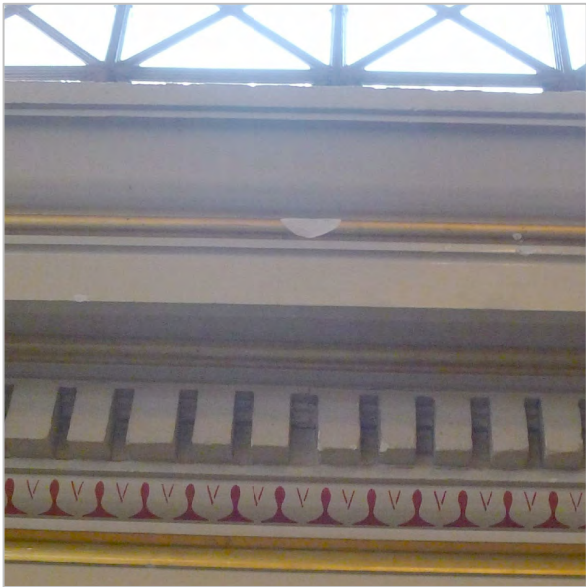
SPALL AT PLASTER CORNICE

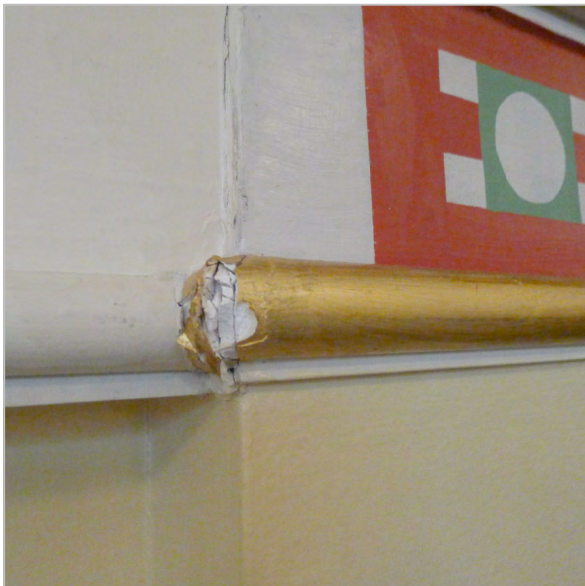
CRACK AND SPALL AT PLASTER CORNICE

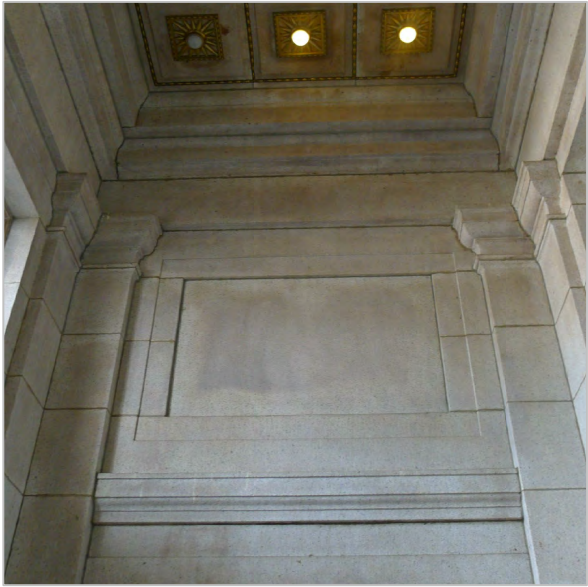
SOILED GRANITE CEILING AND WALL

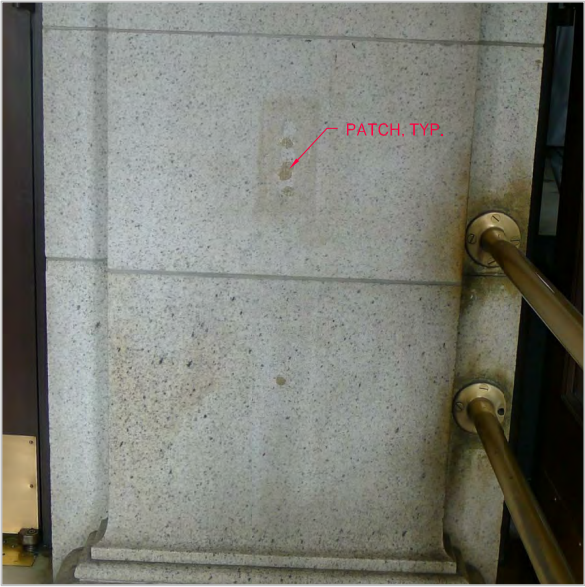
PATCHED HOLES

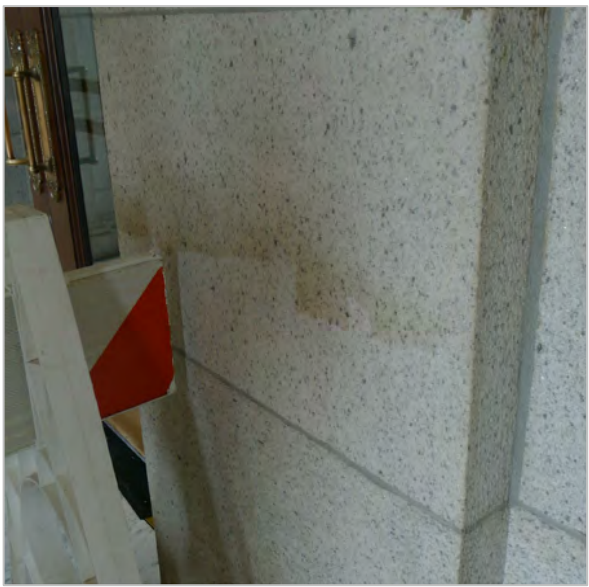
PARTIAL CLEANING

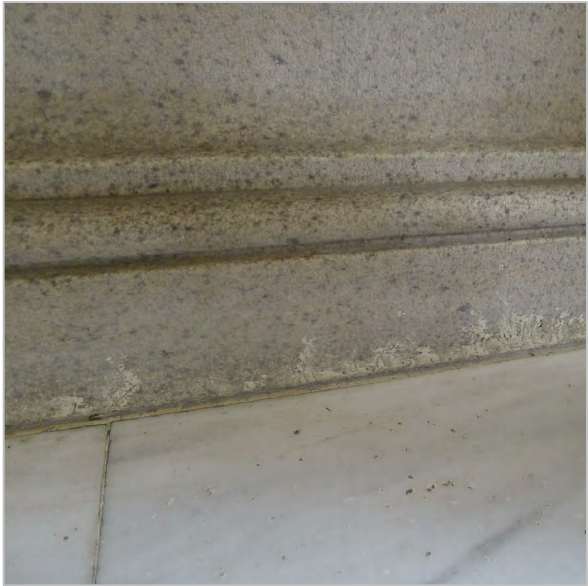
PAINT/WAX RESIDUE

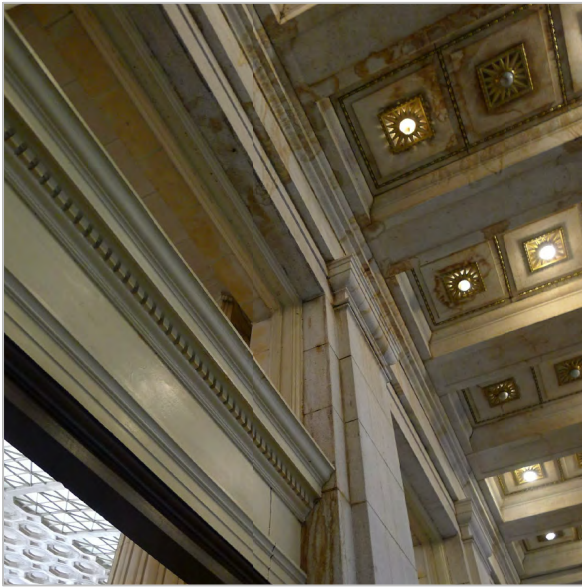
The North Vestibules vary in condition. The westernmost vestibule contains a significant amount of staining from previous water infiltration (possibly related to the sink area in the north gallery above). Other ceilings also have evidence of water infiltration, but they are less severe than at the west vestibule. Because the North Vestibules are located between the headhouse and the concourse, it is also possible there has been water infiltration issues at this juncture on the exterior.

WATER-STAINED AND SOILED GRANITE CEILING AND WALL

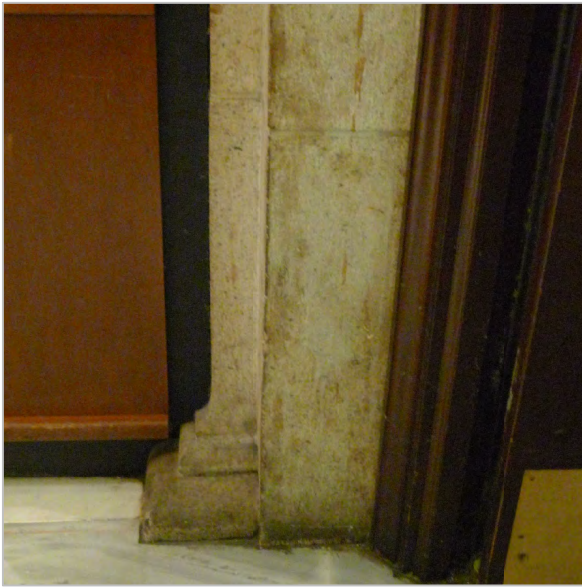
SOILED GRANITE WALL

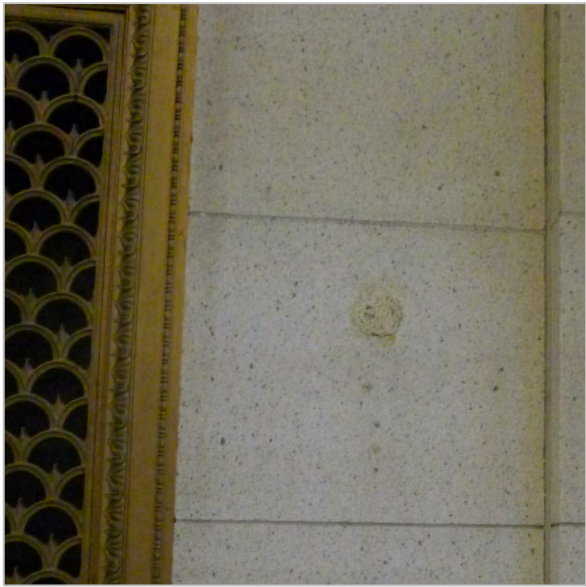
PATCHED HOLE

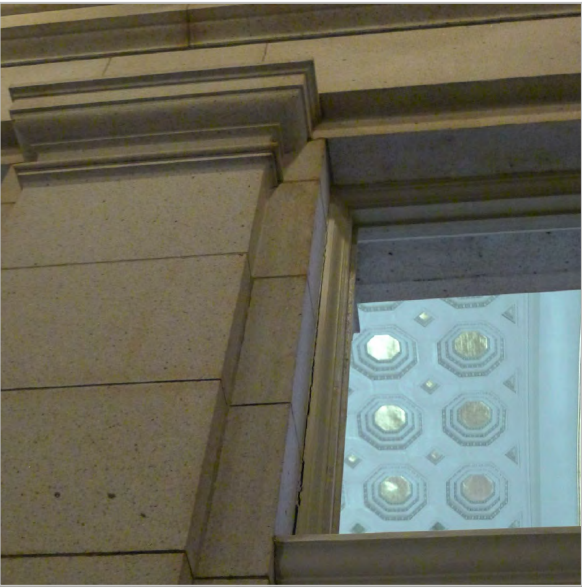
OPEN JOINT BETWEEN GRANITE AND FRAME

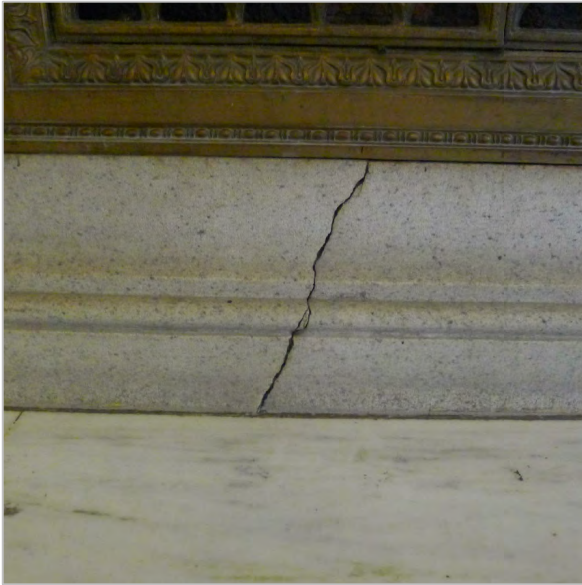
There are large cracks in the base of the granite walls in at least one location, as well as a large loss. Overall, the granite in the North Vestibules appears to be more heavily soiled than in the rest of the Main Hall. Some of the light fixtures and grille doors are damaged.

CRACK AT GRANITE BASE

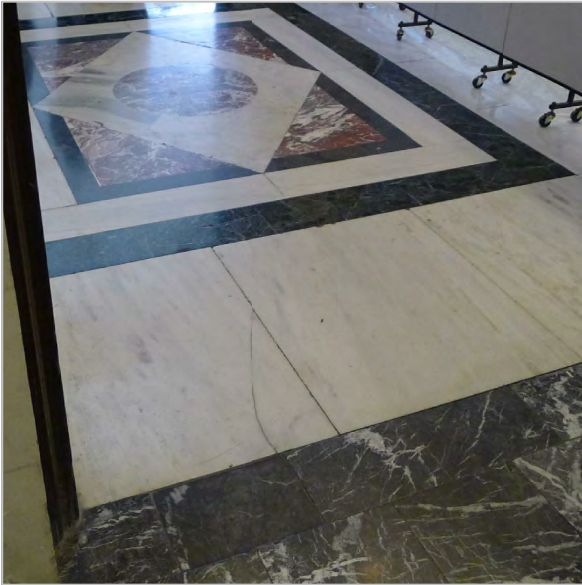
CRACK AT MARBLE FLOOR

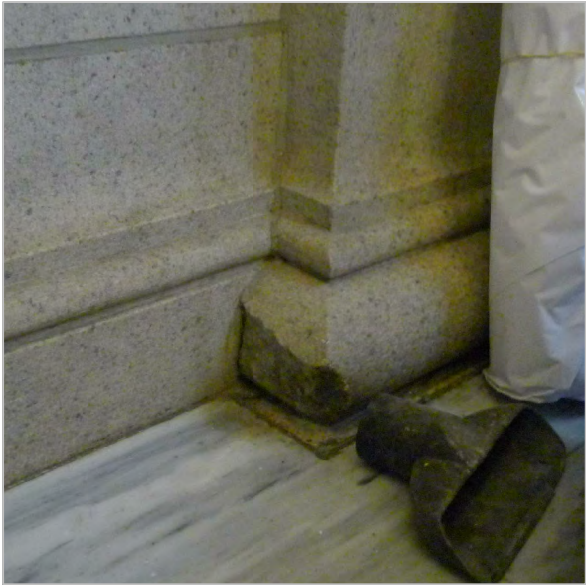
SPALL AT GRANITE BASE

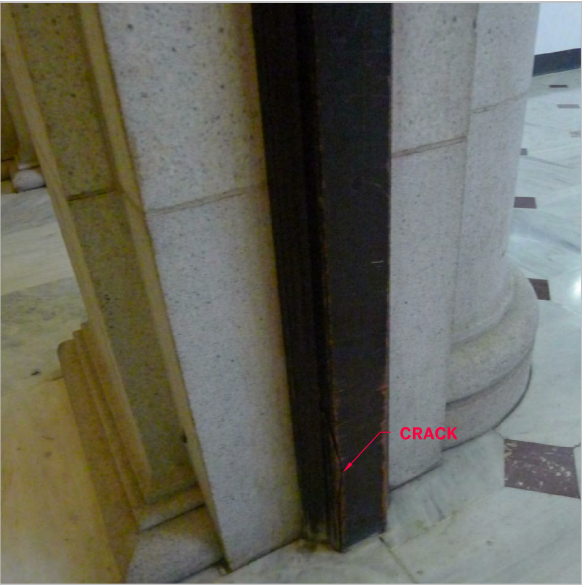
CRACK AT WOOD FRAME

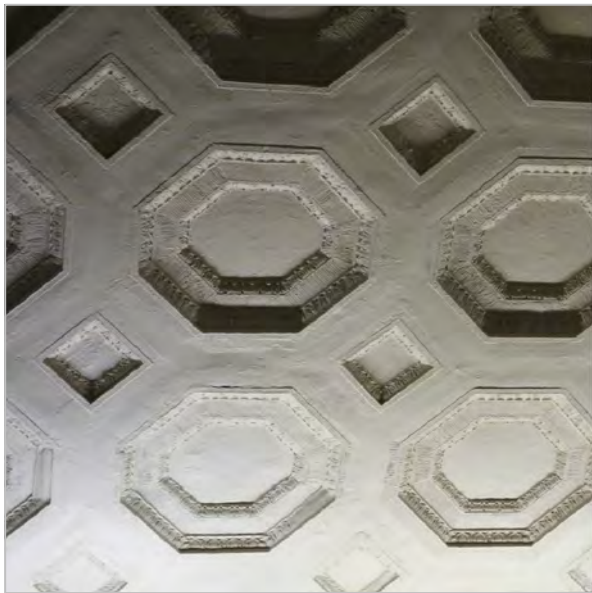
PAINT OVER DETERIORATED PLASTER

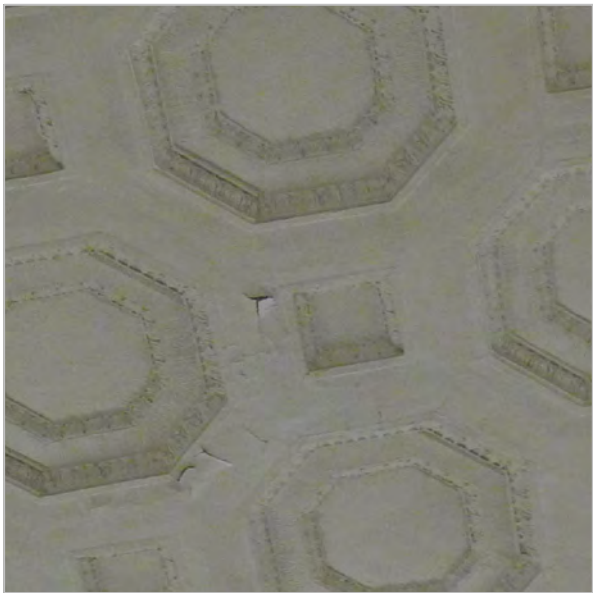
WATER DAMAGE

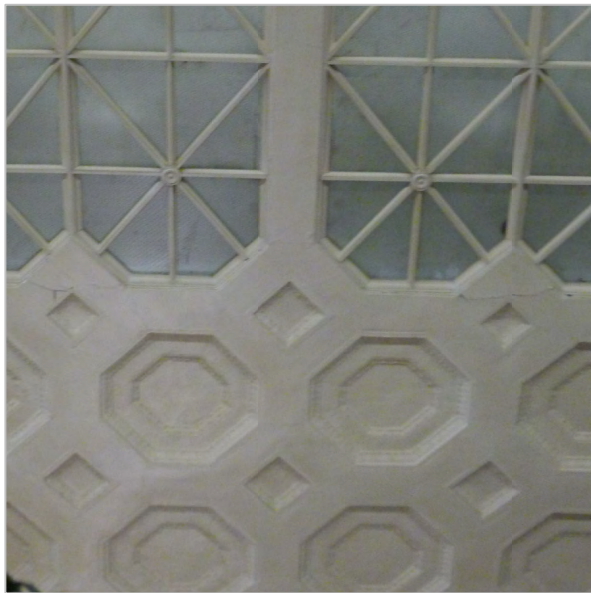
CRACK AT PLASTER

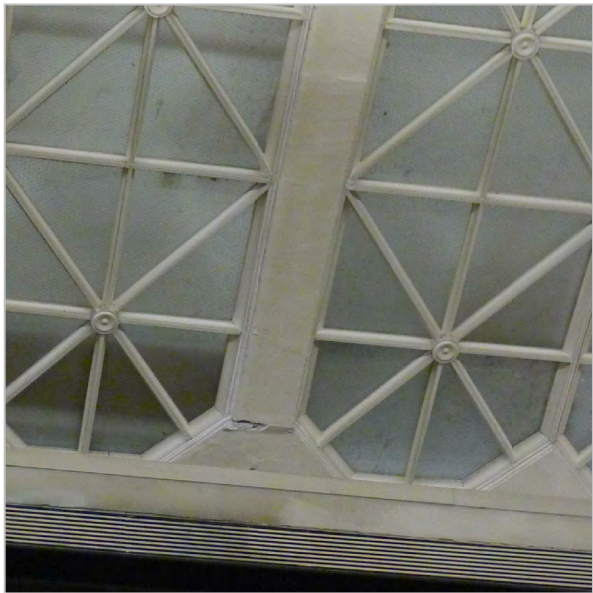
CRACK AT PLASTER BETWEEN LAYLIGHTS, TYP.

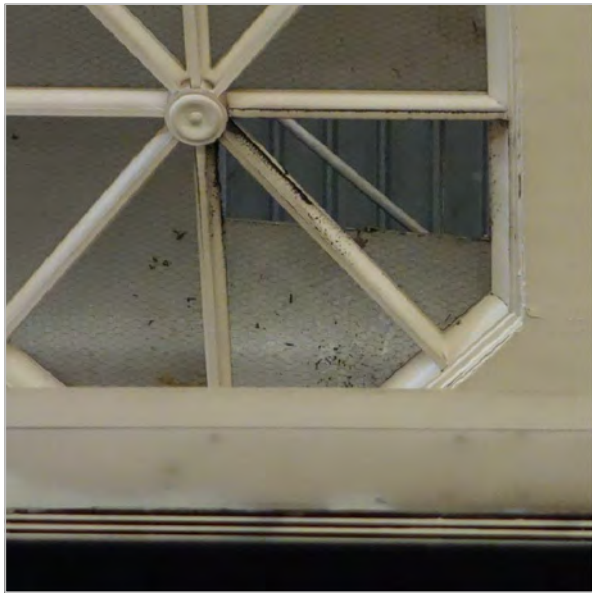
MISSING/BROKEN GLASS

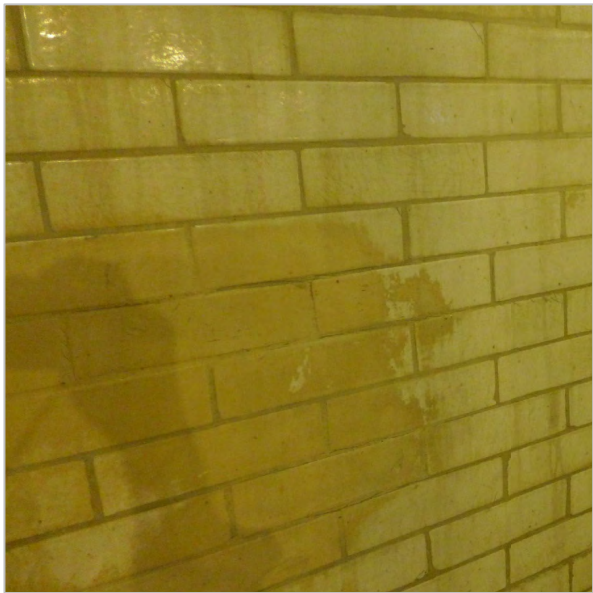
STAINED BRICK

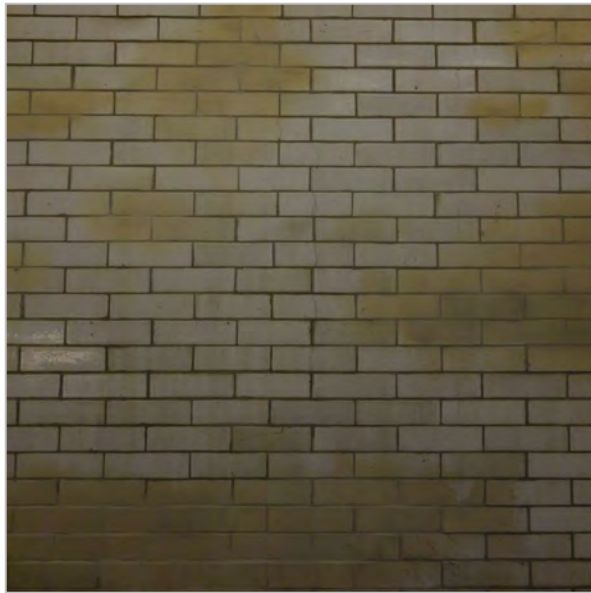
CRACK AT BRICK WALL

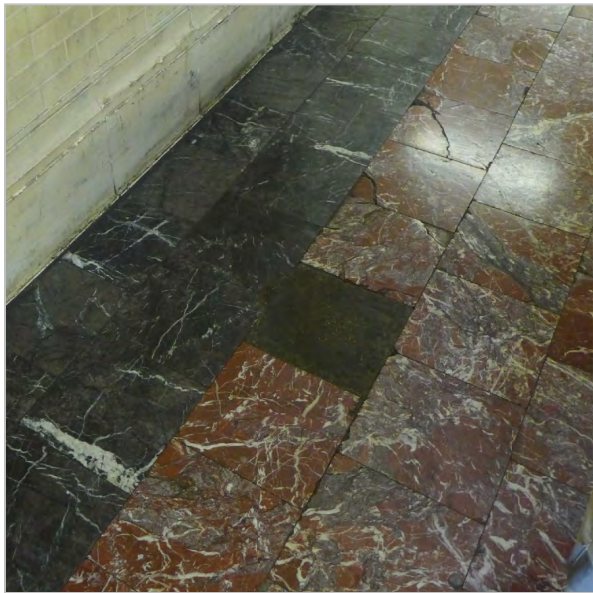
CRACKED AND DISPLACED MARBLE TILE FLOOR, TYP.

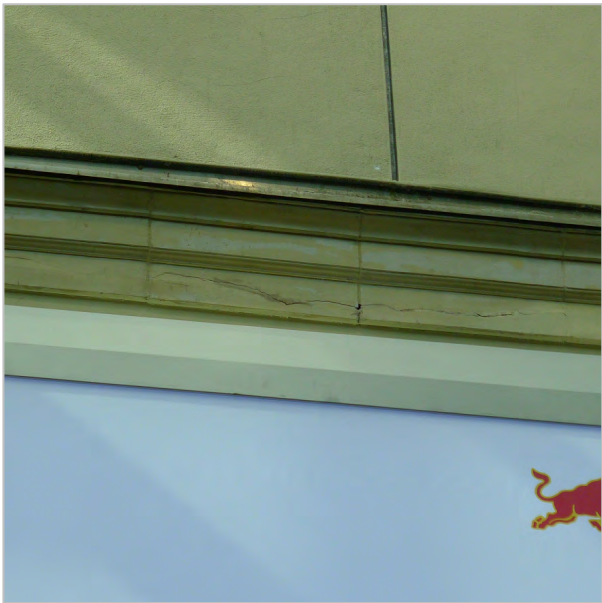
CRACKED AND DISPLACED PIECES AT TERRA COTTA CORNICE (FORMER NORTH EXTERIOR WALL)

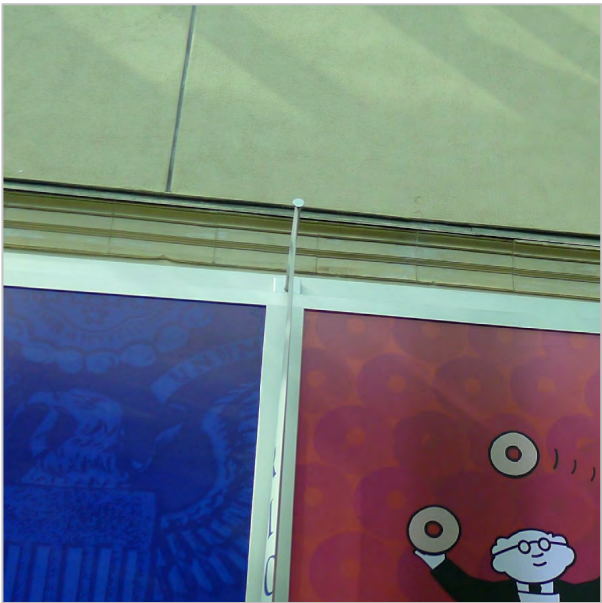
SPALLS AT TERRA COTTA CORNICE (FORMER NORTH EXTERIOR WALL)

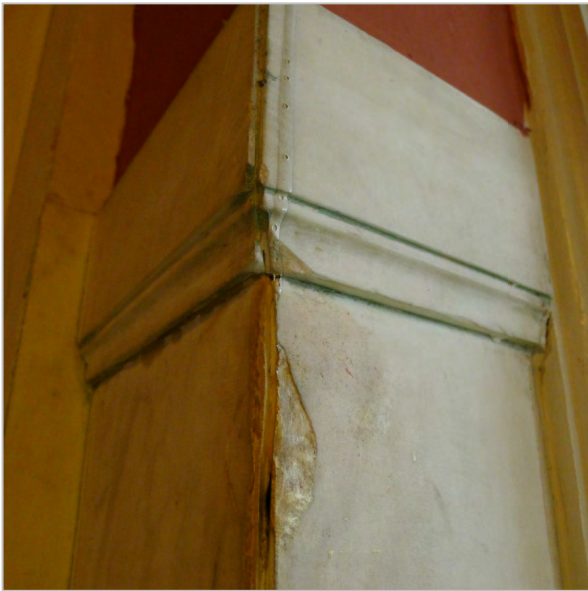
SPALL AT CORNER

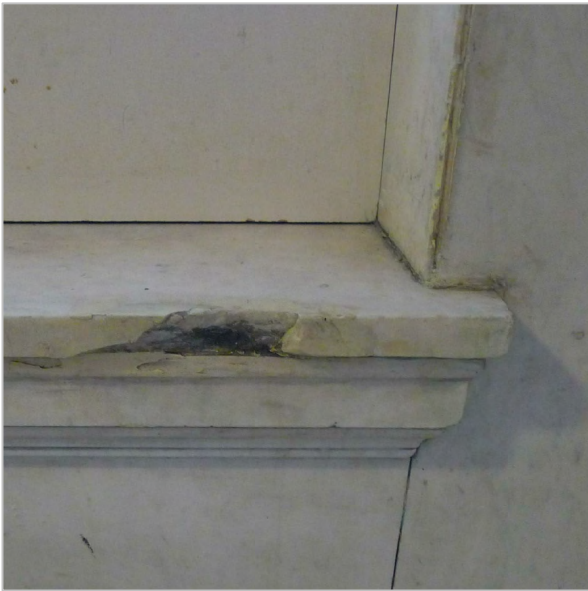
SPALL AT SILL

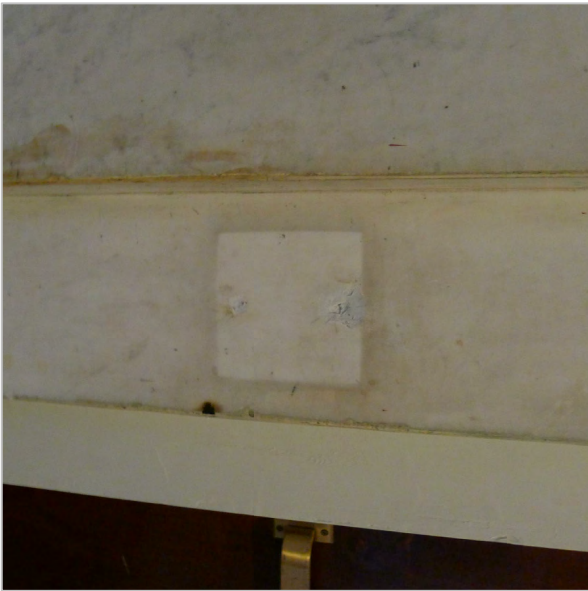
PATCHED HOLE

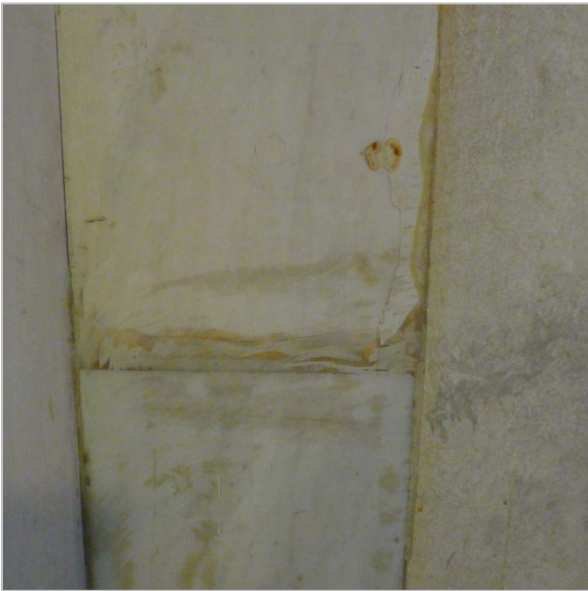
CRACKED AND LOOSE STONE

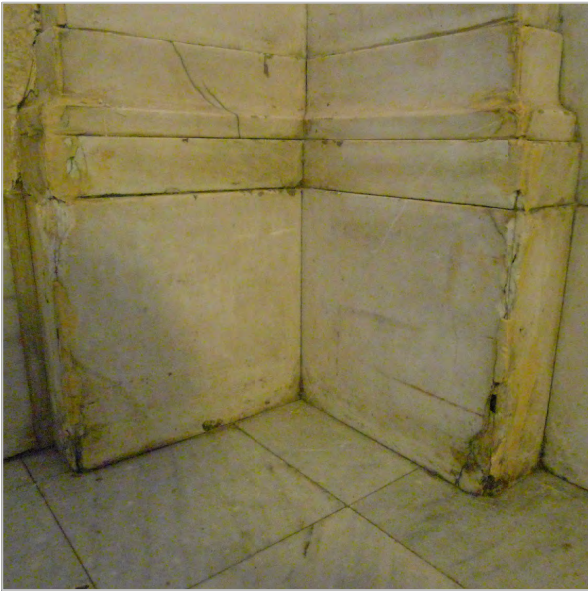
There are many cracks, losses and spalls in the marble floor, baseboards and trim. Many losses and cracks have been repaired, but the repair is failing.

DAMAGED MARBLE BASE

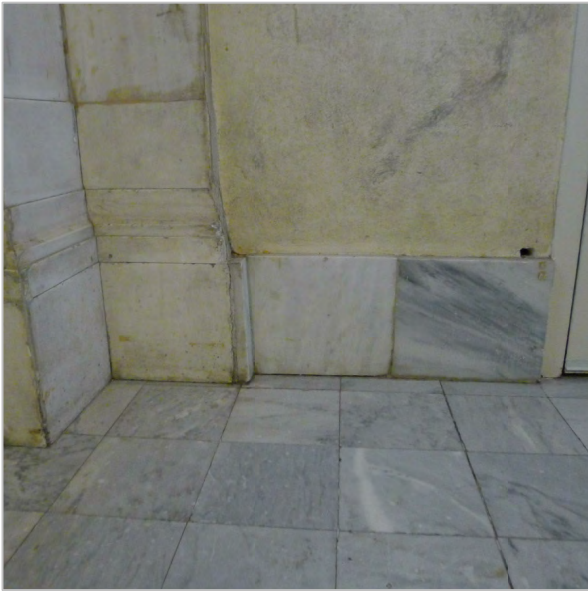
DUTCHMEN AND HOLE AT MARBLE BASEBOARD

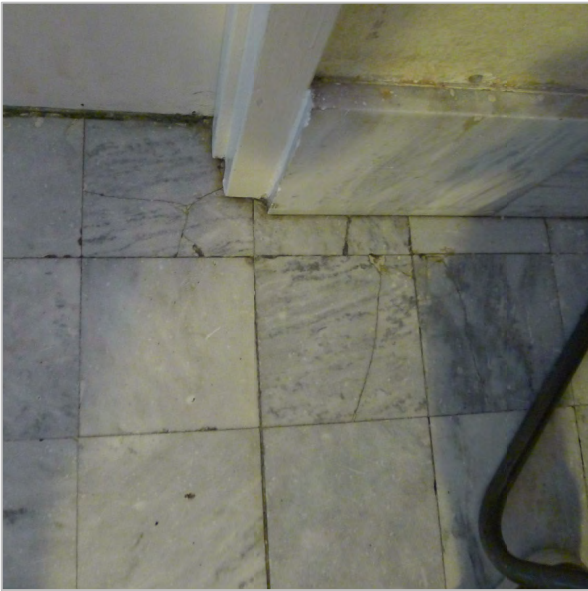
CRACKS AT MARBLE FLOOR TILES

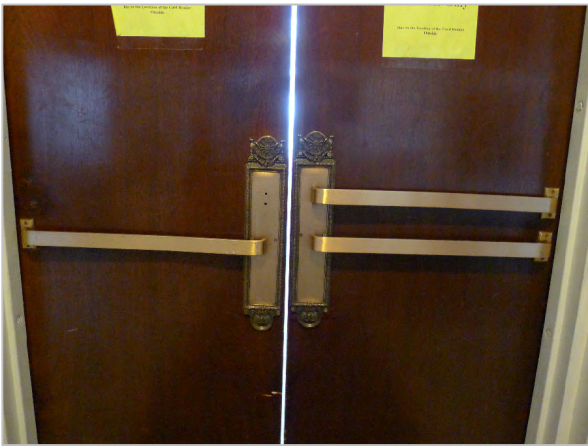
MISSING HARDWARE

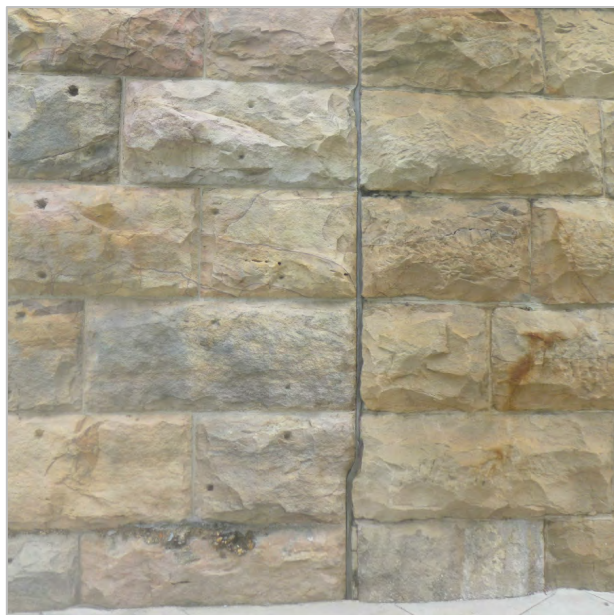
EXPANSION JOINT BETWEEN ORIGINAL AND REBUILT WALLS

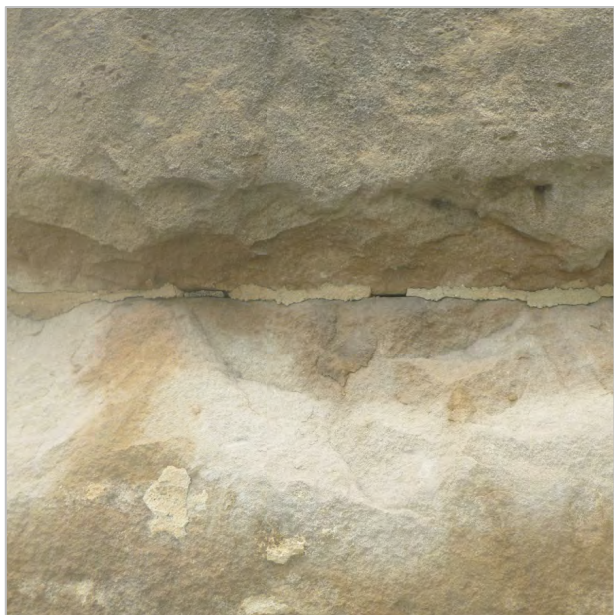
OPEN JOINT AT REBUILT STONE WALL

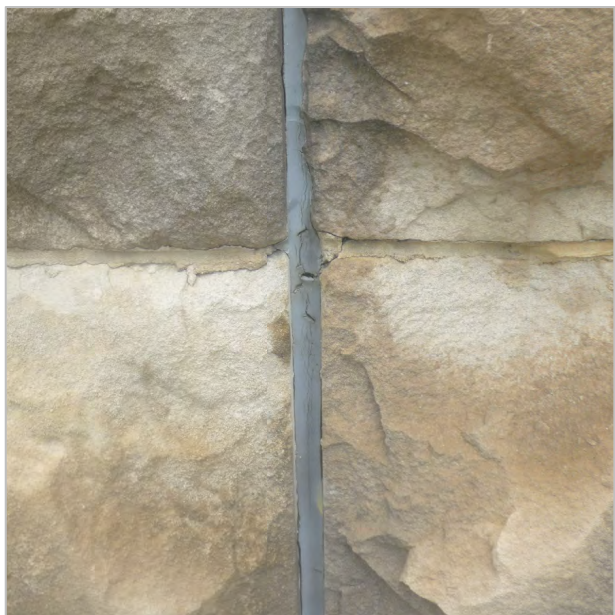
EXPANSION JOINT AT NEW WALLS

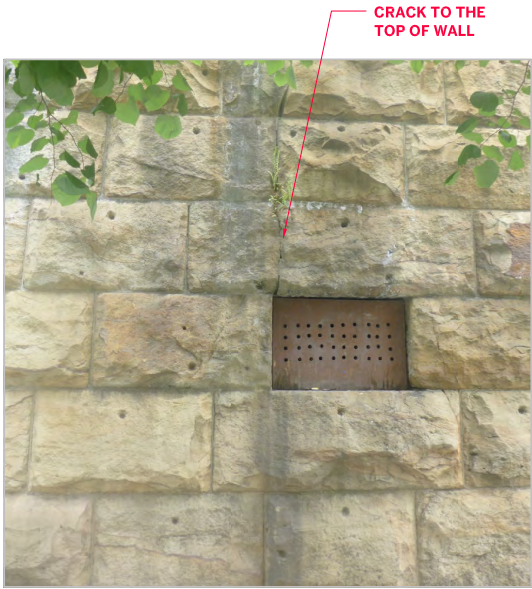
CONTINUOUS CRACK AT LINTEL

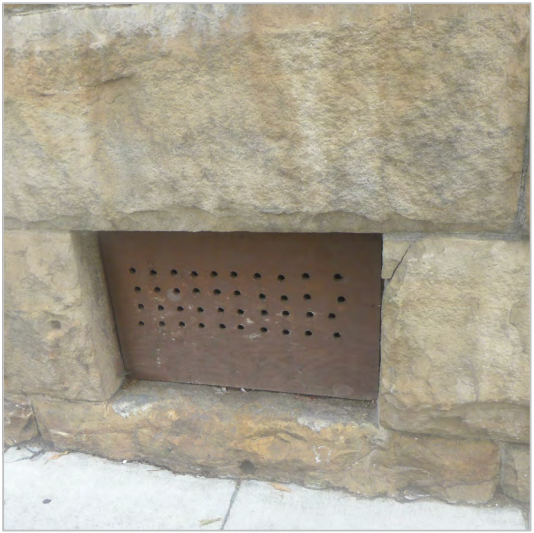
CRACK AT CORNER OF STONE UNIT

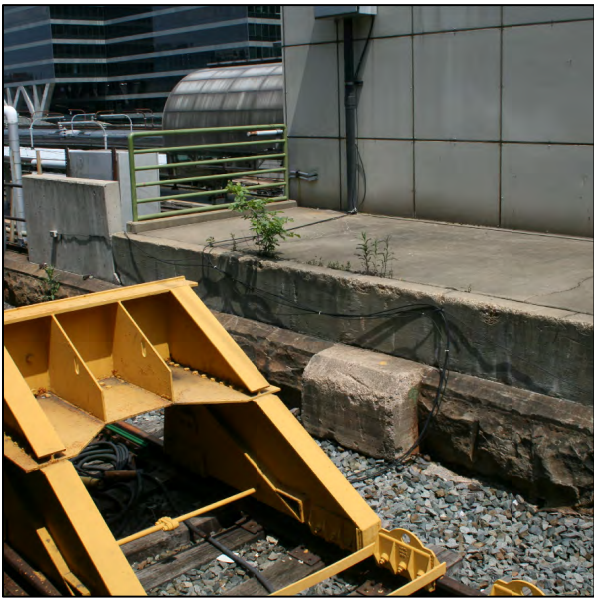
CONCRETE INFILL; FERROUS STAINING AND SOILING

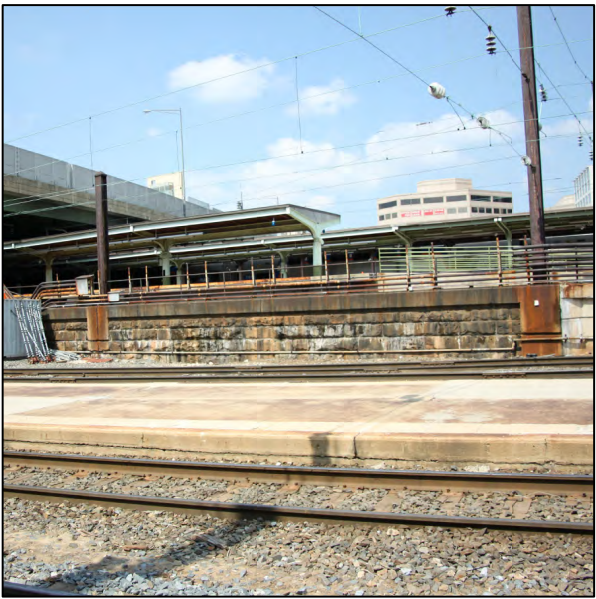
FERROUS STAINING

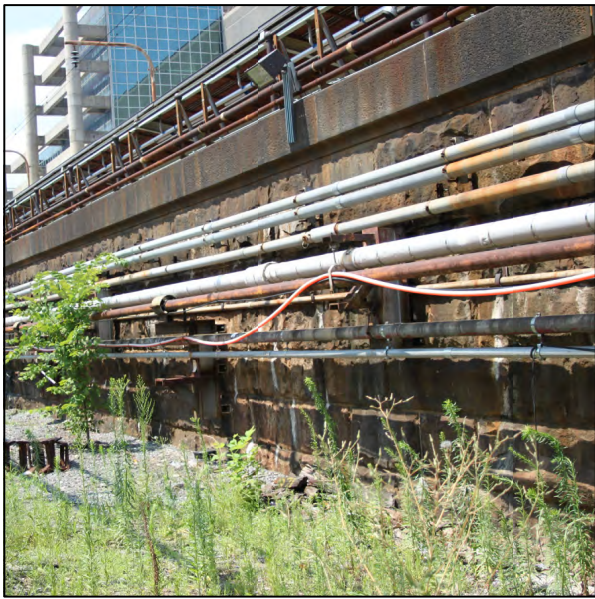
INFRASTRUCTURE INSTALLED ON WALL
