WASHINGTON UNION STATION

HISTORIC PRESERVATION PLAN: VOLUME I

HISTORIC PRESERVATION PLAN

VOLUME I of III

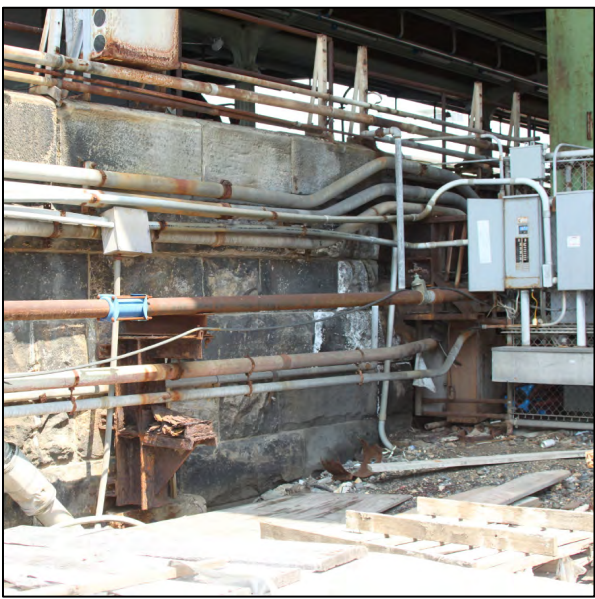
INFRASTRUCTURE INSTALLED ON WALL

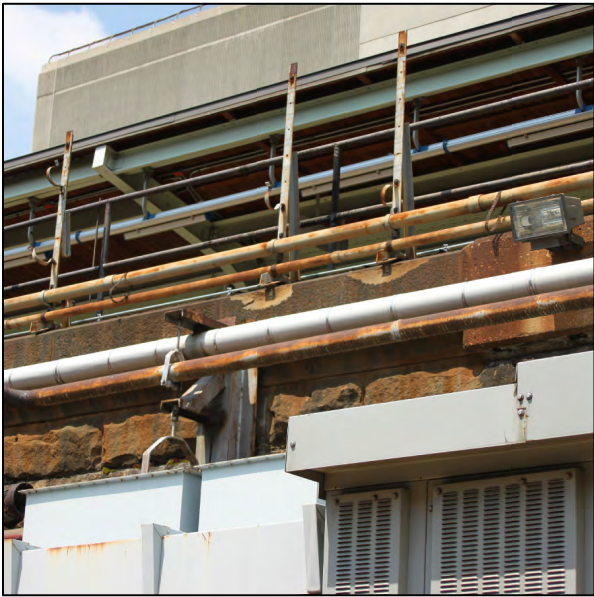
STRUCTURES INSTALLED NEAR WALL; HEAVY FERROUS STAINING

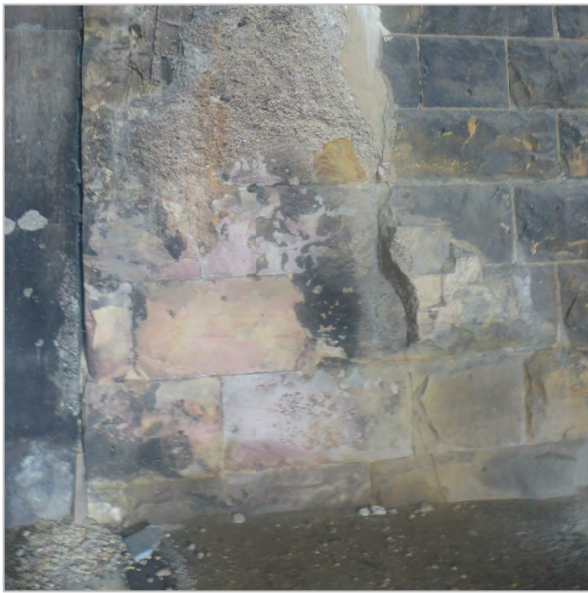
CONCRETE PATCH

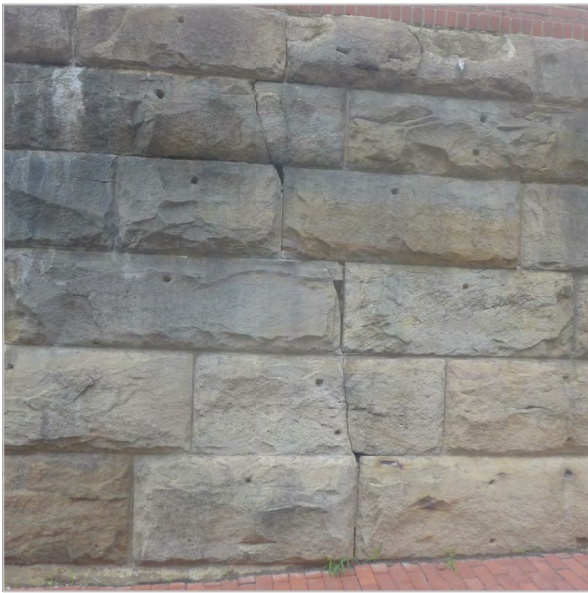
CONTINUOUS CRACK

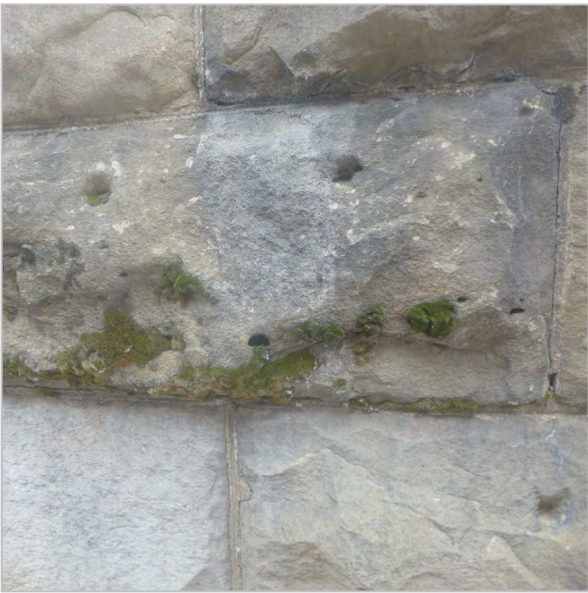
BIOLOGICAL GROWTH

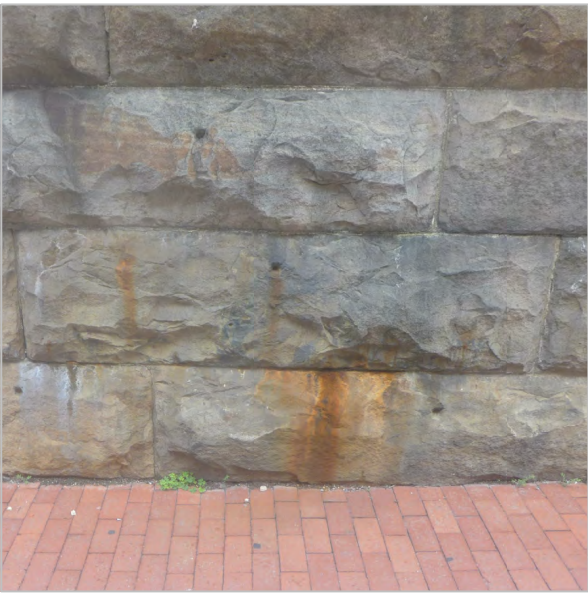
FERROUS STAIN

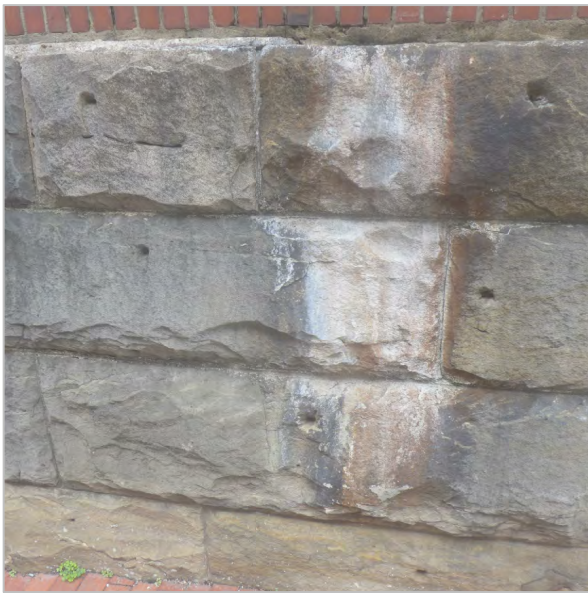
EFFLORESCENCE

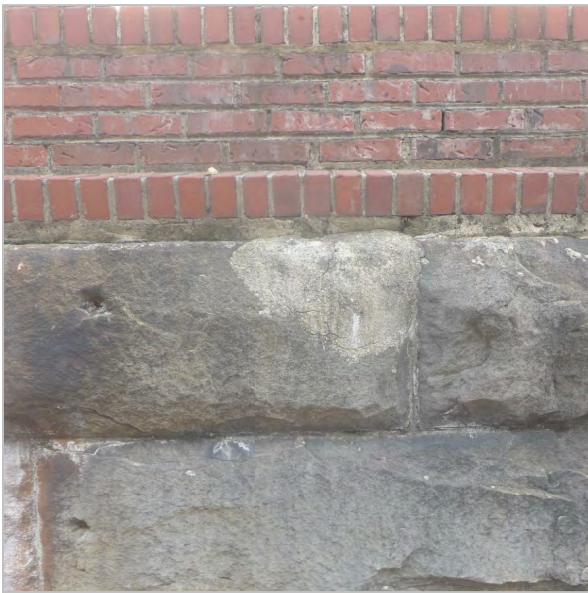
PATCHED STONE

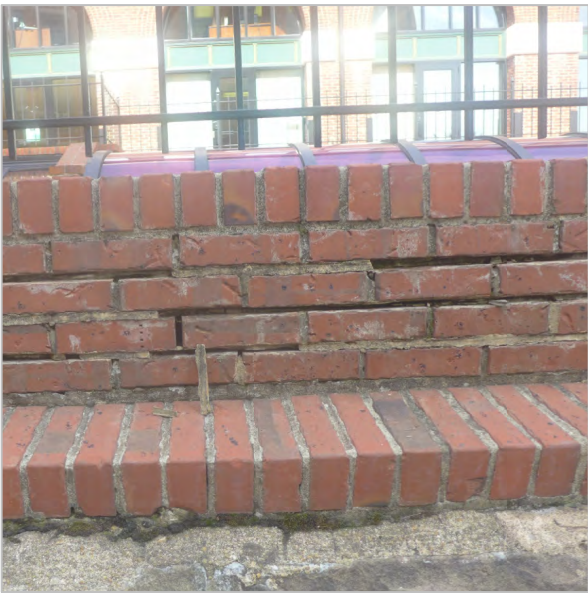
OPEN JOINTS AND LOOSE BRICKS

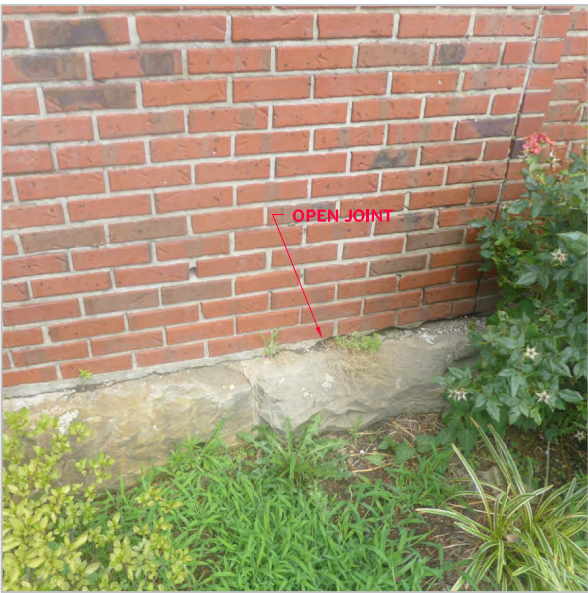
OPEN JOINT BETWEEN STONE AND BRICK

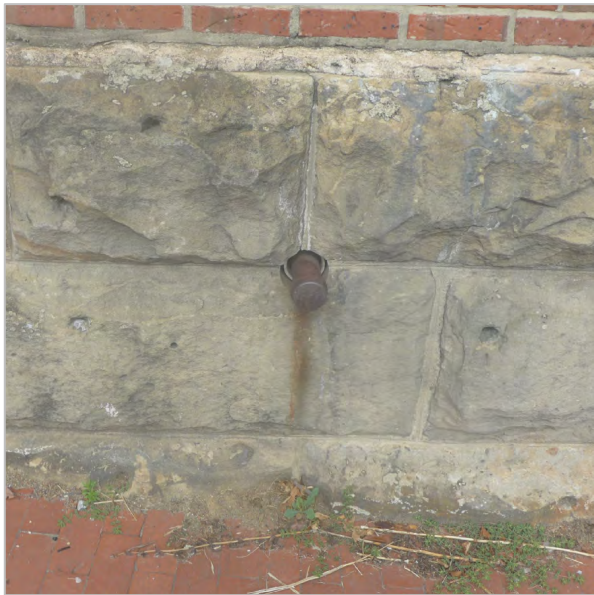
ABANDONED ANCHOR AT STONE WALL

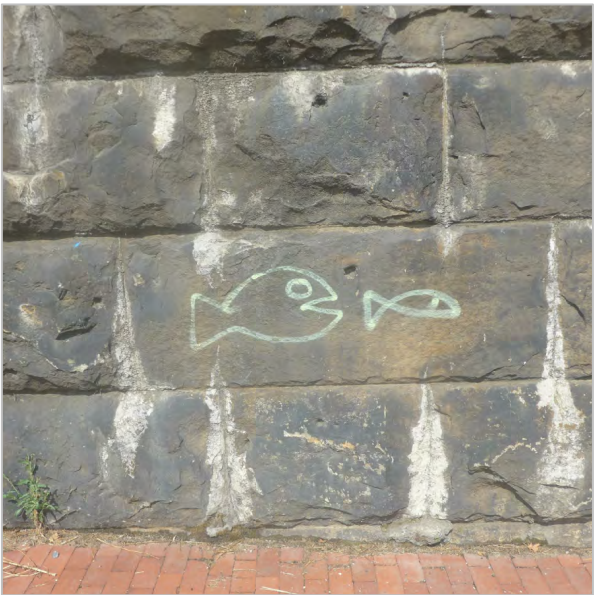
GRAFFITI

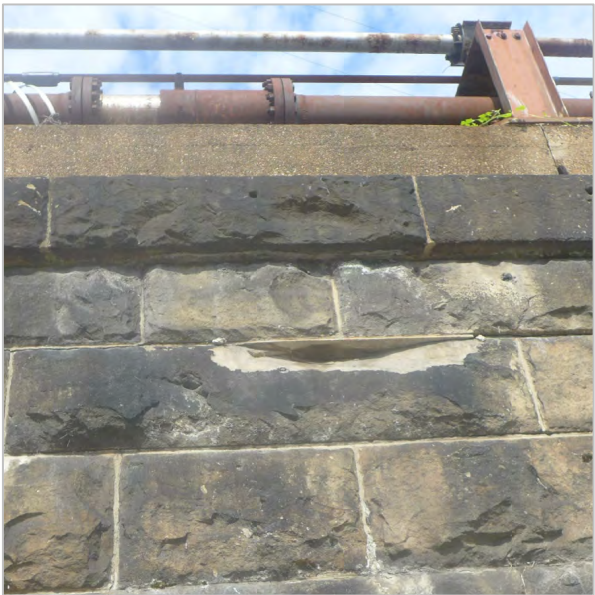
SPALLED STONE

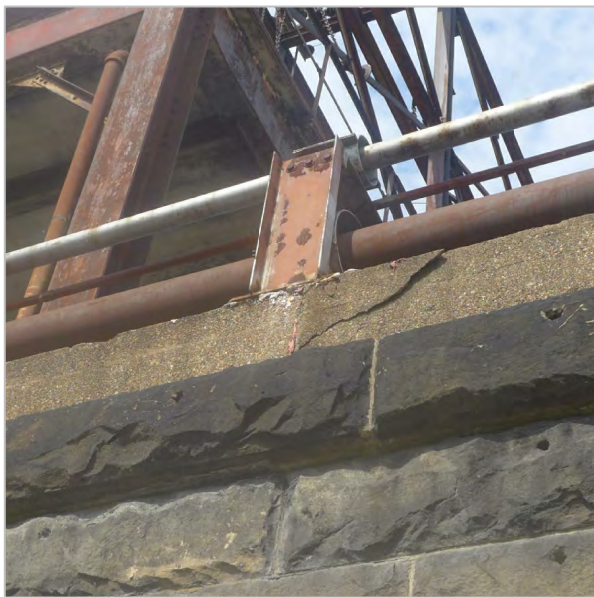
SPALLED CONCRETE COPING

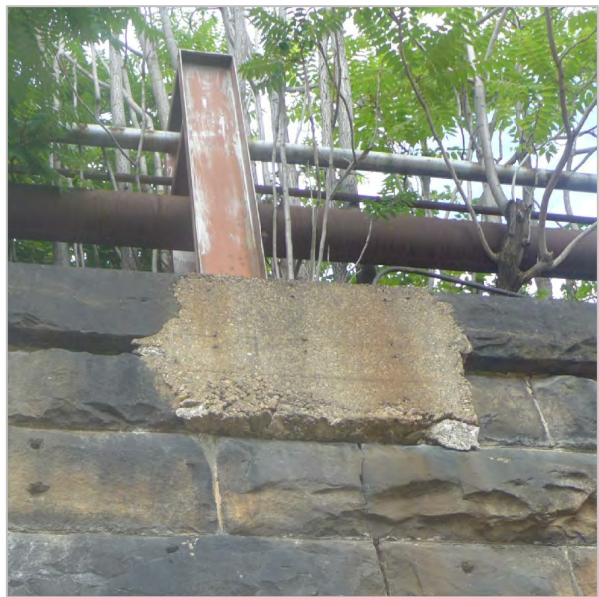
CONCRETE PATCH AT COPING

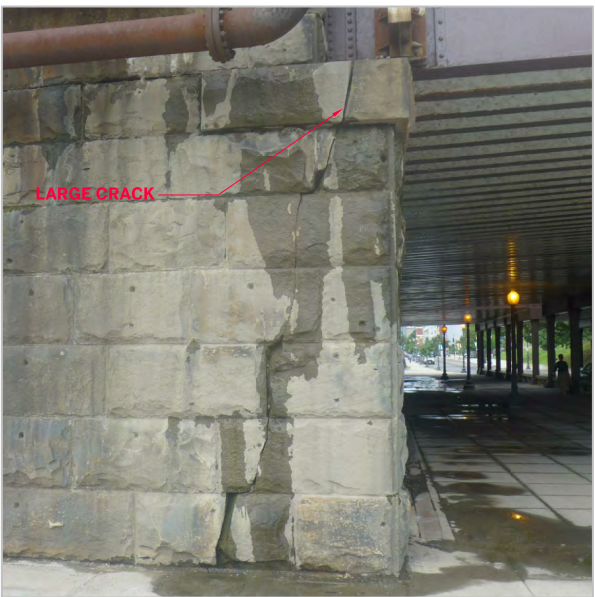
CONTINUOUS CRACK AT WALL CORNER

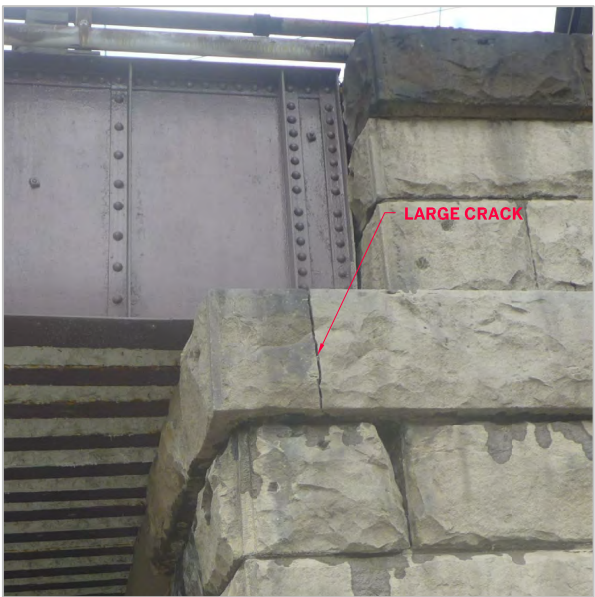
CRACK AT CORNER STONE UNIT

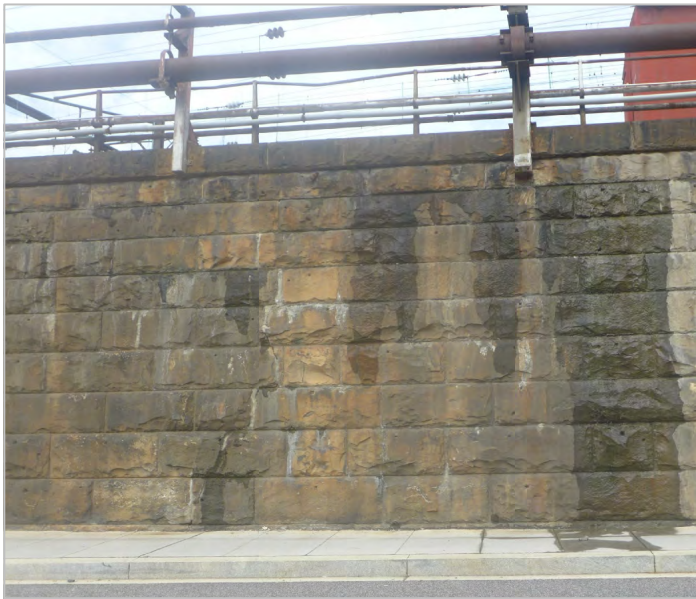
WATER INFILTRATION THROUGH WALL

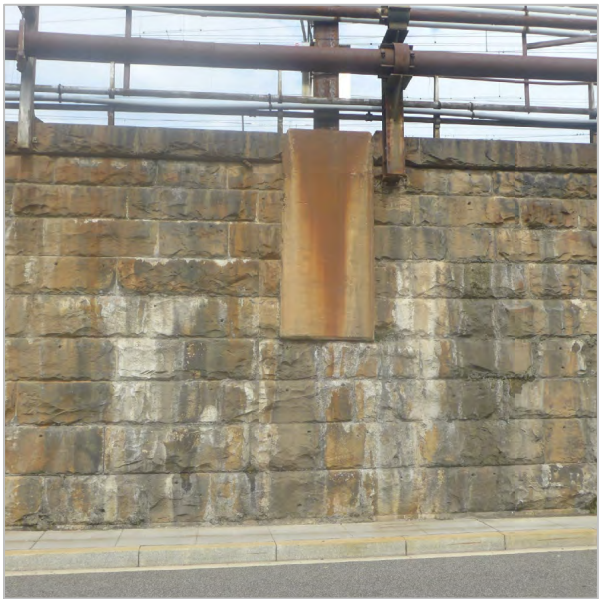
EFFLORESCENCE AND FERROUS STAINS

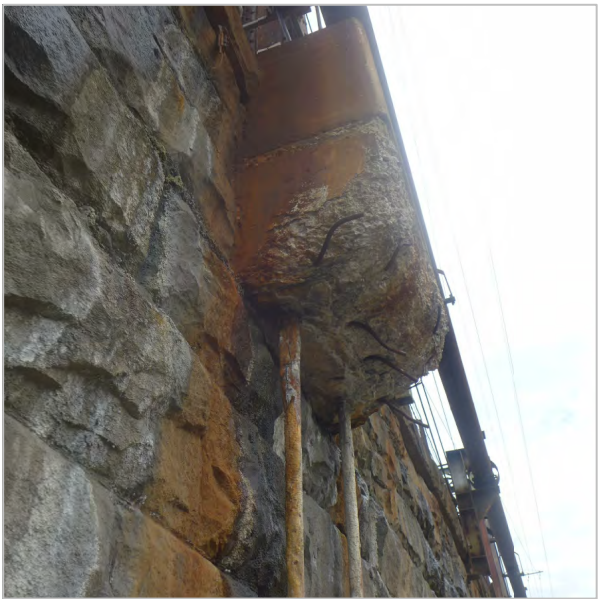
SPALLING CONCRETE

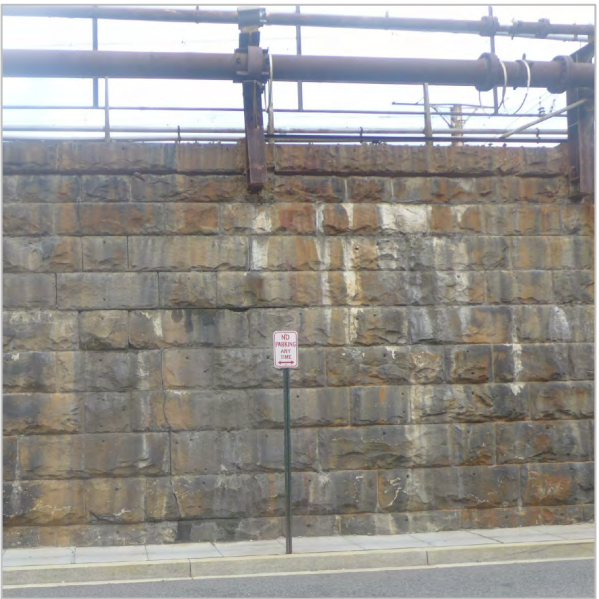
CONTINUOUS CRACKS

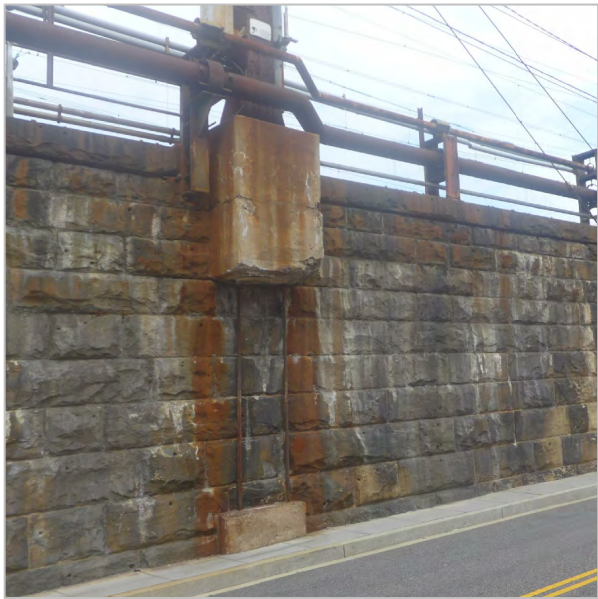
DETERIORATED AND CRACKED CONCRETE,
EXPOSED REBAR AND FERROUS STAIN

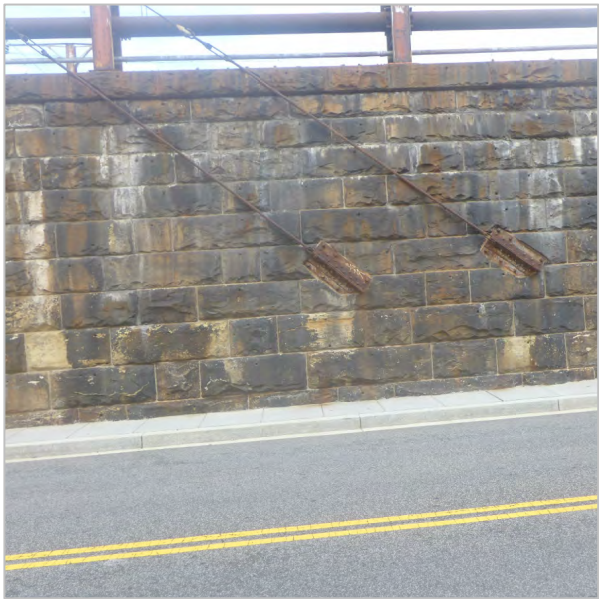
STEEL SUPPORTS

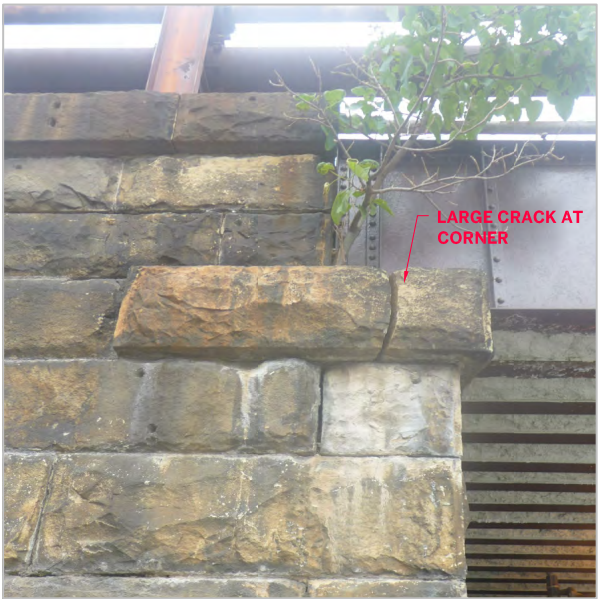
CRACKED CORNER STONE

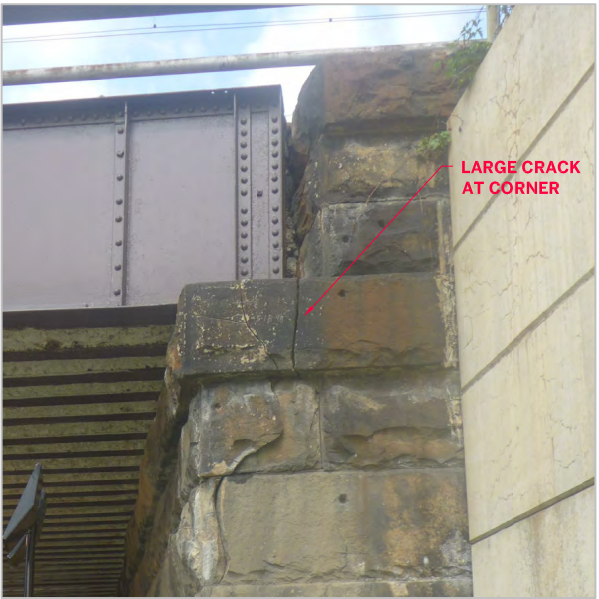
CRACKED CORNER STONE

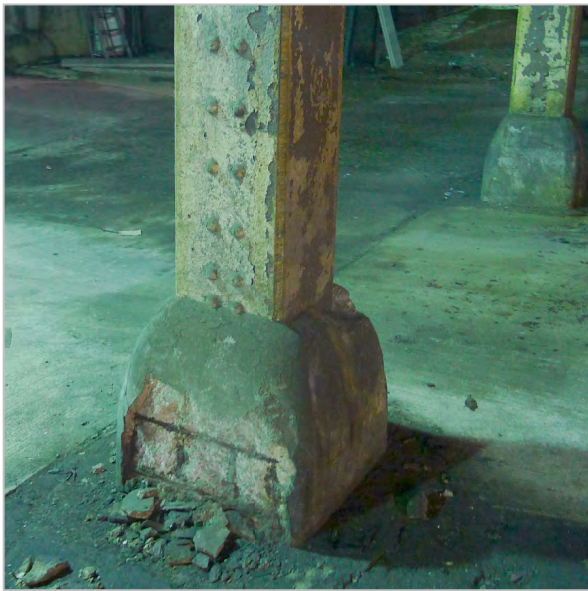
RUSTED COLUMN AND BROKEN CAST IRON BASE
AT H STREET UNDERPASS

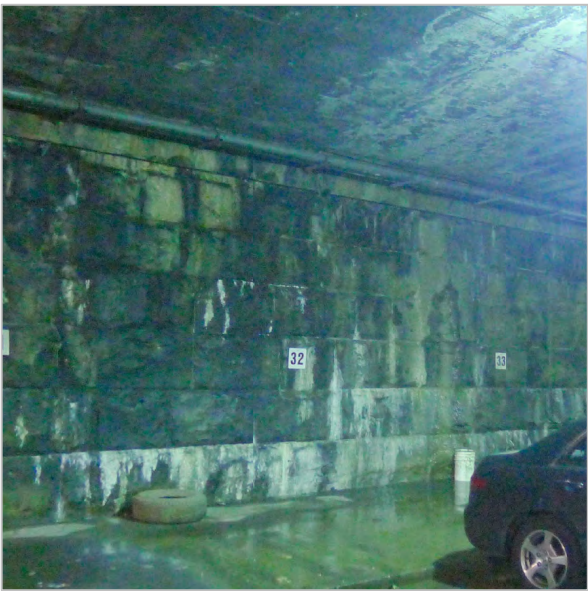
CRACK AT H STREET UNDERPASS

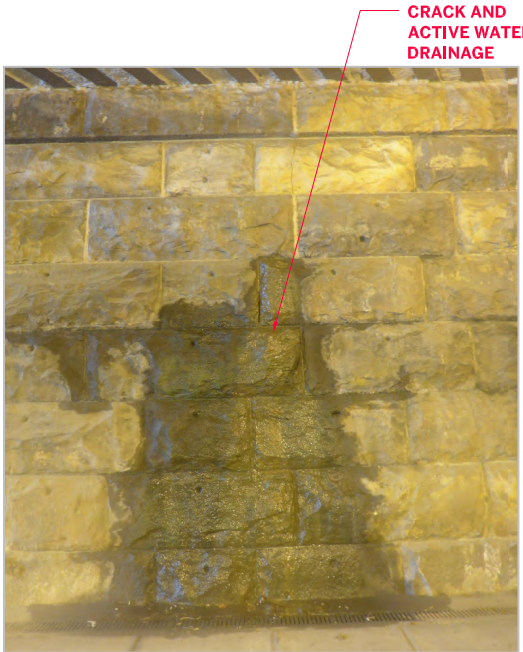
CONTINUOUS CRACK AT K STREET UNDERPASS

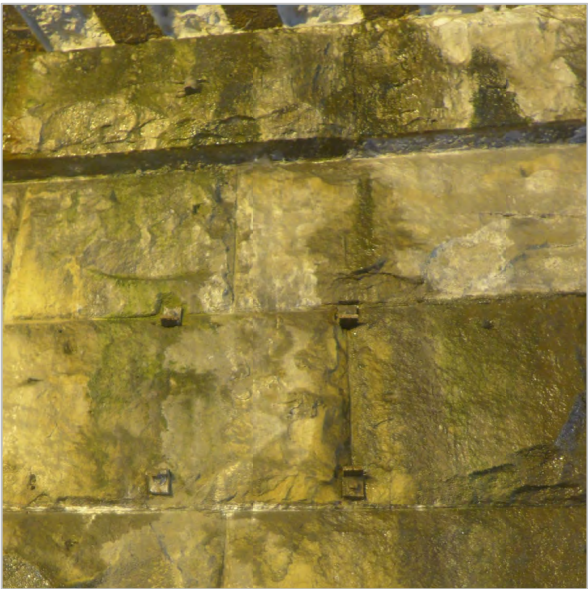
ABANDONED ANCHORS AT K STREET
UNDERPASS

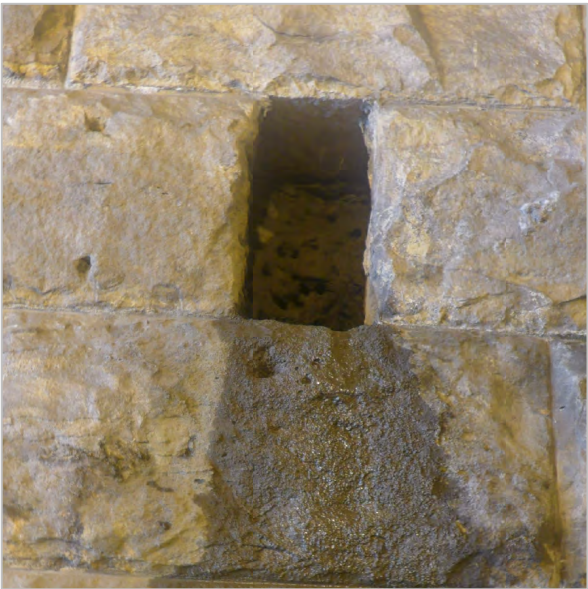
MISSING STONE AT K STREET UNDERPASS

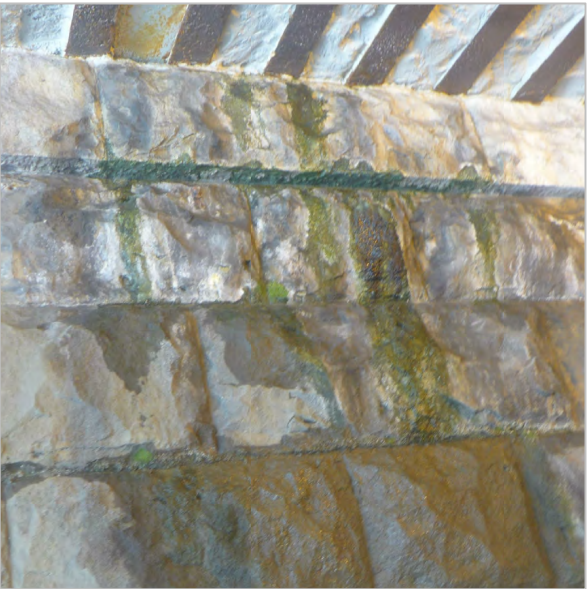
BIOLOGICAL GROWTH AT K STREET UNDERPASS

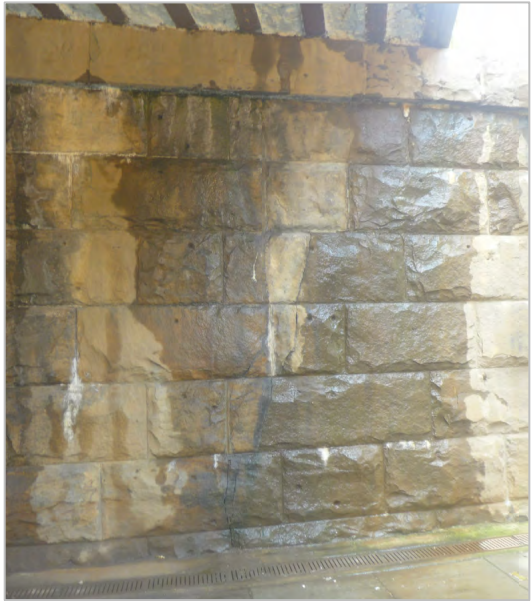
CONTINUOUS CRACK AT I STREET UNDERPASS

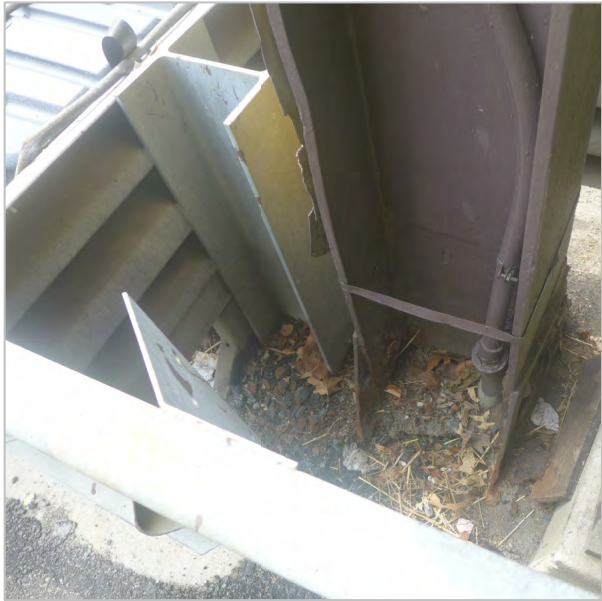
MISSING COLUMN BASE AT I STREET UNDERPASS

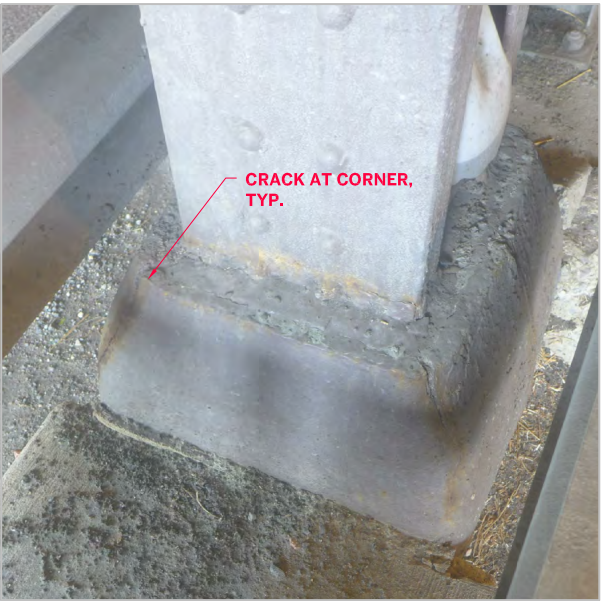
CRACKED CAST IRON COLUMN BASE AT I STREET UNDERPASS

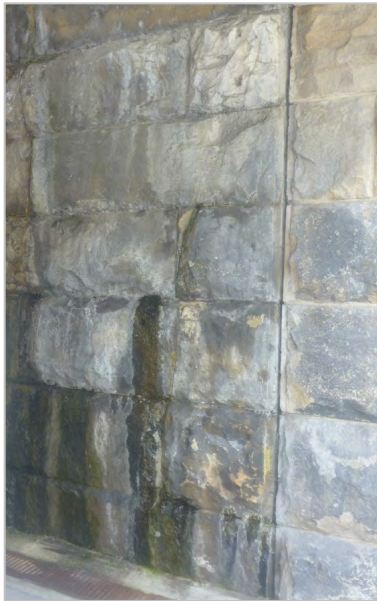
CONTINUOUS CRACK AT M STREET UNDERPASS

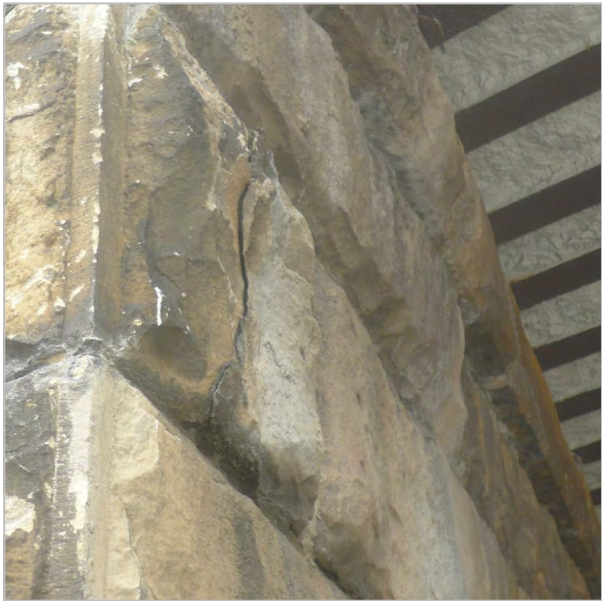
LOOSE SPALL AT M STREET UNDERPASS

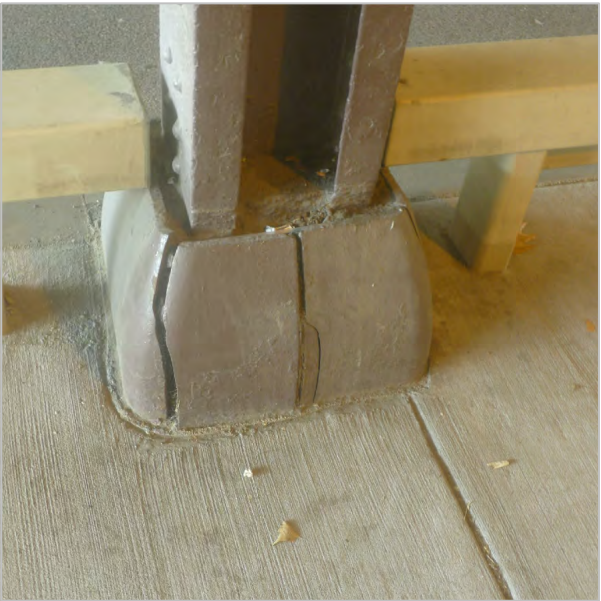
CRACKED CAST IRON COLUMN BASE AT M STREET UNDERPASS

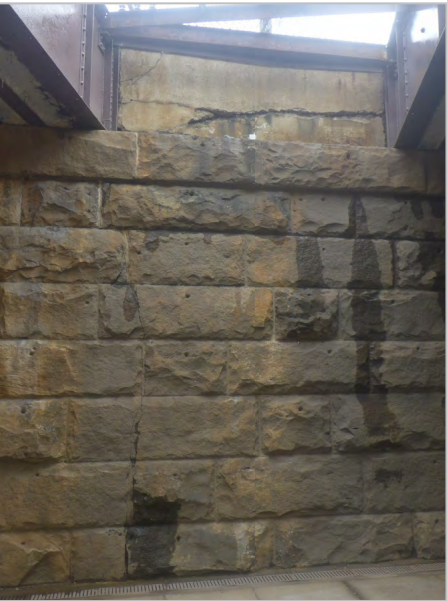
CRACKED STONE AND CONCRETE WALL AT M STREET UNDERPASS

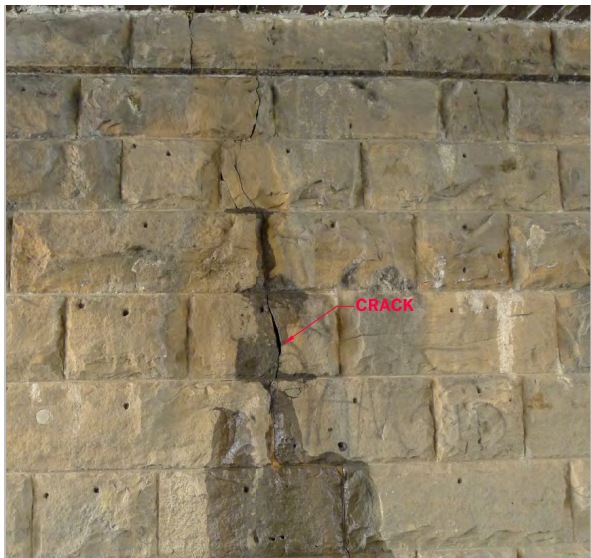
CONTINUOUS CRACK WITH WATER INFILTRATION AT FLORIDA AVENUE UNDERPASS

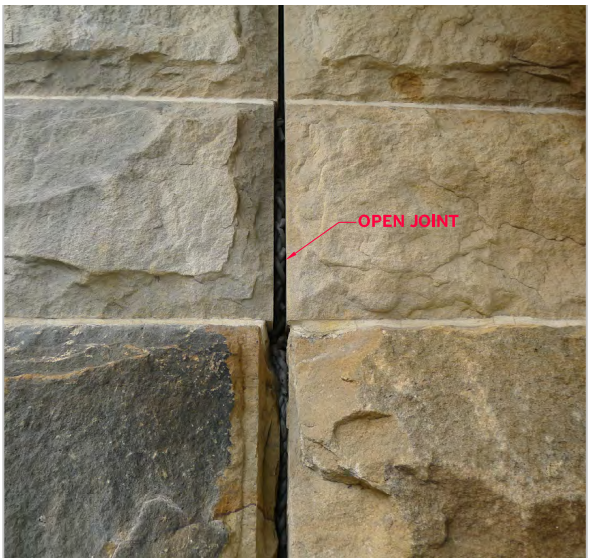
OPEN JOINT BETWEEN NON-HISTORIC AND ORIGINAL WALL AT FLORIDA AVENUE UNDERPASS

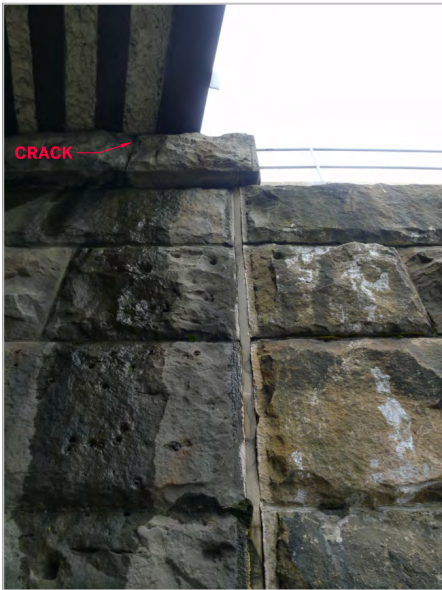
CRACKED STONE AND WATER INFILTRATION AT FLORIDA AVENUE UNDERPASS

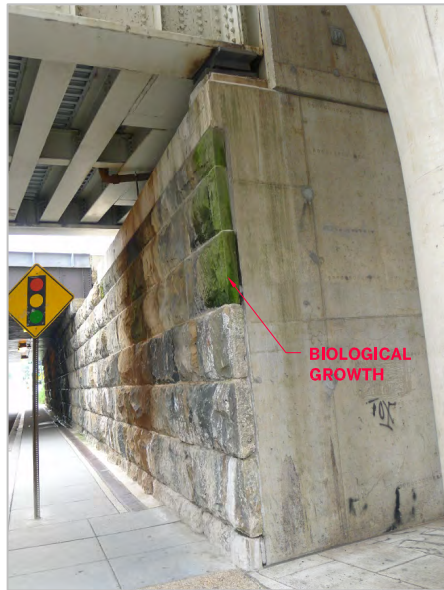
BIOLOGICAL GROWTH AT FLORIDA AVENUE UNDERPASS

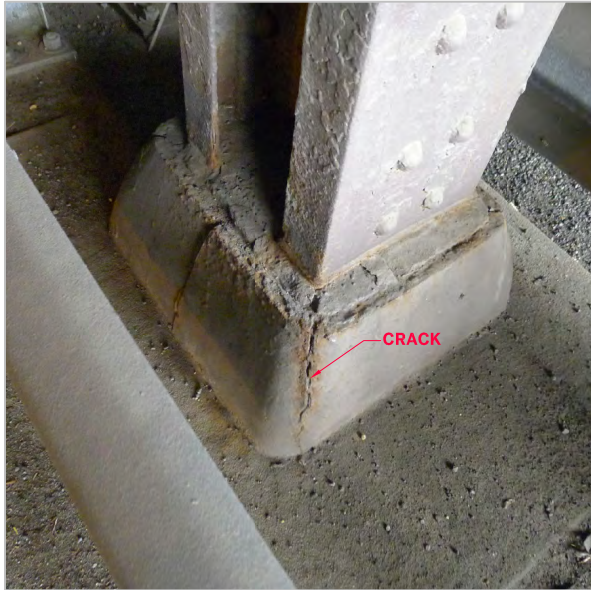
CRACKED COLUMN BASE AT FLORIDA AVENUE UNDERPASS

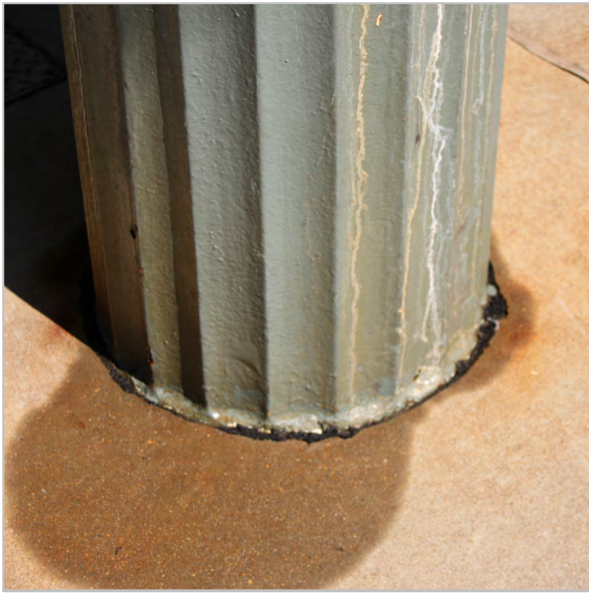
BASE COVERED BY RAISED CONCRETE PLATFORM

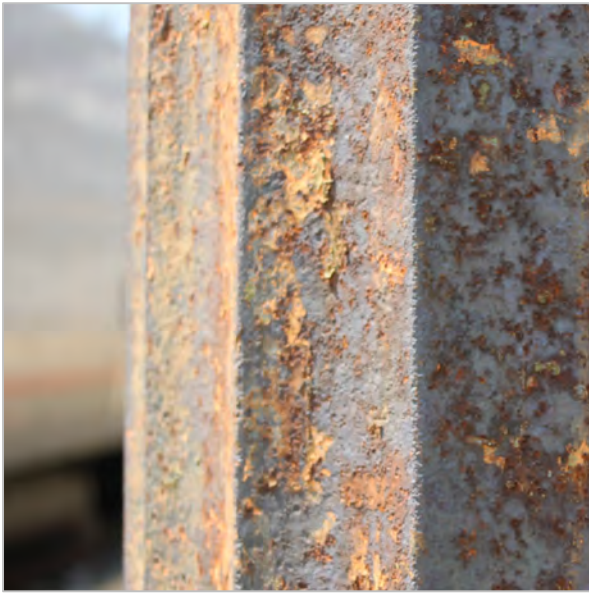
SURFACE CORROSION

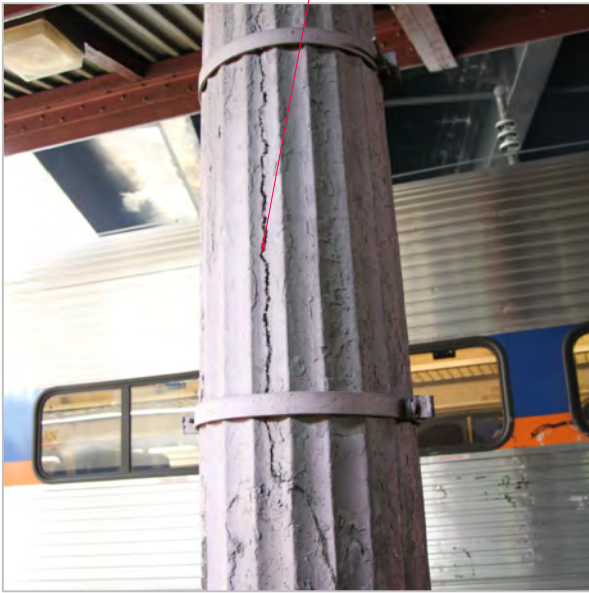
CRACKING THROUGH COLUMN

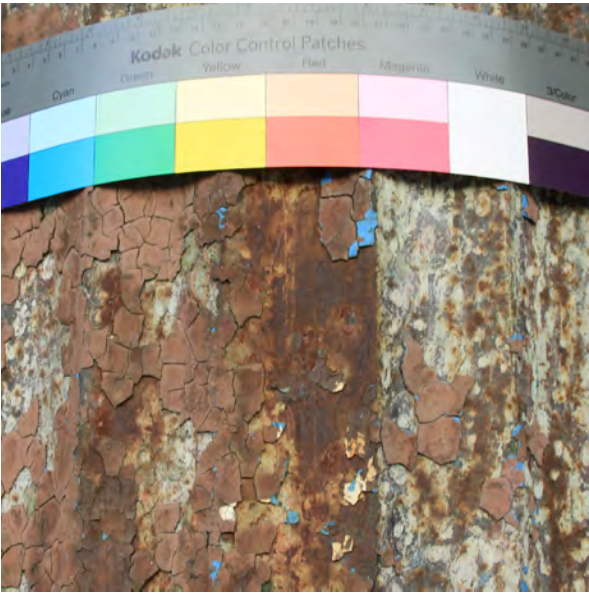
DETERIORATED PAINT

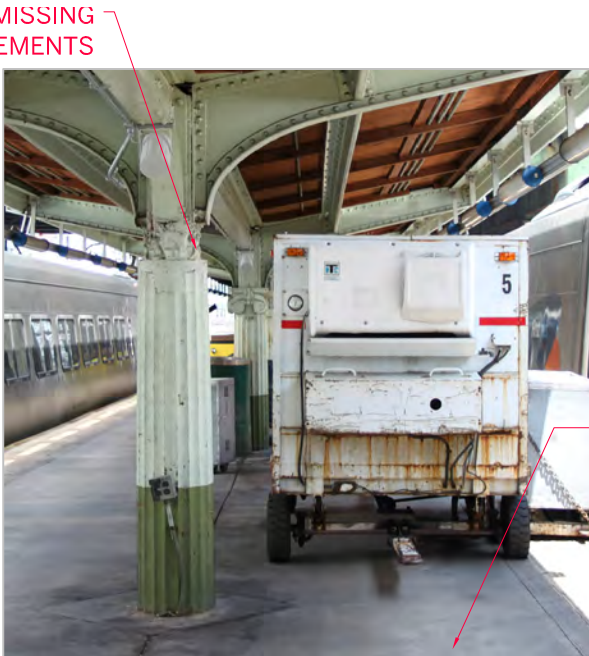
COMMISSARY TRUCK ON RAISED PLATFORM

MISSING
ELEMENTS
ARE MOST
PROMINENT
ON
PLATFORMS
WITH RAISED
FLOORS

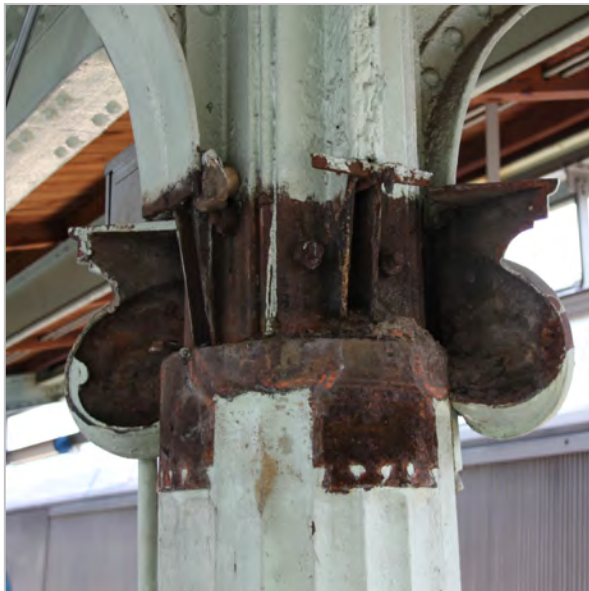
MISSING COLUMN CAPITAL ELEMENTS

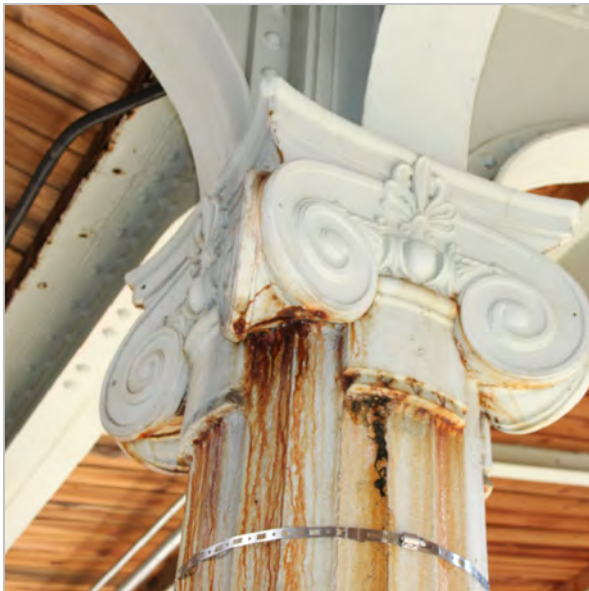
RUST STAINING

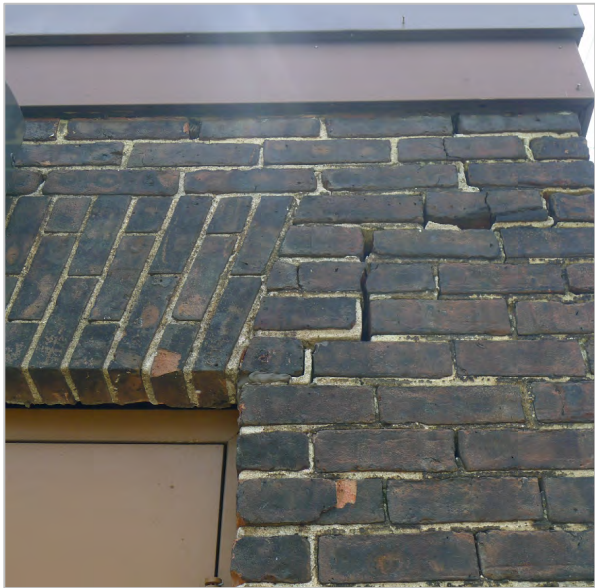
CONTINUOUS CRACK AT NORTH ELEVATION

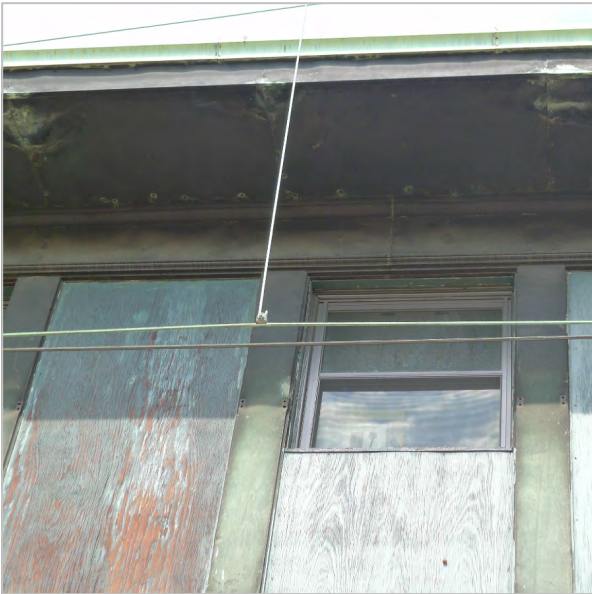
WATER STAINING, MISSING FASTENERS, BOARDED WINDOWS

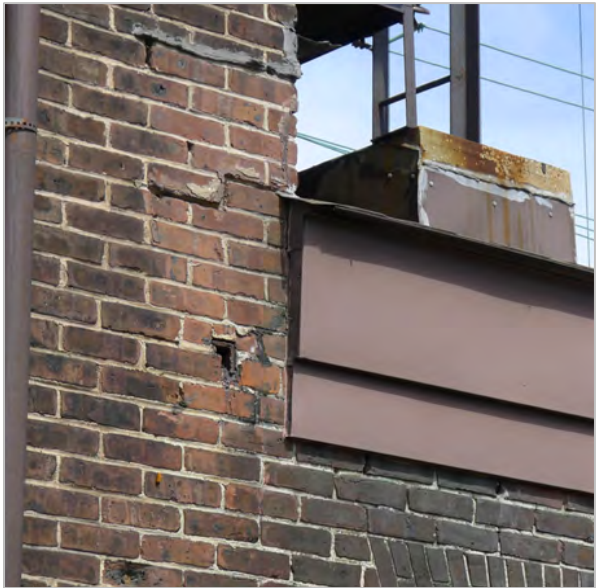
RECONFIGURED ROOFLINE

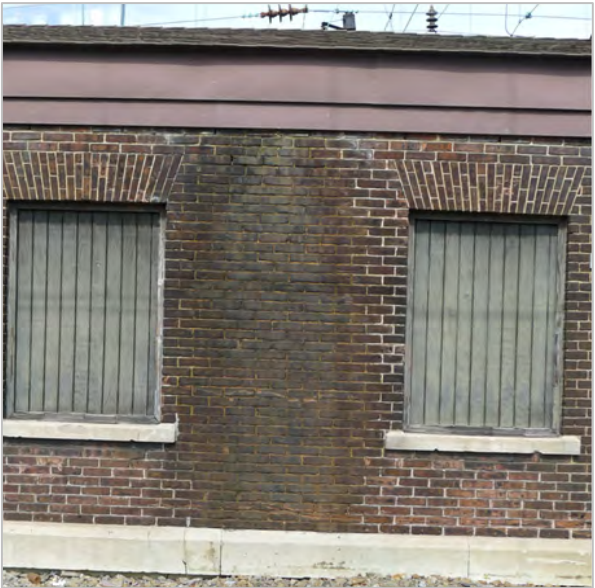
Typical conditions for the brick walls include: staining, spalls (likely a result of impact), and deteriorated mortar. The latter condition is most pronounced where the second floor rises from the first and underneath the sheet metal fascia. There are a few continuous cracks between and under windows. There is a fairly wide continuous crack at the northwest corner of the building that appears to originate from the corner of the door.

STAINING, SURFACE DAMAGE, MORTAR DETERIORATION, SPALLS

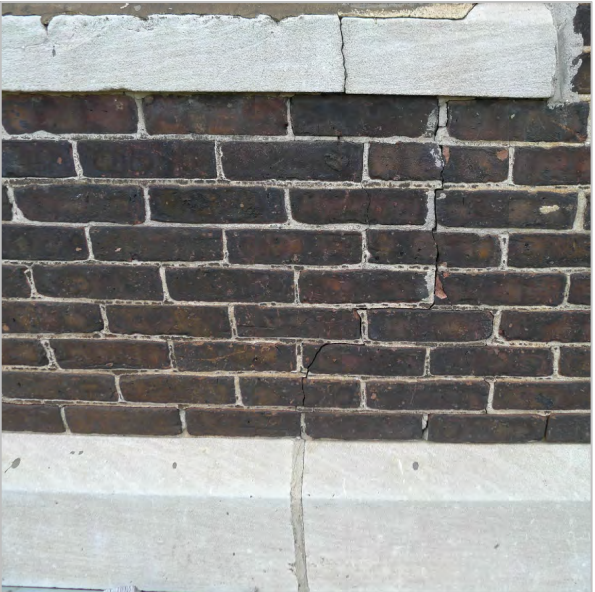
CONTINUOUS CRACK UNDER WINDOW

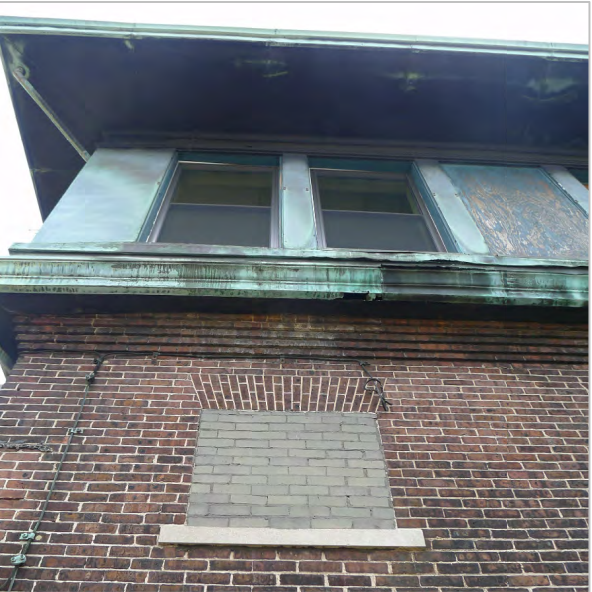
WATER STAINING AND BENT COPPER CLADDING

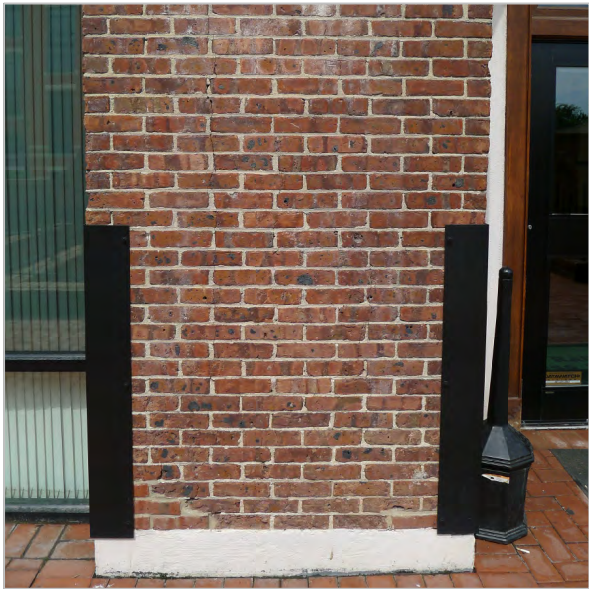
The building is generally in good condition with few problematic conditions observed. Several piers on the east elevation contain multiple continuous cracks through the brick. There are also a number of cracks at the corners of the limestone base, most likely related to the metal protection installed at the corners of the piers. The upper limestone stringcourses contain a few visible spalls. Typical conditions for the brick include: spalls, abandoned anchors, deteriorated mortar joints, inappropriate repairs, and loss. White staining was also typically visible underneath the first-floor limestone elements. On the north and south elevations over the west windows, a cut off I-beam is exposed near the second level. This may relate to an earlier canopy, or possibly another structure attached to the building. There are deteriorated mortar joints, patching, and replacement brick between the first and second stories on both the north and south elevations, suggesting evidence of other structures and/or elements. A few bricks on the west elevation are displaced.

CONTINUOUS CRACKS

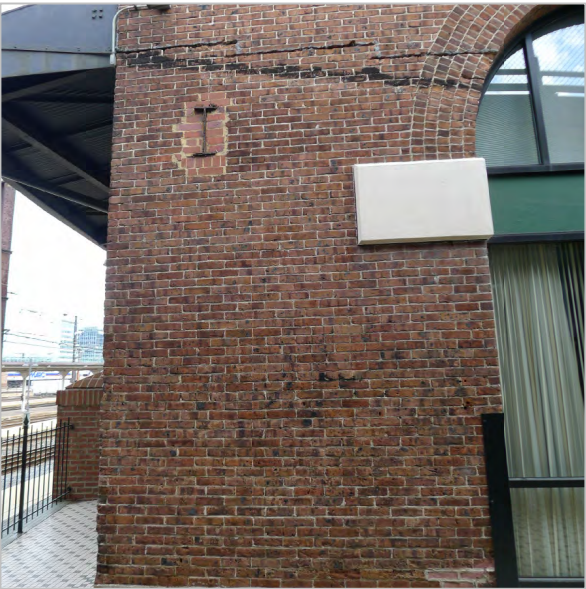
EVIDENCE OF PREVIOUS STRUCTURES

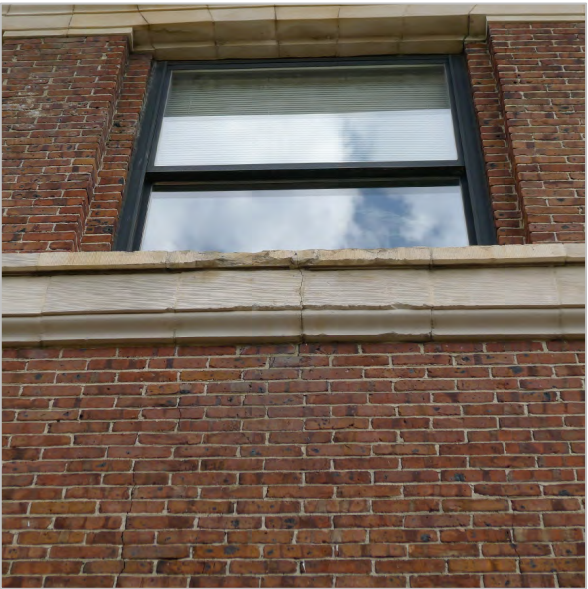
STONE TRIM DAMAGE

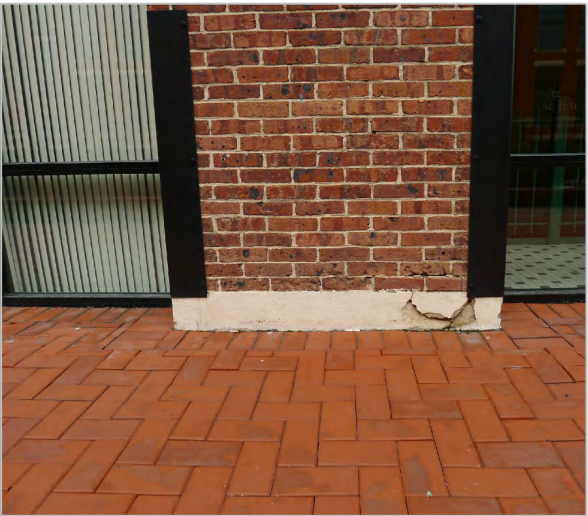
SPALLS AT STONE BASE

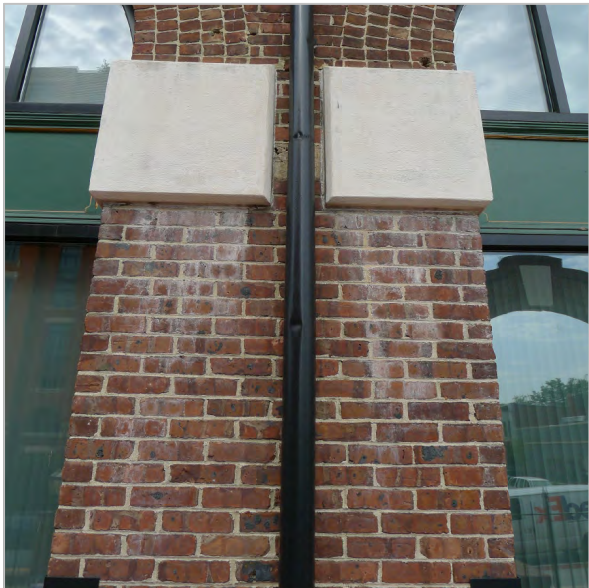
WHITE STAINING

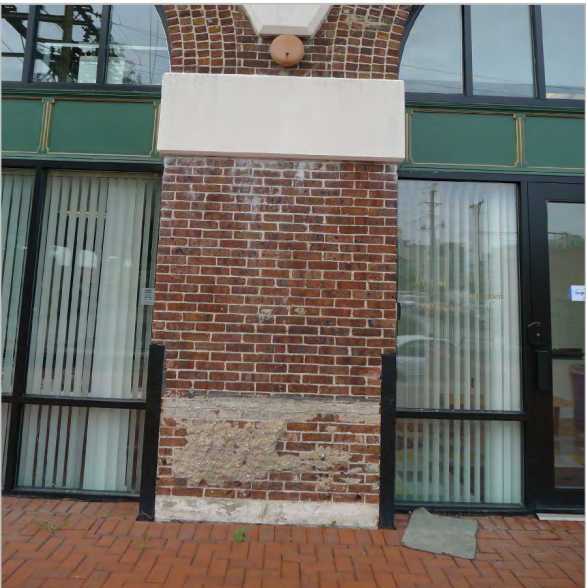
MORTAR RESIDUE

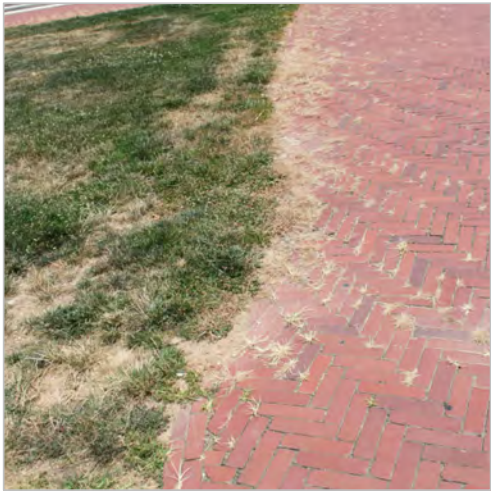
TURF GROWING OVER AN AREA OF DEPRESSED BRICKS
