WASHINGTON UNION STATION

HISTORIC PRESERVATION PLAN: VOLUME I

HISTORIC PRESERVATION PLAN

VOLUME I of III

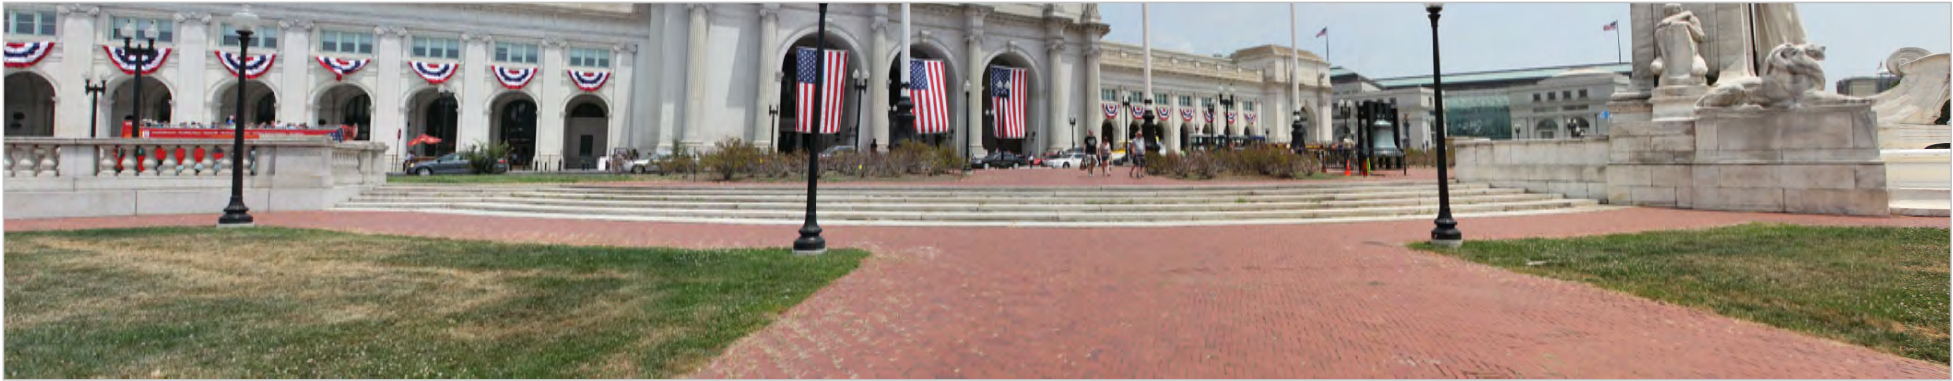
WEST PORTION OF GRANITE STEPS

Both the granite curbs and steps have open and deteriorated mortar joints, with select areas of displaced stones. The steps were installed without a foundation and settled with a negative slope, resulting in ponding of water and debris at the back of the steps. The slabs have cracked and there are spalls, staining, and soiling on the surface of the stone. Ponding of water is also present on the granite curbs and areas of the brick pavers. There are many areas of displacement of the brick, related both to settlement issues and exasperated by open and deteriorated mortar joints. As a result of the displacement, there are many missing and damaged bricks that are potential walking hazards.

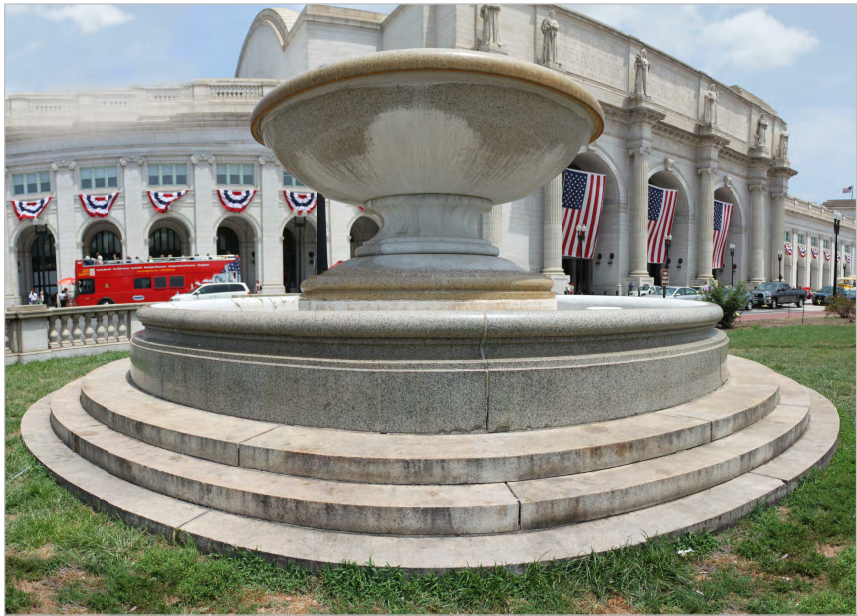
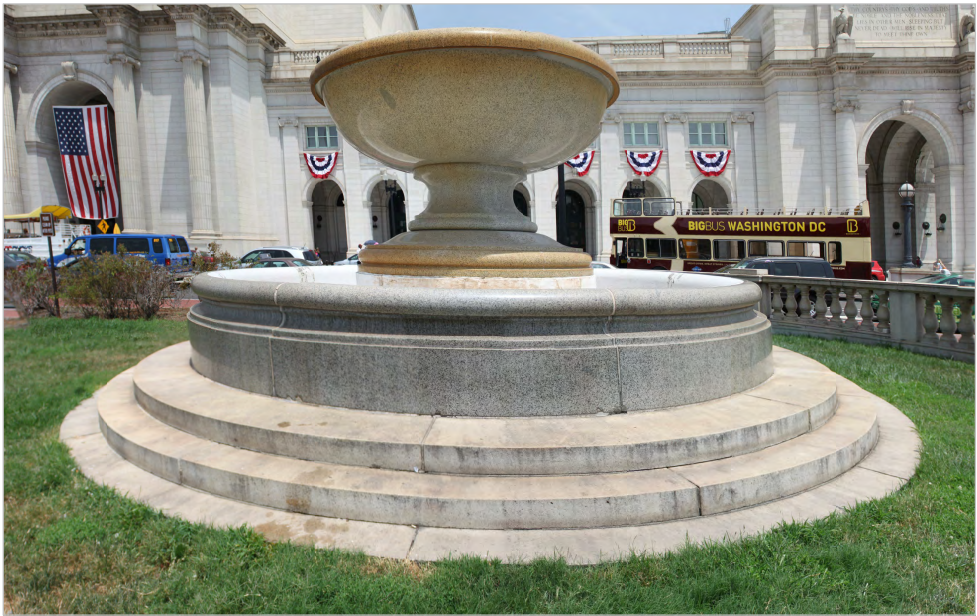
The polished granite stone bowl surface exhibits localized soiling, staining, and chalky white and red-orange encrustation layers. The polished surface is heavily deteriorated on the west bowl fountain, exposing the textured stone. The mortar joints on both the bowl and base are generally very deteriorated and open. The fiberglass liners for the basin of the fountain are largely missing, with remaining sections very deteriorated. The bowl is heavily soiled on the interior surface with a thick coating of mud and debris. There are also isolated areas of graffiti.

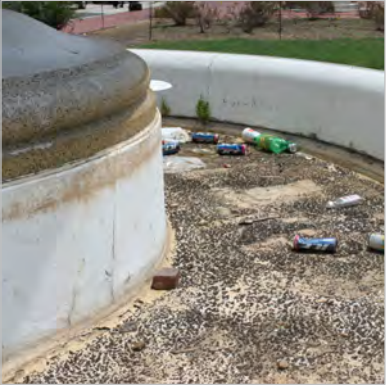
EXPOSED CONCRETE IN BASIN

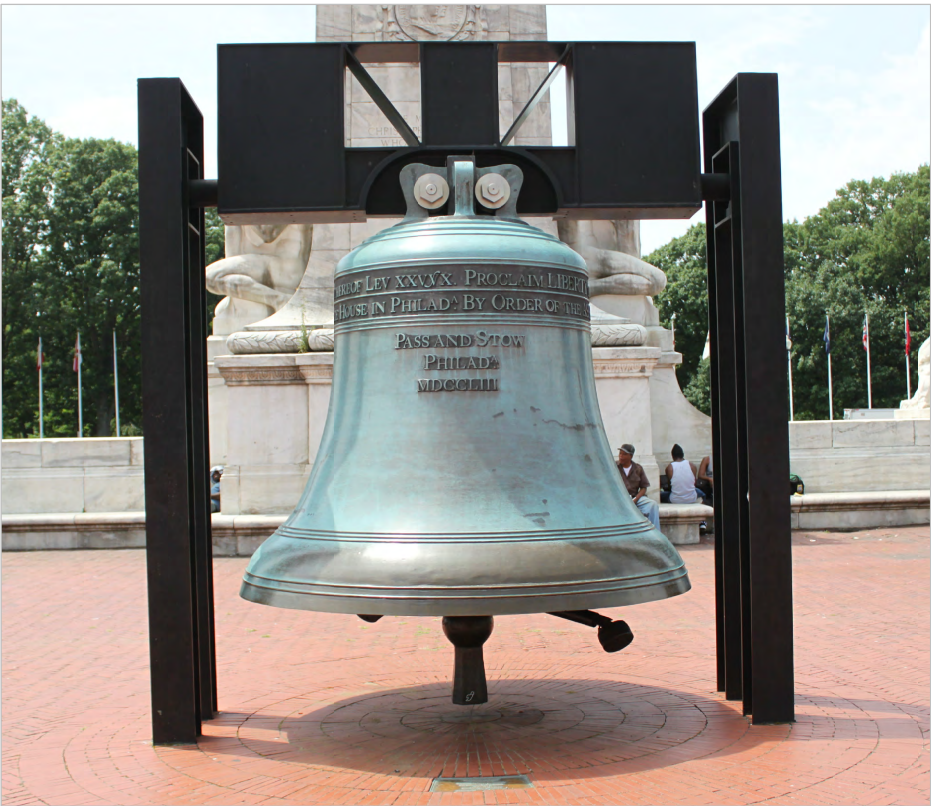
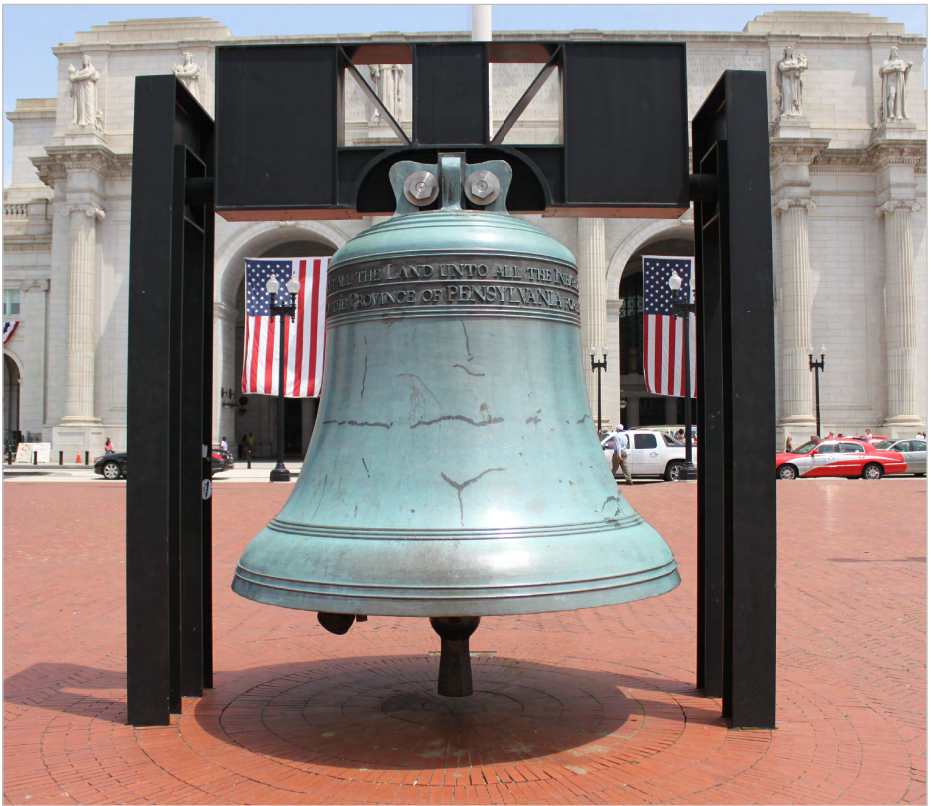
There are minimal isolated areas of corrosion on the metal surface where the protective coating has failed. The bronze bell and horizontal bands of lettering on the exterior have extensive wax buildup and traces of an adhesive residue across the surface. The interior of the bell has extensive graffiti.

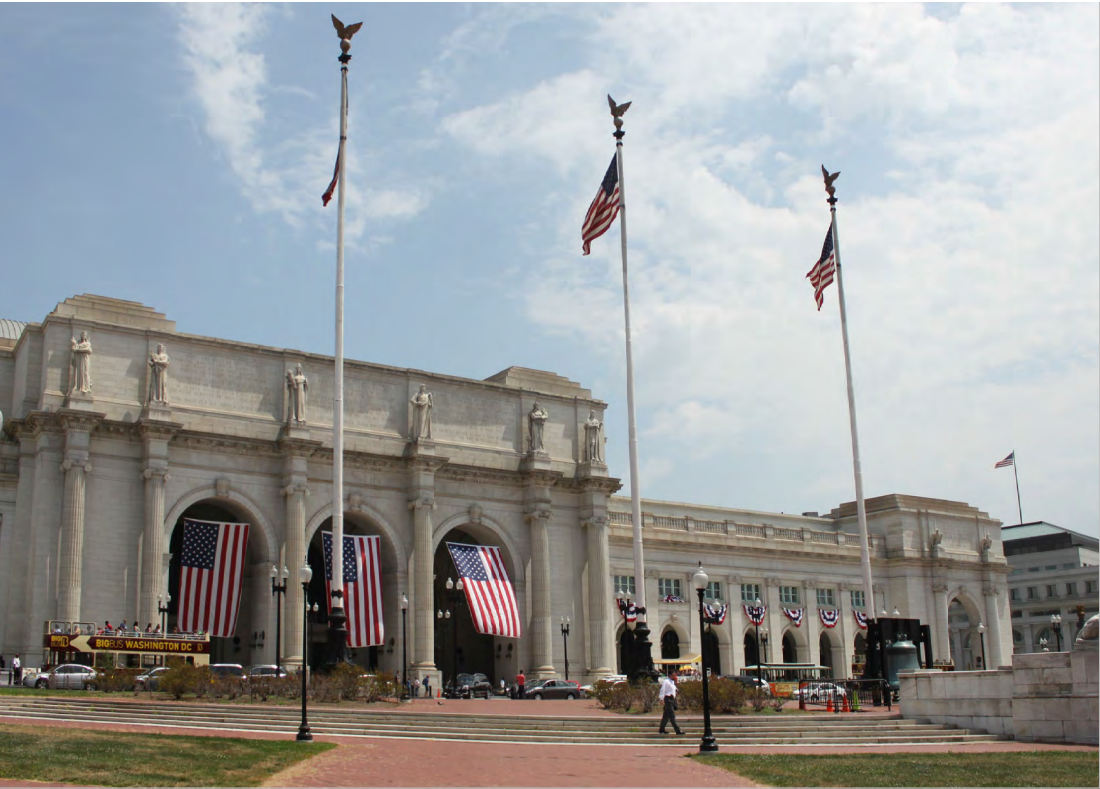
1. FLAGPOLES, LOOKING NORTH

Localized spalls, minor cracking, iron staining, and soiling is typical at the granite pedestals. Most of the mortar joints are deteriorated and open, with vegetation growing in isolated areas. There are minor isolated areas of surface corrosion on the cast iron bases where paint has failed. The flagpole shafts have large areas of paint loss and surface corrosion. The decorative eagles are finished in gold, which is deteriorated on the west and east flagpoles.

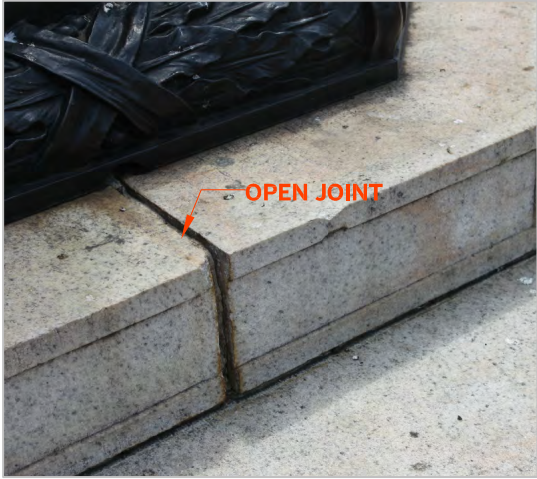
OPEN JOINTS IN GRANITE PEDESTAL

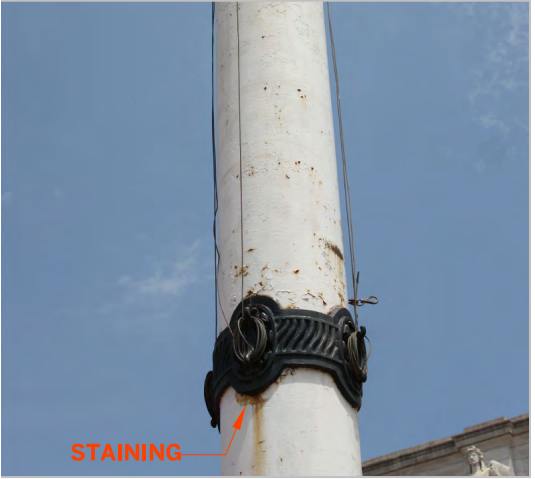
PAINT FAILURE ON FLAGPOLE SHAFT

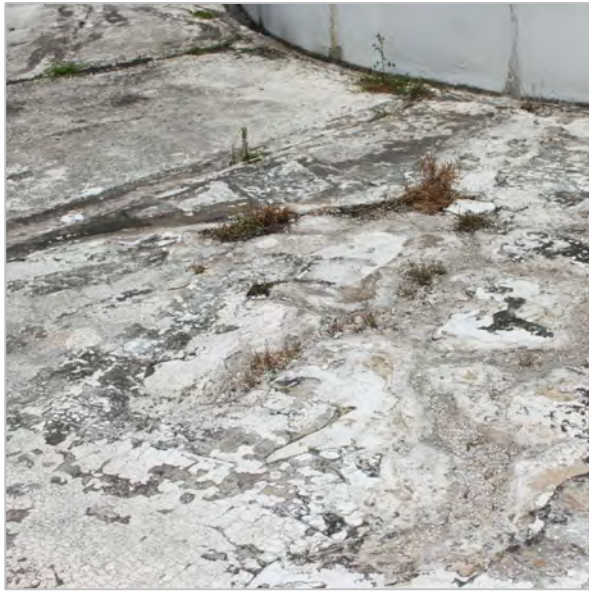
Heavy soiling and staining, along with cracking, pervasive spalls, and surface erosion is typical throughout the granite elements. In general, the worst stone conditions appear below the water table course. Most of the mortar joints are deteriorated and open. There is extensive bird activity, especially at the crowning globe on the central orthogonal shaft. Diagonal cracking is apparent on the south faces of the east and west lion sculptures. The fiberglass liners in the fountain basins are deteriorated or missing, and visible portions of the concrete slab below exhibit spalls and cracking. Much of the coating on the stone of the two semicircular fountain pools is flaking and lost.

BASIN COATING FAILURE

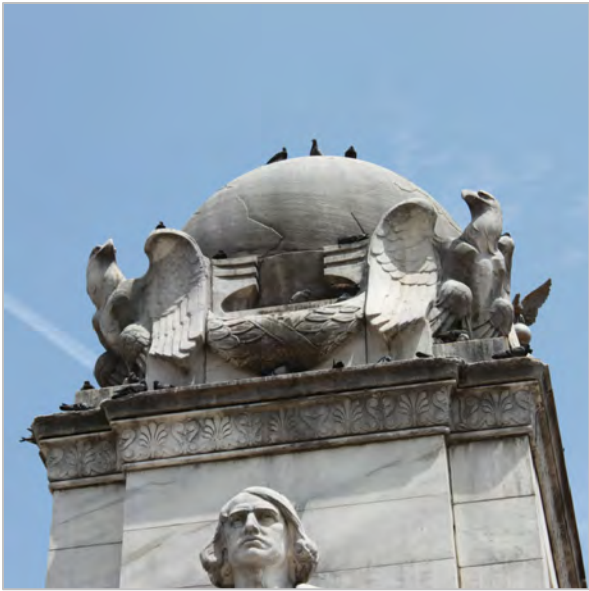
HEAVY BIRD ACTIVITY ON SCULPTURE

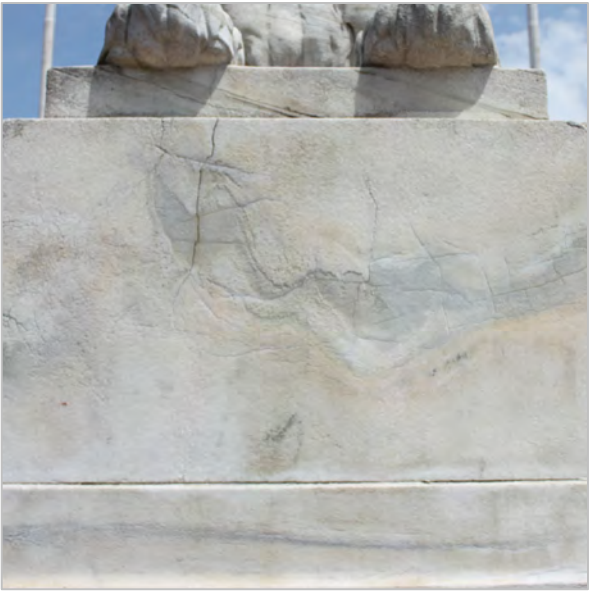
MAP CRACKING ON STONE SURFACE

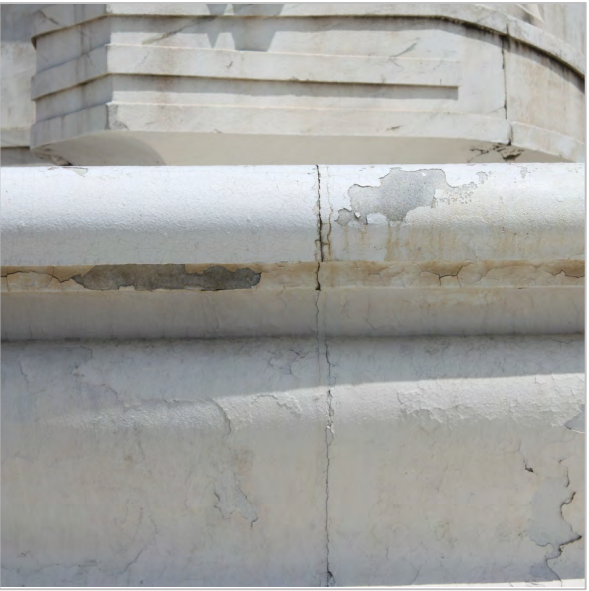
PAINT FAILURE ON FOUNTAIN BASIN

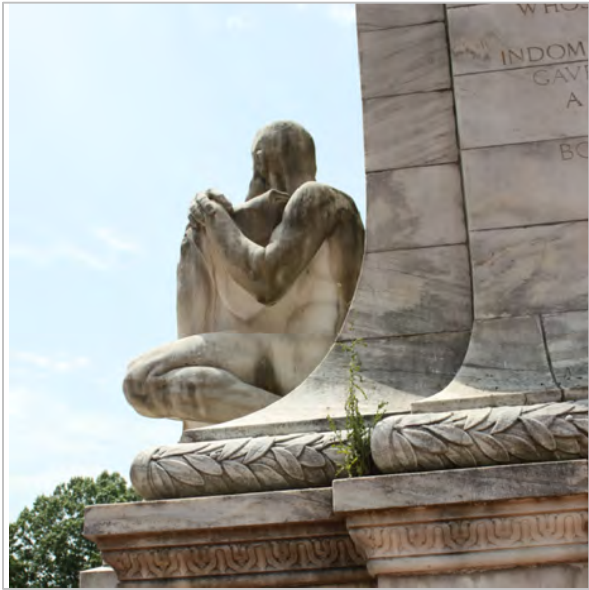
GENERAL SOILING AND VEGETATIVE GROWTH

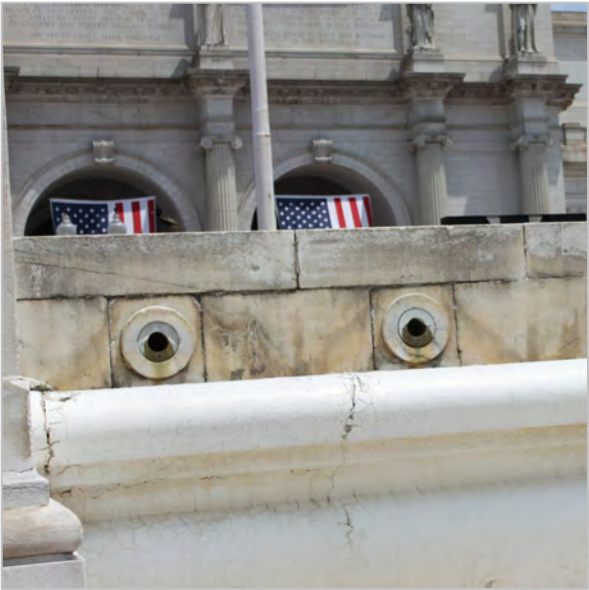
STAINING AND STONE DETERIORATION AT WATER SPOUT

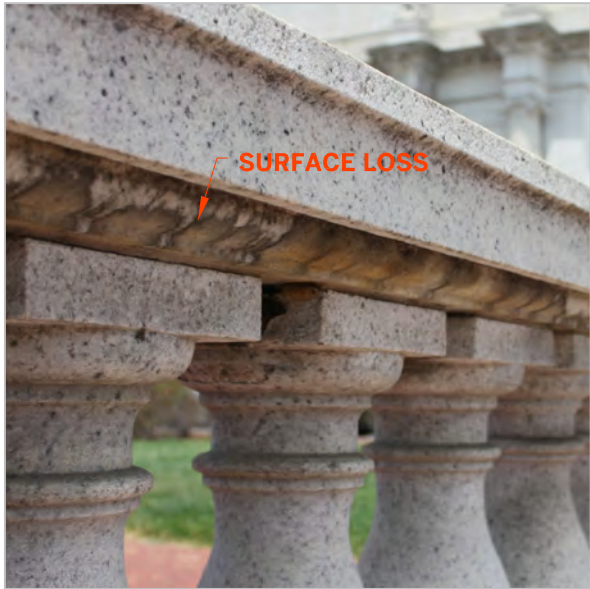
Soiling and staining of the granite surface is pervasive throughout each set of balustrades. The worst stone conditions include delaminating, brittleness, and spalling at the underside of the top rails and top portions of the balusters. Cracking of the balusters is more dramatic on the east side. The mortar joints are generally very deteriorated and open and have become hosts for vegetation and debris. A yellow residue was observed under the drop edge on the east side.

SURFACE LOSS AT UNDERSIDE OF RAILING

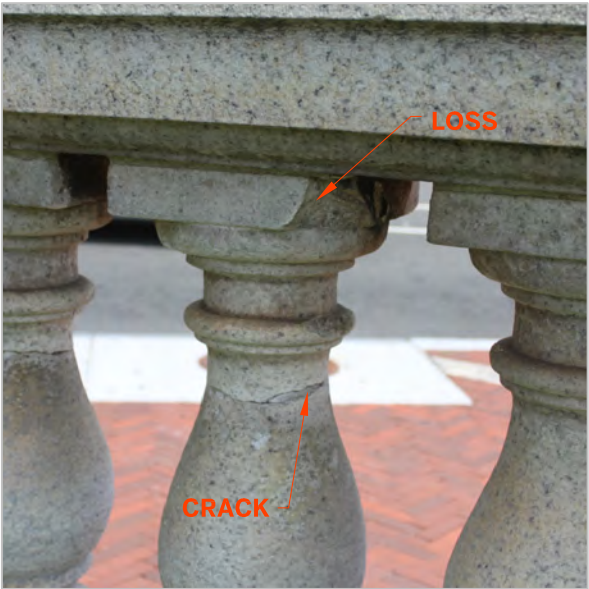
CRACKING AND LOSS AT BALUSTER

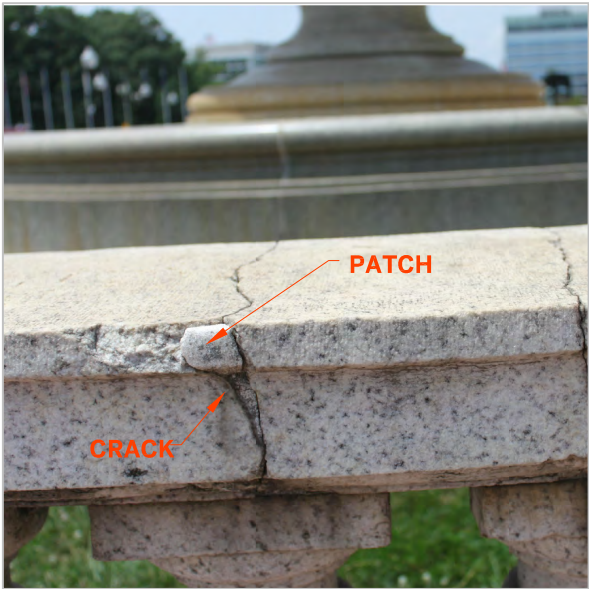
CRACKING AND PATCH THROUGH BALUSTRADE RAILING

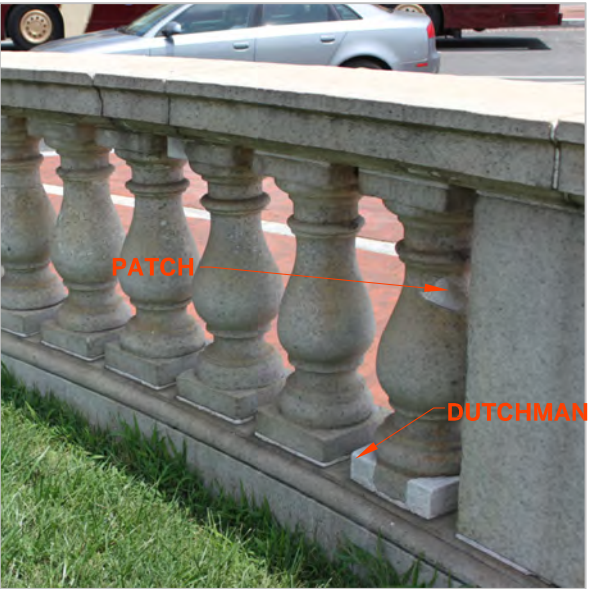
CRACKS AND PATCHES ON BALUSTERS

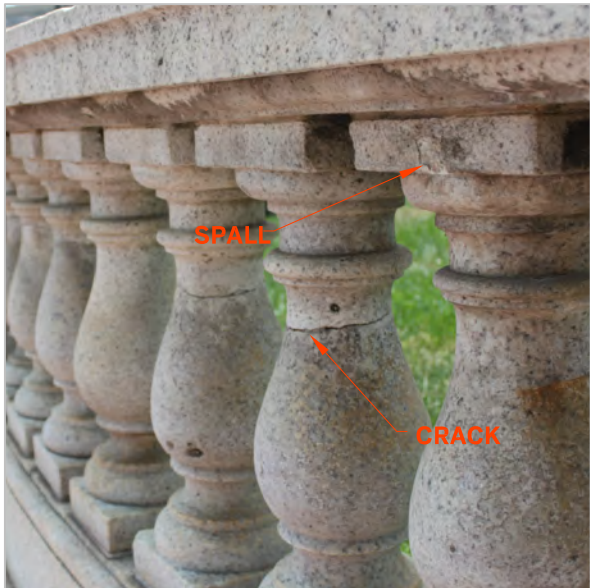
SPALLS AND CRACKS AT BALUSTERS

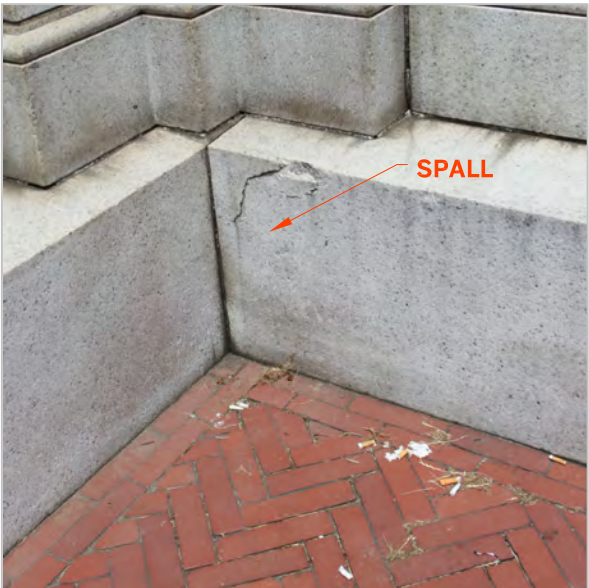
SPALL AT BASE OF BALUSTRADE

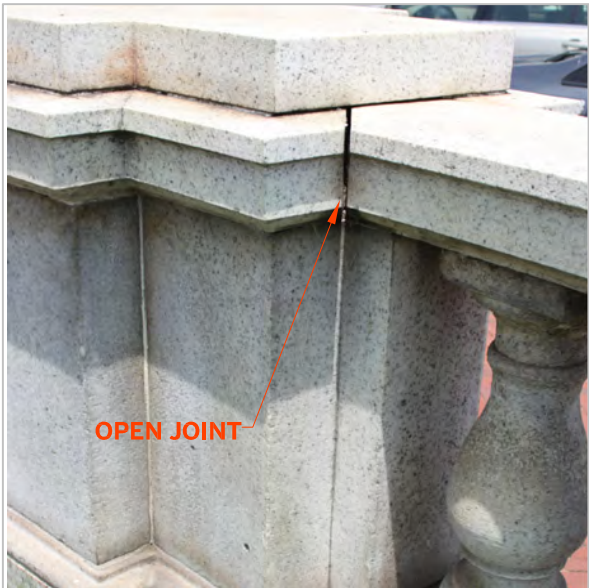
OPEN JOINTS IN BALUSTRADE ASSEMBLY

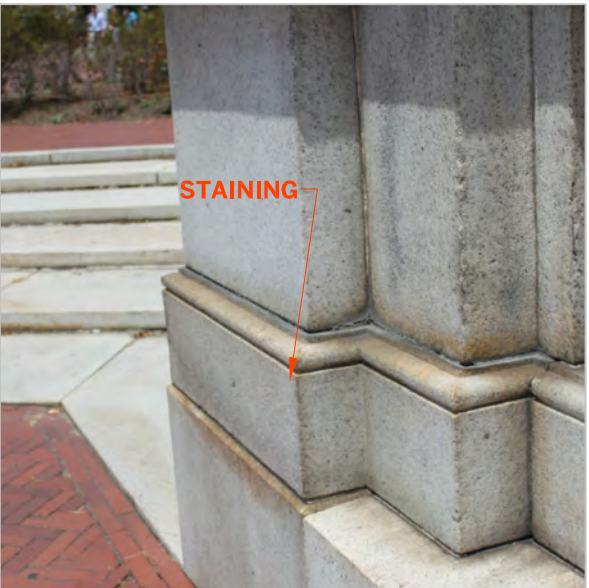
STAINING ON STONE BALUSTRADE
